**AIRCRAFT SERIOUS INCIDENT
INVESTIGATION REPORT**

KOREAN AIR

H L 7 2 4 0

**KOREAN AIR
AIRBUS INDUSTRY A300B4-600R, HL7240
AT AN ALTITUDE OF APPROXIMATELY 33,000 FT, OVER THE
VICINITY OF HIKARI CITY, YAMAGUCHI PREFECTURE,
JAPAN
AT ABOUT 19:36 JST, JUNE 23, 2009**

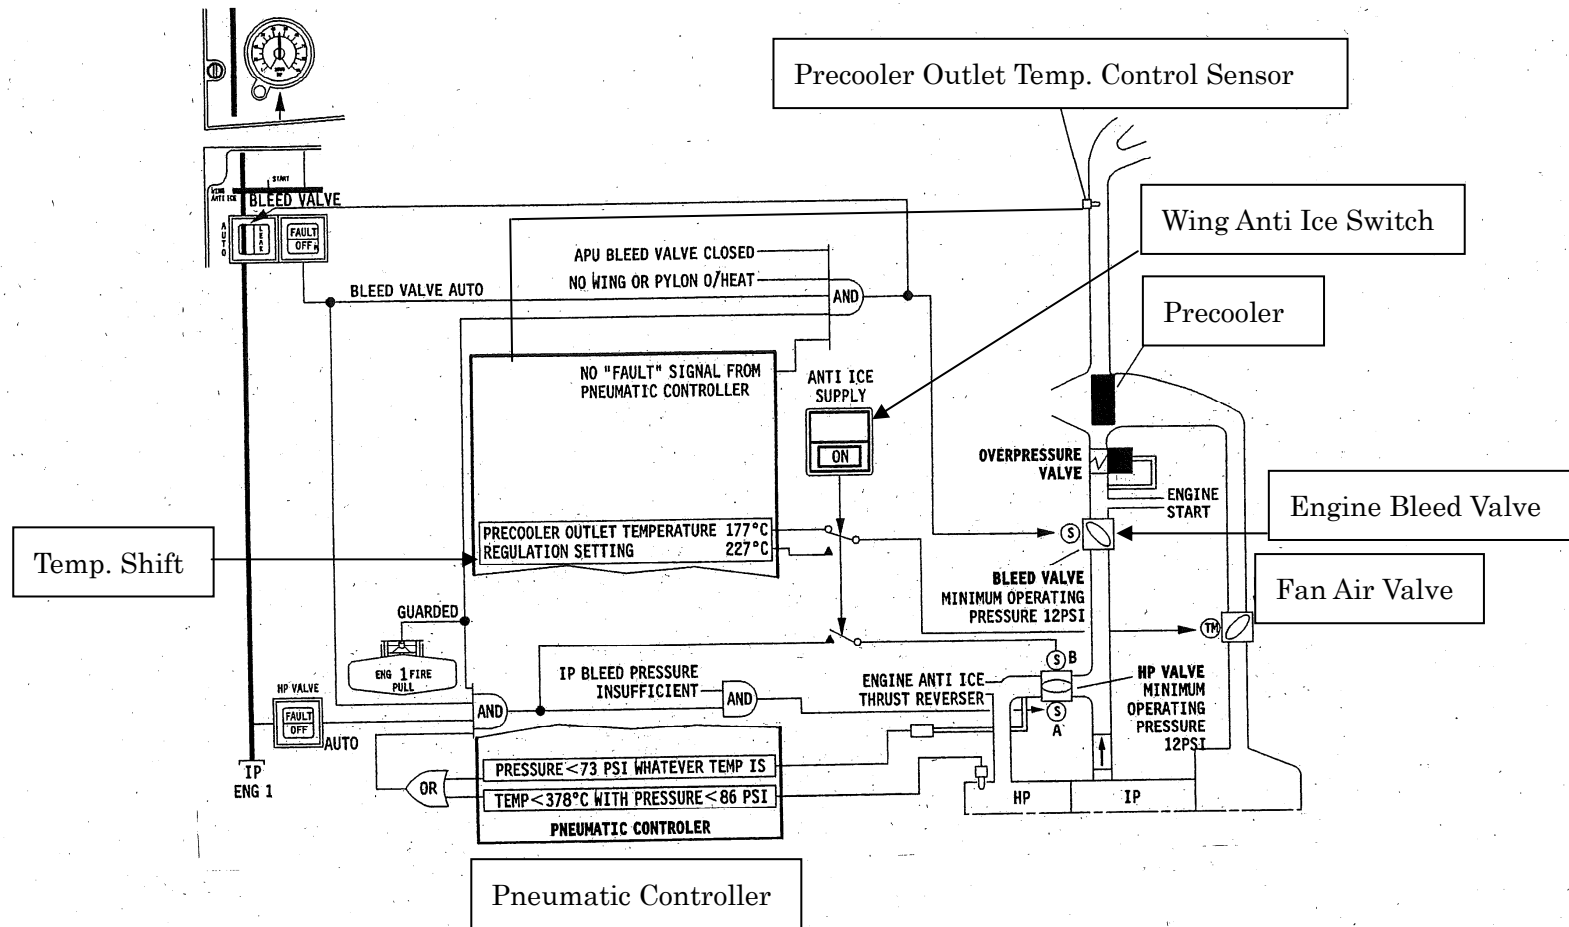
Figure 6 Fan Air Valve Control

- (2) It is considered highly probable that the reason why the “ENG BLEED 2 FAULT” message was displayed on the ECAM is, as suggested by the inspection results in 2.12, that the failure of the No. 2 pneumatic controller on temperature shift made the No. 2 engine bleed valve closed. At the same time, as the manufacturer of the Aircraft stated in 2.14 (4), it is considered somewhat likely that the bleed valve closed as a result of detection of overheating.

Temp. Shift by Pneumatic Controller :

- When Wing Anti Ice OFF : $177 \pm 12^{\circ}\text{C}$
- When Wing Anti Ice ON or Air Bleed One system OFF : $227 \pm 12^{\circ}\text{C}$

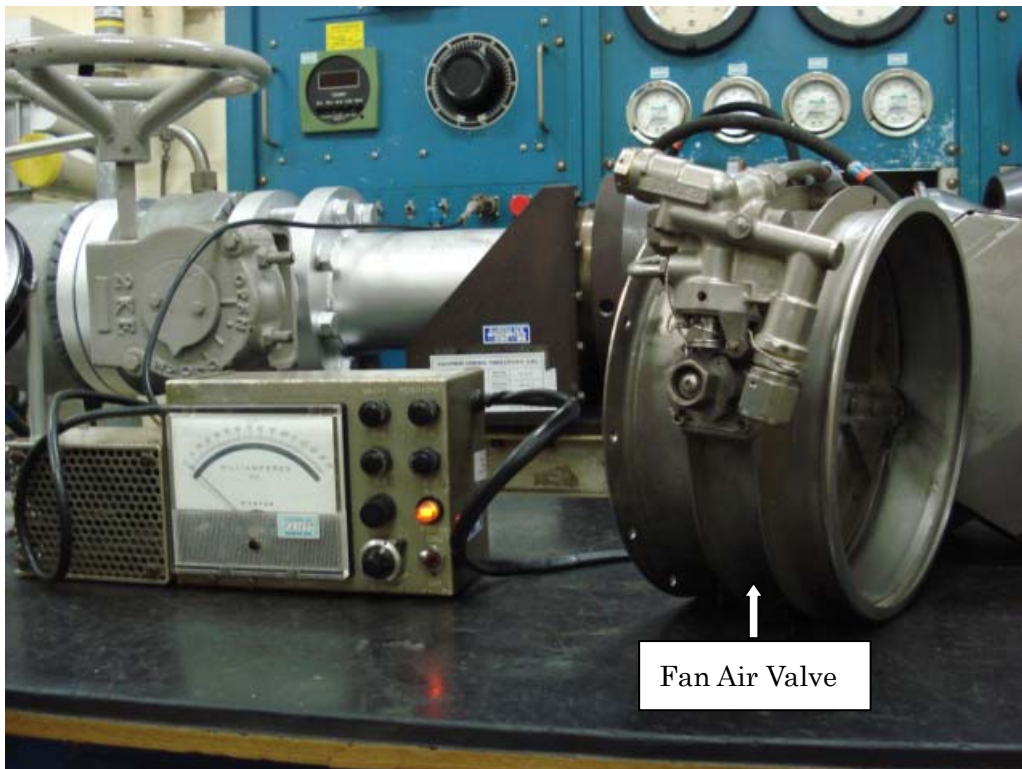
Photo 8 Fan Air Valve

- ① There was no external damage to the receptacle pins.
- ② The valve position light on the control box did not illuminate when the fan air valve butterfly was moved from the "close position" to the "open position."
- ③ Continuity test on the position switch revealed intermittent loss of continuity at Pin C *¹¹.
- ④ When the compound was removed from the connector, a slight gap was found in the weld of Pin C.
- ⑤ There were traces of arcing caused by the poor weld of Pin C.

Based on the above, it was determined that poor continuity caused by the poor weld of Pin C contributed to the display of the "BLEED FAULT" message in the cockpit.

- (1) The “ENG BLEED 1 FAULT” message was displayed on the ECAM soon after the wing anti-ice system was turned on. As described in 2.12, poor welding was found on a connector pin of the No. 1 fan air valve. It is therefore considered highly probable that this poor welding caused the failure of the temperature shift function, which would have changed the temperature setting of the pre-cooler outlet from 177°C to 227°C when the wing anti-ice system was turned on, making the No. 1 engine bleed valve closed, and resulted in displaying of the message on the ECAM. At the same time, as the manufacturer of the Aircraft stated in 2.14 (4), it is considered somewhat likely that the bleed valve closed as a result of detection of overheating.
