**AIRCRAFT SERIOUS INCIDENT
INVESTIGATION REPORT**

**KOREAN AIRLINES CO., LTD.
HL 7573**

AIRCRAFT DISABLED TO CONTINUE TAXIING
DUE TO FRACTURED LANDING GEAR AXLE
KOREAN AIRLINES CO., LTD.
BOEING 777-300, HL7573
AT NARITA INTERNATIONAL AIRPORT, JAPAN
AROUND 12:43 JST, JUNE 29, 2018

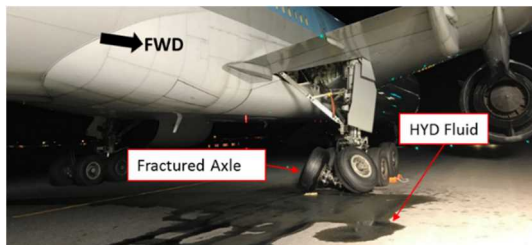
Figure 2 Condition of Aircraft

Around 13:10, the captain decided, from the information of the Narita Ground and, in addition, the detailed explanations on the condition of the aircraft from the engineers of the Operator, who arrived at the aircraft site, that the tires pointed to the unusual direction caused by the fractured axle and the hydraulic fluid was leaking, that the aircraft could not continue taxiing.

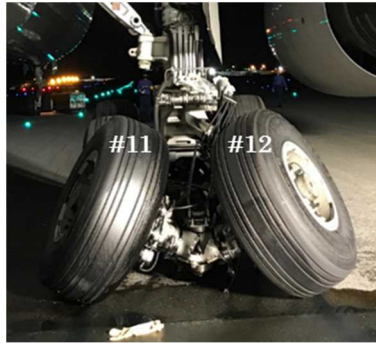
Figure 3 R-MLG (Rear View)

- Slightly damaged
- The R-MLG AFT Axle was fractured.
 - The R-MLG Truck beam was damaged.
 - The R-MLG Steering system was damaged.
 - Hydraulic hoses of Brake and the Steering system were cut.
 - Hydraulic system fluid leaked.
 - Brake components were damaged.
 - Electric cables and junction box of the R-MLG were damaged.

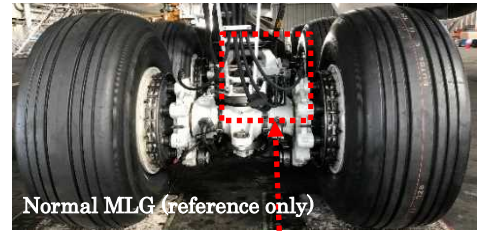
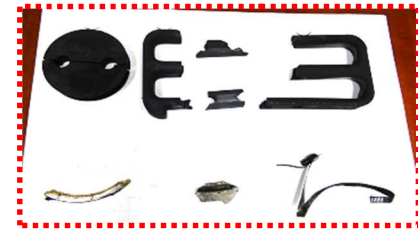
Figure 8 Recovered Parts from RWY

All parts recovered from runway and stated below turned out to be identical to the damaged portions of right main landing gear of the aircraft as a result of comparing (see Figure 8).

- Clamp of HYD hose
- Guide of HYD hose
- Thrust washer debris
- Axle debris

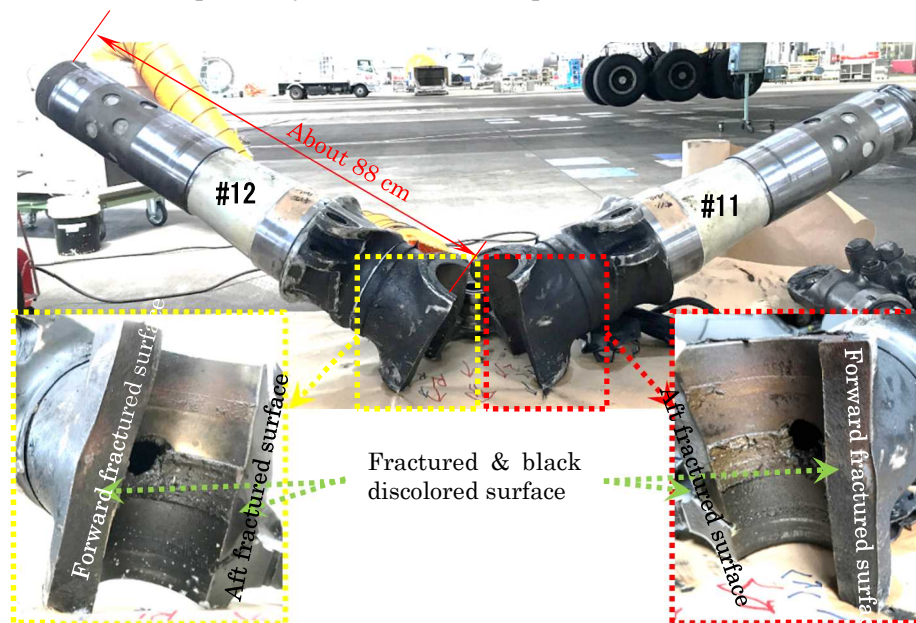
Figure 9 Fractured Axle of R-MLG (Front View)

new metal surface were confirmed on the fractured surface of the aft side of the pivot.

- i) The axle was fractured at the point of the pivot, and the bushing suffered damage as well. It was observed that the pivot, to which the bushings were attached, had corrosion and wearing.
- ii) Material analysis and hardness test were conducted on the heat-treated axle, which indicate that metallic composition and hardness met the

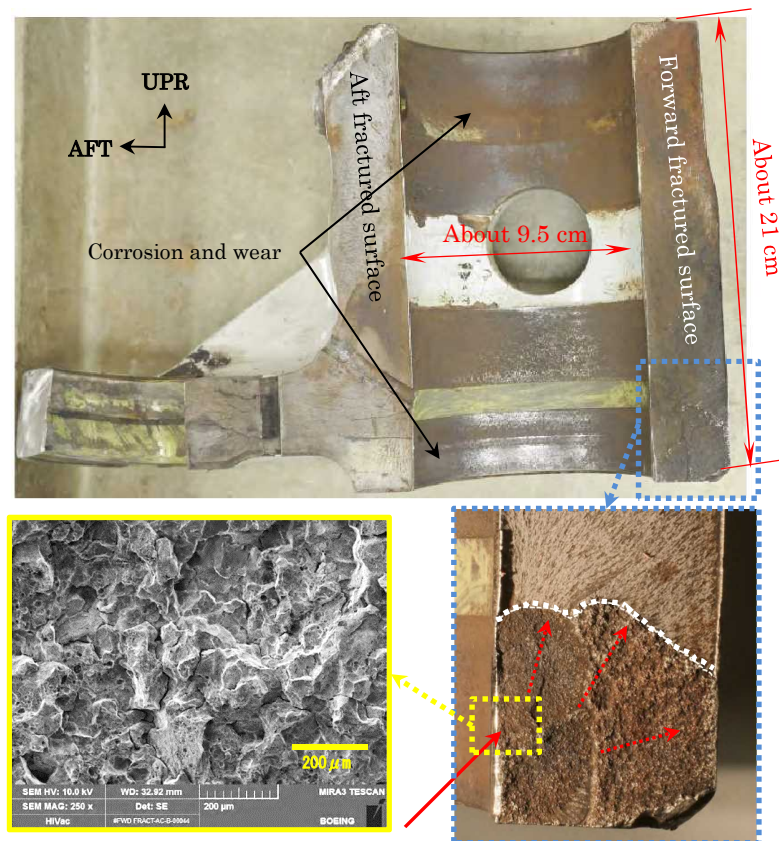
Figure 10 Forward Fractured Surface of Left Half of Fractured Axle (after Cleaning)

- iii) Part of the axle was cut and cleaned for observation using Scanning Electron Microscope (SEM).
- iv) The front fractured surface had a corrosion initiating region on the lower side of the pivot bore (see red arrows in Figure 10), which was further developed to SCC (see white dotted line in Figure 10).
- v) The aft fractured surface had a corrosion initiating region on the lubrication passage on the lower side of the pivot bore, which was further developed to SCC. It was observed that the cracking that further progressed afterward (see red dotted lines in Figure 11).

SCC Initiating Region

and finally was fractured due to repetitively imposed loads. Besides, it is highly probable that a long period of time had passed since the fracture occurred from the entire fractured surface, which was discolored black by dusts and corrosion. However, it could not be determined when the fracture had occurred due to the nature of corrosive condition of the fractured surface, which varies depending on the operating environment of aircraft.

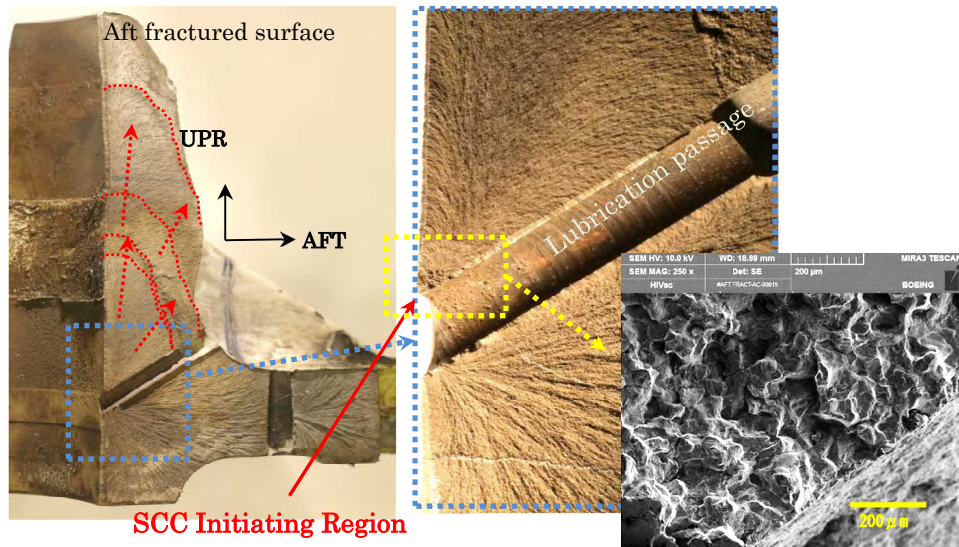
Figure 11 Aft Fractured Surface of the Right Half of the Fractured Axle (after Cleaning)

It is probable that the aft fractured surface was caused by SCC initiated by the corrosion generated on the lubrication passage, which then led to progressing cracking due to repetitively imposed loads. Besides, part of the aft fractured surface was discolored black by dusts and corrosion. In view of what is stated above, it is highly probable that the forward side of the pivot bore had fractured first; and, even thereafter, the aircraft kept operations with the aft side of the pivot bore partially cracked. Consequently, it is highly probable that the axle was finally fractured at the time of landing in the serious incident.

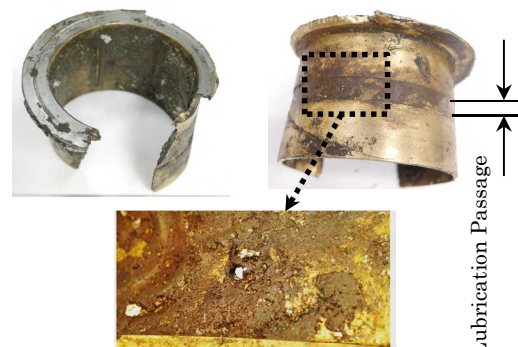
Figure 12 Bushing B2

Dried and Hardened Grease in Lubrication Passage

viii) Remnants of dried and hardened grease residues were found at multiple locations (G3, B2, B3 and Thrust washer) throughout the pivot joint assembly lubrication passage. These Clay-like products impeded the proper flow of grease to the pivot joint interfaces.

(9) It is also probable that “dried and hardened grease” sampled from the pivot could possibly contributed to the pivot pin and the bushings, which impeded the free rotation of the pin. It is possible, from the fact that the Operator did not have records of using Clay-thickened grease in the grease up work of the pivot joint, that the grease in question was Clay-thickened grease (ASG 7), which had been applied during the overhaul in 2009 and had remained in the lubrication passage until the serious incident. Dispense grease into the grease fitting until the used grease is visually removed and only new grease comes out in one or more locations at this joint interface; however, it is probable that AGS 7 grease applied during the overhaul had not completely been replaced with new grease ASG 33, and then, it dried up and became solid due to the absence of circumferential grease groove on bushing ID surface and the limited grease to no more than 10 - 15 pumps from a grease gun according to AMM.

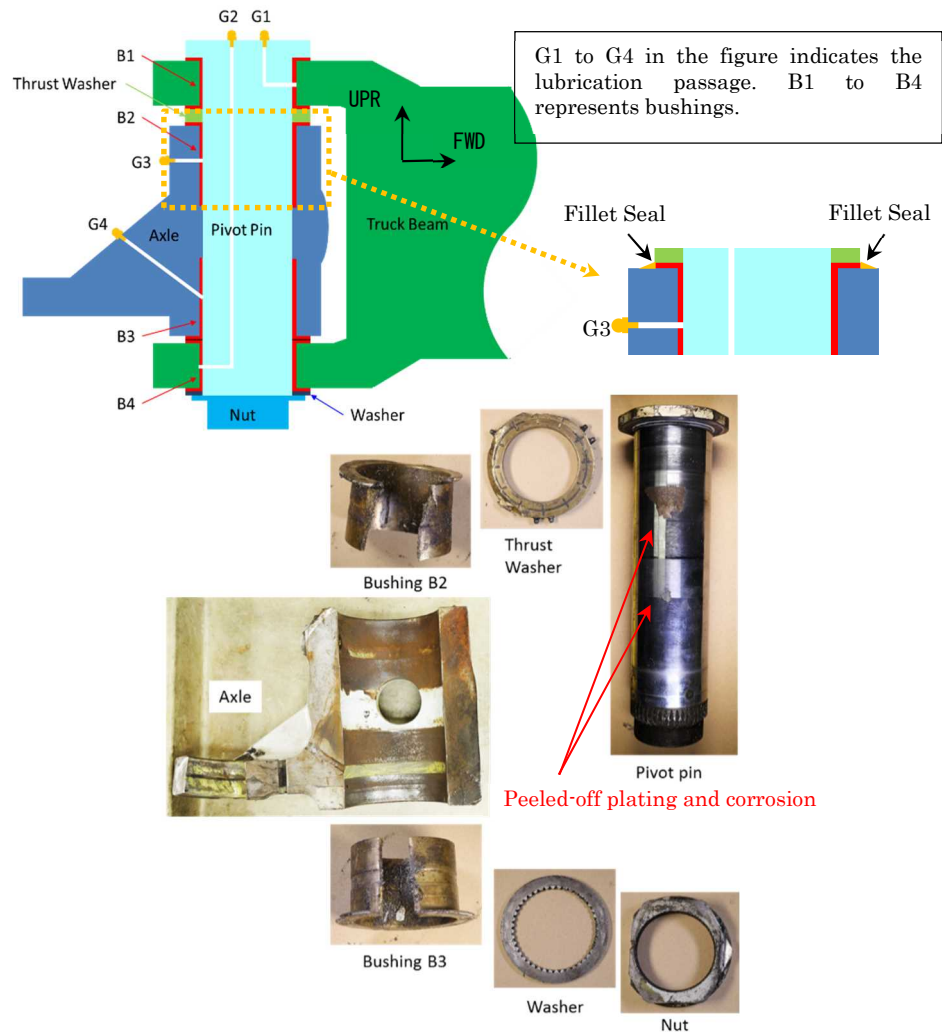
Figure 13 Cross Sections of Pivot and Disassembled Parts

vi) Wear and corrosion were generated on the inner surface of the pivot. The bushings were press-fitted to the inner surface of the pivot and a fillet seal is applied on flange to prevent environmental ingress (see Figure 13). It is probable that the fillet seal was damaged due to the rotation of the bushings, which allowed water to penetrate between the pivot bore and the bushings; and thereafter, plating and primer applied on pivot bore were deteriorated, peeled off, developed to wearing and corrosion through a long period of time and finally resulted in the initiation of SCC. The observation indicates that the front side of the axle fractured first, followed by the fracture of the aft side.

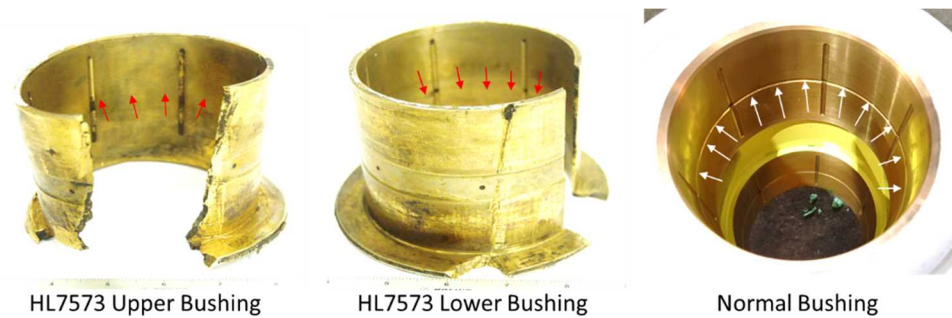
Figure 15 Circumferential grease groove on Bushing ID

The bushing is to have a grease passage (groove) on bushing ID surface in a circumferential direction formed by machining when it is manufactured at the time of overhaul. To the contrary, the fractured bushing did not have the circumferential groove (see Figure 15).

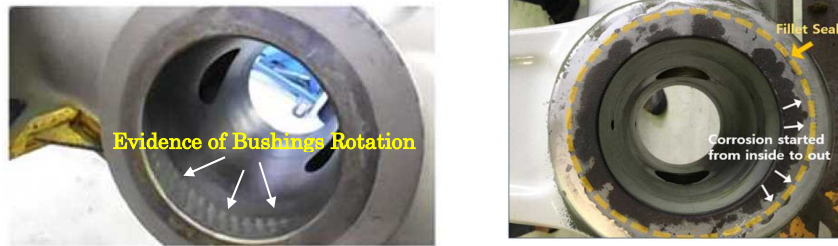
Figure 16 Axle Pivot of the Same Type of the Aircraft (after removing bushing)

It was confirmed that the axle of the pivot of the same type of the aircraft of the Operator, which had been overhauled before CMM was revised, had evidence of rotation of the bushings and corrosion in the pivot bore. Pivot pin and grease of axle pivot were maintained in good condition.

(11) Investigation of the condition of the axle pivots of the same type of the aircraft conducted by the Operator revealed that some of axles had corrosion. It is highly probable, from the fact that those axles had been overhauled before CMM was revised, that the corrosion inhibitor, which had not been coated on bushings assembly portions, contributed to the corrosion. Besides, it is observed that even the axle pivot, which kept the pivot pins and grease in good condition, had evidence of bushings rotation. This implies that the bushings could possibly rotate even if the pivot pin did not impede the free rotation of

<p>The Operator conducted visual inspection on seven aircraft, which had been overhauled before CMM was revised, to see if they had any damage. Thereafter, the Operator replaced all of aft axles of the main landing gear of those seven aircraft (14 axles in total).</p> <p>The Operator implemented measures, which ensures that adequate grease up work is conducted, by adding in the job card appropriate ways to take in the event that plugging up has occurred during the grease up work, and eventually, has prevented new grease from spreading thoroughly in the surfaces.</p>
--
