**AIRCRAFT ACCIDENT
INVESTIGATION REPORT**

ASIANA AIRLINES INC.

H L 7 7 6 3

ASIANA AIRLINES INC. (REPUBLIC OF KOREA)
AIRBUS A321-200, HL7763
ON RUNWAY 06L OF KANSAI INTERNATIONAL AIRPORT
AT ABOUT 10:08 JST, OCTOBER 28, 2009

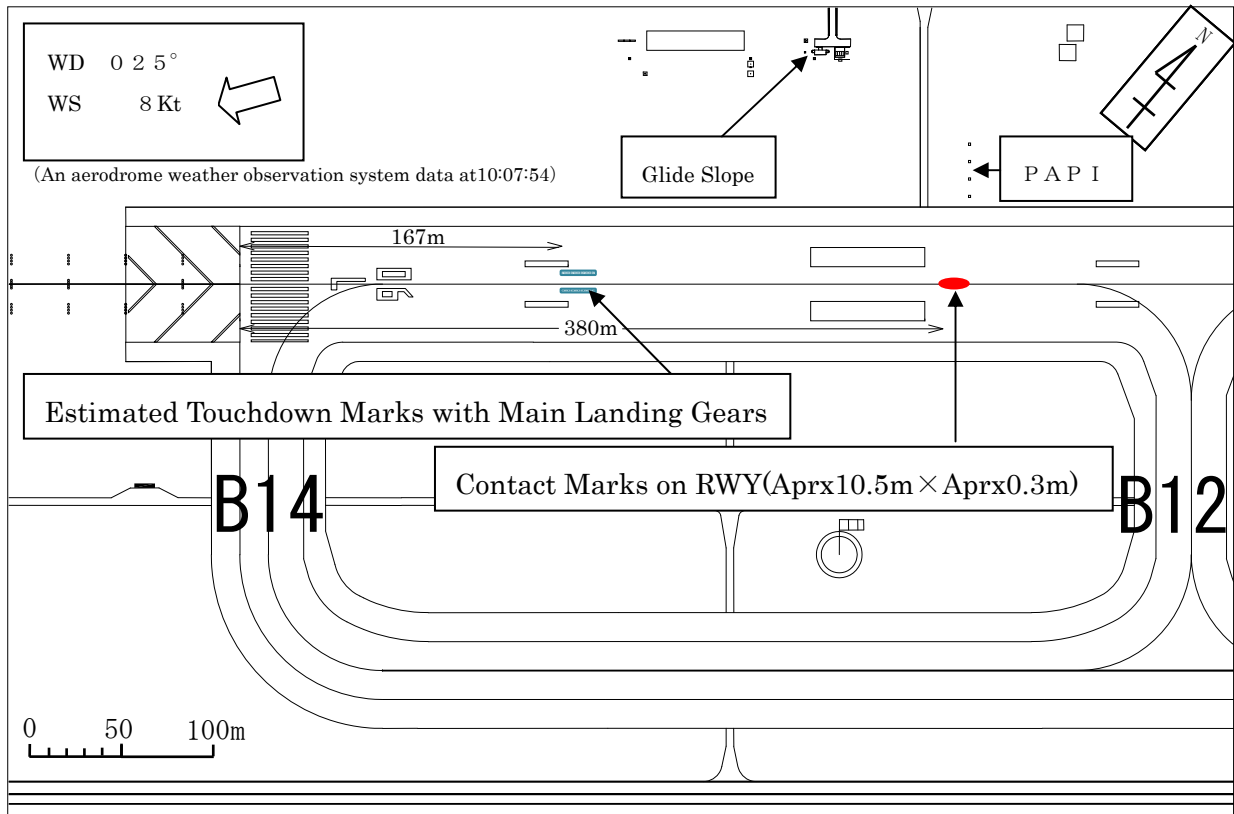
Figure 2 Accident Site Layout

- (1) The Airport is an offshore airport located about 5 kilometers off the Senshu coast facing Osaka Bay in the southern part of Osaka Prefecture. It has two runways that run parallel to each other along the coastline—runway A with a length of 3,500 meters and a width of 60 meters (06R/24L) and runway B with a length of 4,000 meters and a width of 60 meters (06L/24R) which connects to runway A via taxiways and lies about 2 kilometers further off the runway A.

- (2) Parallel tire marks at a distance of about 7.6 meters were left intermittently from a point about 167 meters from the threshold of runway 06L. The distance between the marks corresponded to the center-to-center distance between the two main landing gears of the Aircraft.

- (3) Contact marks of orange paints had been left in an area about 10.5 meters long and a maximum about 0.3 meter wide on the runway center line from a point about 380 meters from the threshold of runway 06L. The contact marks left on the runway and the skin abrasion seen in the lower aft part of the Aircraft's fuselage almost corresponded with each other.

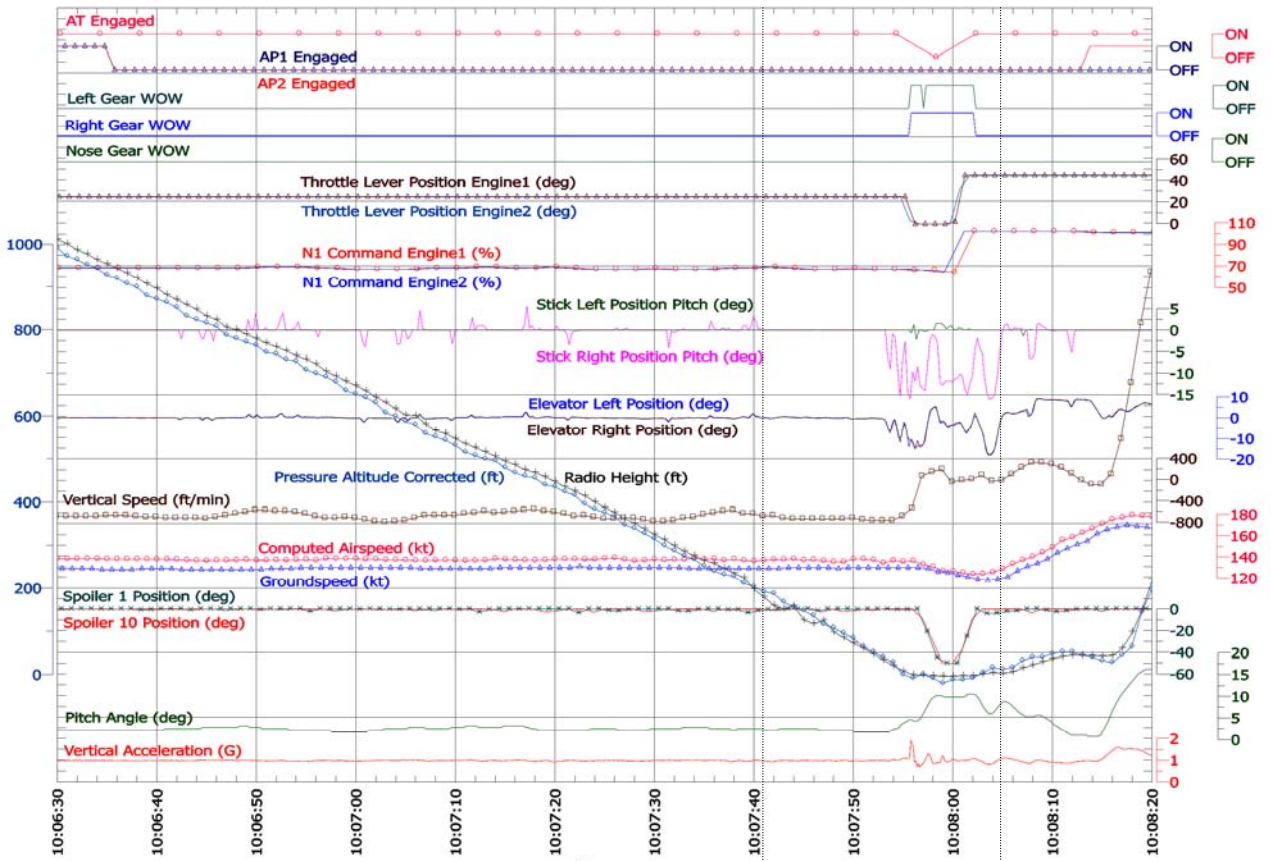
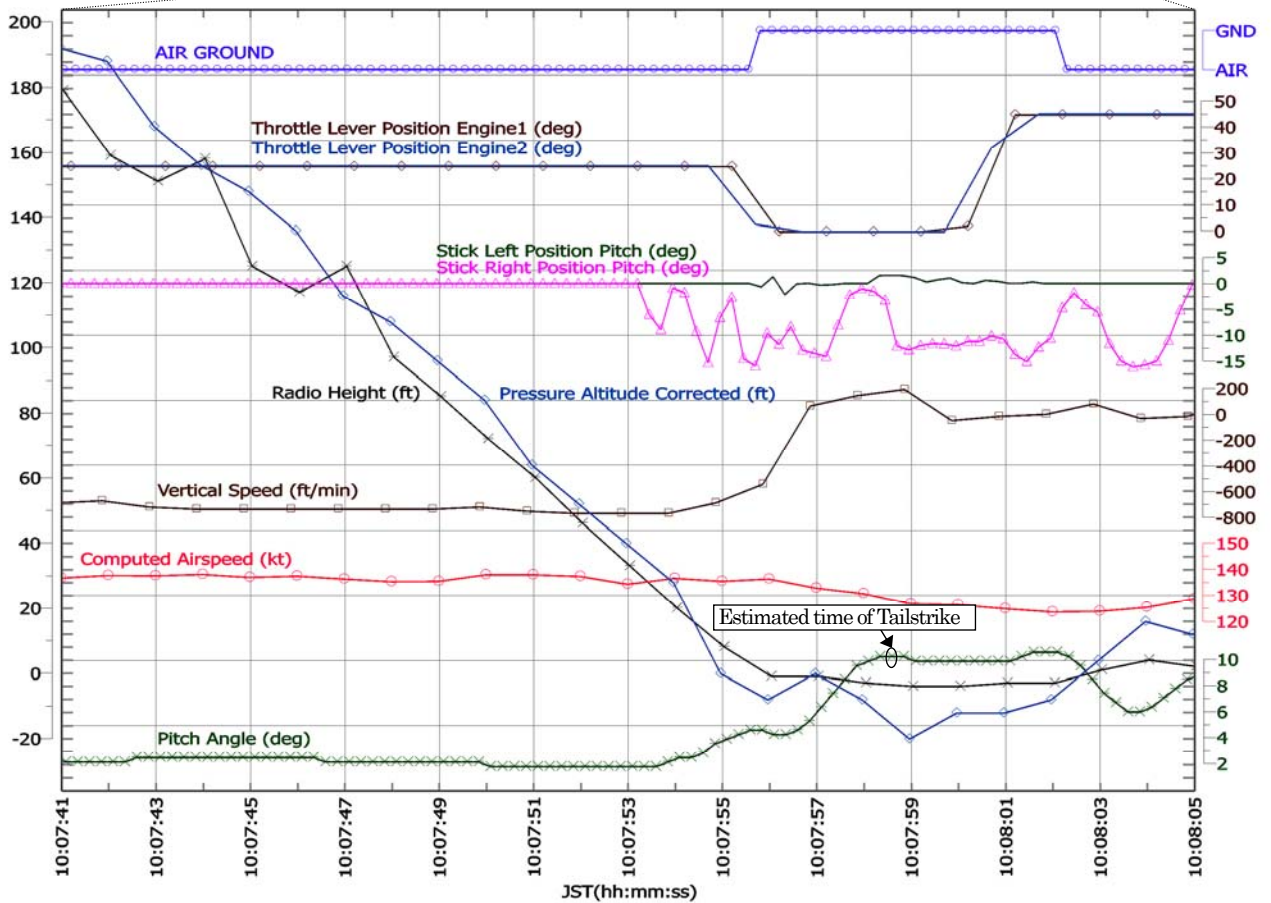
Figure 3 DFDR Records

Radio Altitude	(125 ft)	(85 ft)	(46 ft)	Start of Flare (33 ft)	Touchdown (-1 ft)
CAS (kt)	137	135	137	134	136
Pitch angle (degree)	2.5	2.1	1.8	1.8	4.6
Descent Rate (ft/min)	736	736	768	768	544

Judging from the DFDR records in Figure 3, it is considered highly probable that a flare operation was started by the First Officer from an radio altitude of 33 feet by moving the side-stick on the right side. It is considered probable that, this made the pitch angle of the Aircraft begin to increase gradually from 1.8 degrees, but just after this, since the side-stick was returned to 0.9 degree, the elevator angle became zero degree, and caused temporarily leveling off of the increase of the pitch angle.

Later, a nose-up signal for a maximum of 15.9 degrees was inputted from the side-stick. It is considered highly probable that this operation caused the pitch angle to begin to increase again and the pitch angle became 4.6 degrees at the time of touchdown. The altitude where the flare operation was initiated was in line with the provisions described in 2.11.4, but the Aircraft's descent rate decreased from 768 ft/min at the time of initiating the flare to only 544 ft/min at the time of touchdown as described in 2.11.2. There was no major change in the CAS, either. Therefore, it is considered highly probable that the effect of this flare operation was not sufficiently effective. With regard to the insufficient effect of the flare operation, it is considered highly probable that, since the return of the side-stick caused the temporarily leveling off of the increase of the pitch angle as described above, there was not enough time to increase the pitch angle to a level where a necessary lift can be obtained to reduce the Aircraft's sinking.

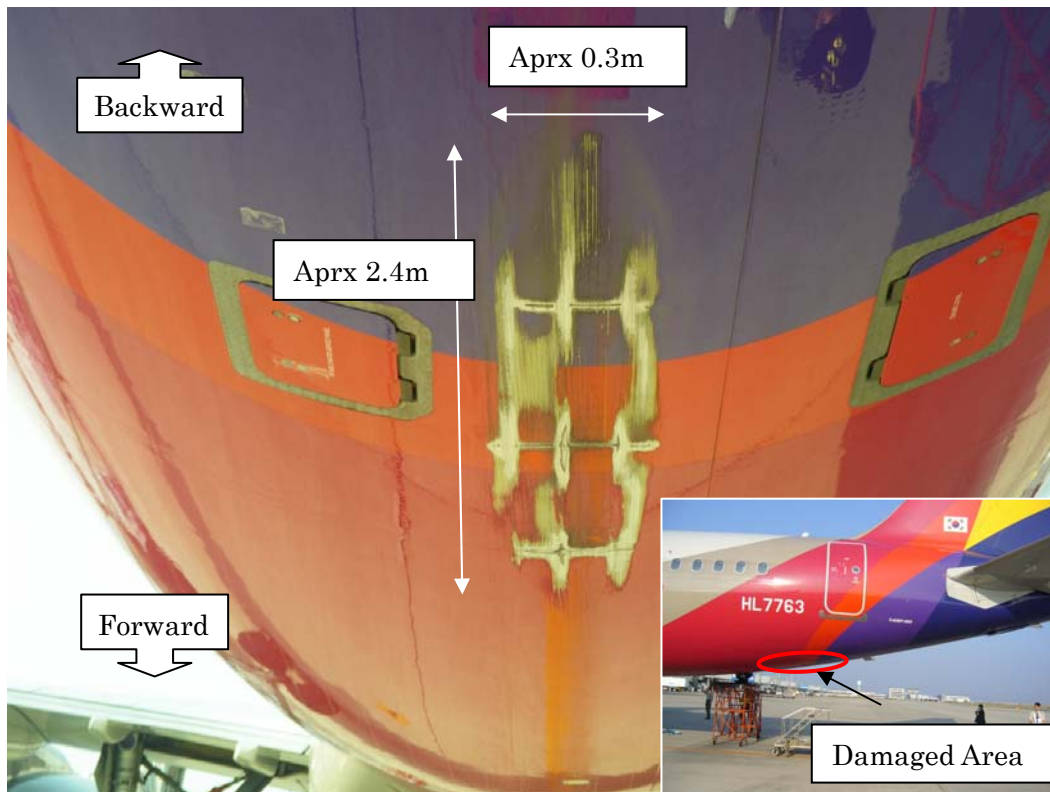
Photo 2 Damaged Fuselage

(1) Fuselage

- ① Skin abrasion was found in an area about 2.4 meters long and a maximum about 0.3 meter wide on the lower aft part of the fuselage.
- ② The following damages were found on three pieces of frame in the aft part of the fuselage where skin abrasion was found:

FR64	20 centimeters long, 1.8 millimeters deep
FR65	28 centimeters long, 3.8 millimeters deep
FR66	16 centimeters long, 1.0 millimeter deep

Skin abrasion was found with the water drain mast.

In this accident, it is considered highly probable that, during the landing on Kansai International Airport, the Aircraft sustained damage in the aft part of the fuselage which contacted the runway, since the pitch angle became excessively large after the touchdown on the runway.
