**AIRCRAFT ACCIDENT
INVESTIGATION REPORT**

ASIANA AIRLINES INC.

H L 8 2 5 8

PASSENGER INJURY BY THE SHAKING OF THE AIRCRAFT
ASIANA AIRLINES INC.
AIRBUS A330-300, HL8258 (THE REPUBLIC OF KOREA)
AT AN ALTITUDE OF APPROX. 40,000 FT, OVER MATSUE CITY,
SHIMANE PREFECTURE, JAPAN
AT AROUND 15:17 LOCAL TIME, AUGUST 21, 2012

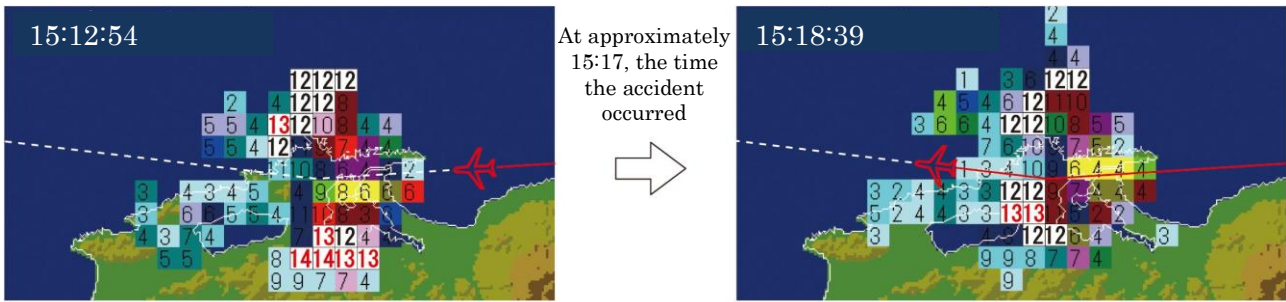
According to Doppler radar echo top distribution imagery from equipment installed at Miho Aerodrome adjacent to the accident occurrence point, within the time period of the accident multiple cumulonimbus were generated as a cluster in the vicinity of the accident airspace. The clouds were analyzed to be cumulonimbus with a cloud top height exceeding the Aircraft's flight altitude of 40,000 ft.

Numbers within frames indicate the maximum cloud top height (units: 1,000 m) within those frames.

Maximum cloud top height within frame: 39,400 ft
	Maximum cloud top height within frame: 42,700 ft
	Maximum cloud top height within frame: 46,000 ft
	Estimated position of the Aircraft
* Taken from and added to materials provided by the Ministry of Defense

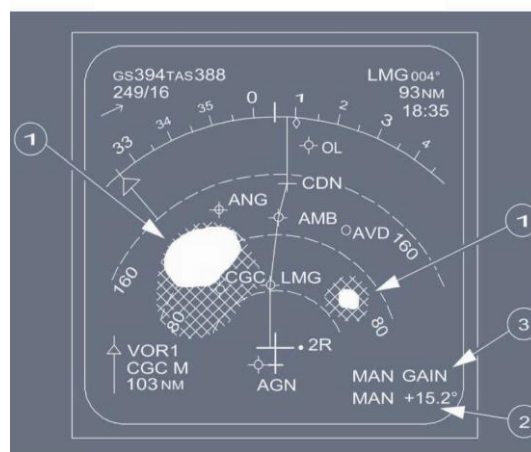
Example ND display

According to the statements in 2.1.2, at the time when the accident occurred the PIC and the R Captain indicated that they were using the weather radar but that no echoes were displayed on the ND. As described in 2.1.1 and 2.8, however, the Aircraft's weather radar was off. Because there were no malfunctions found with the Aircraft's weather radar system, it is highly probable that if the weather radar image on the ND had been on, the operating status of the weather radar could have been confirmed even without echoes by using the ND display (e.g., radar sweep, tilt angle).

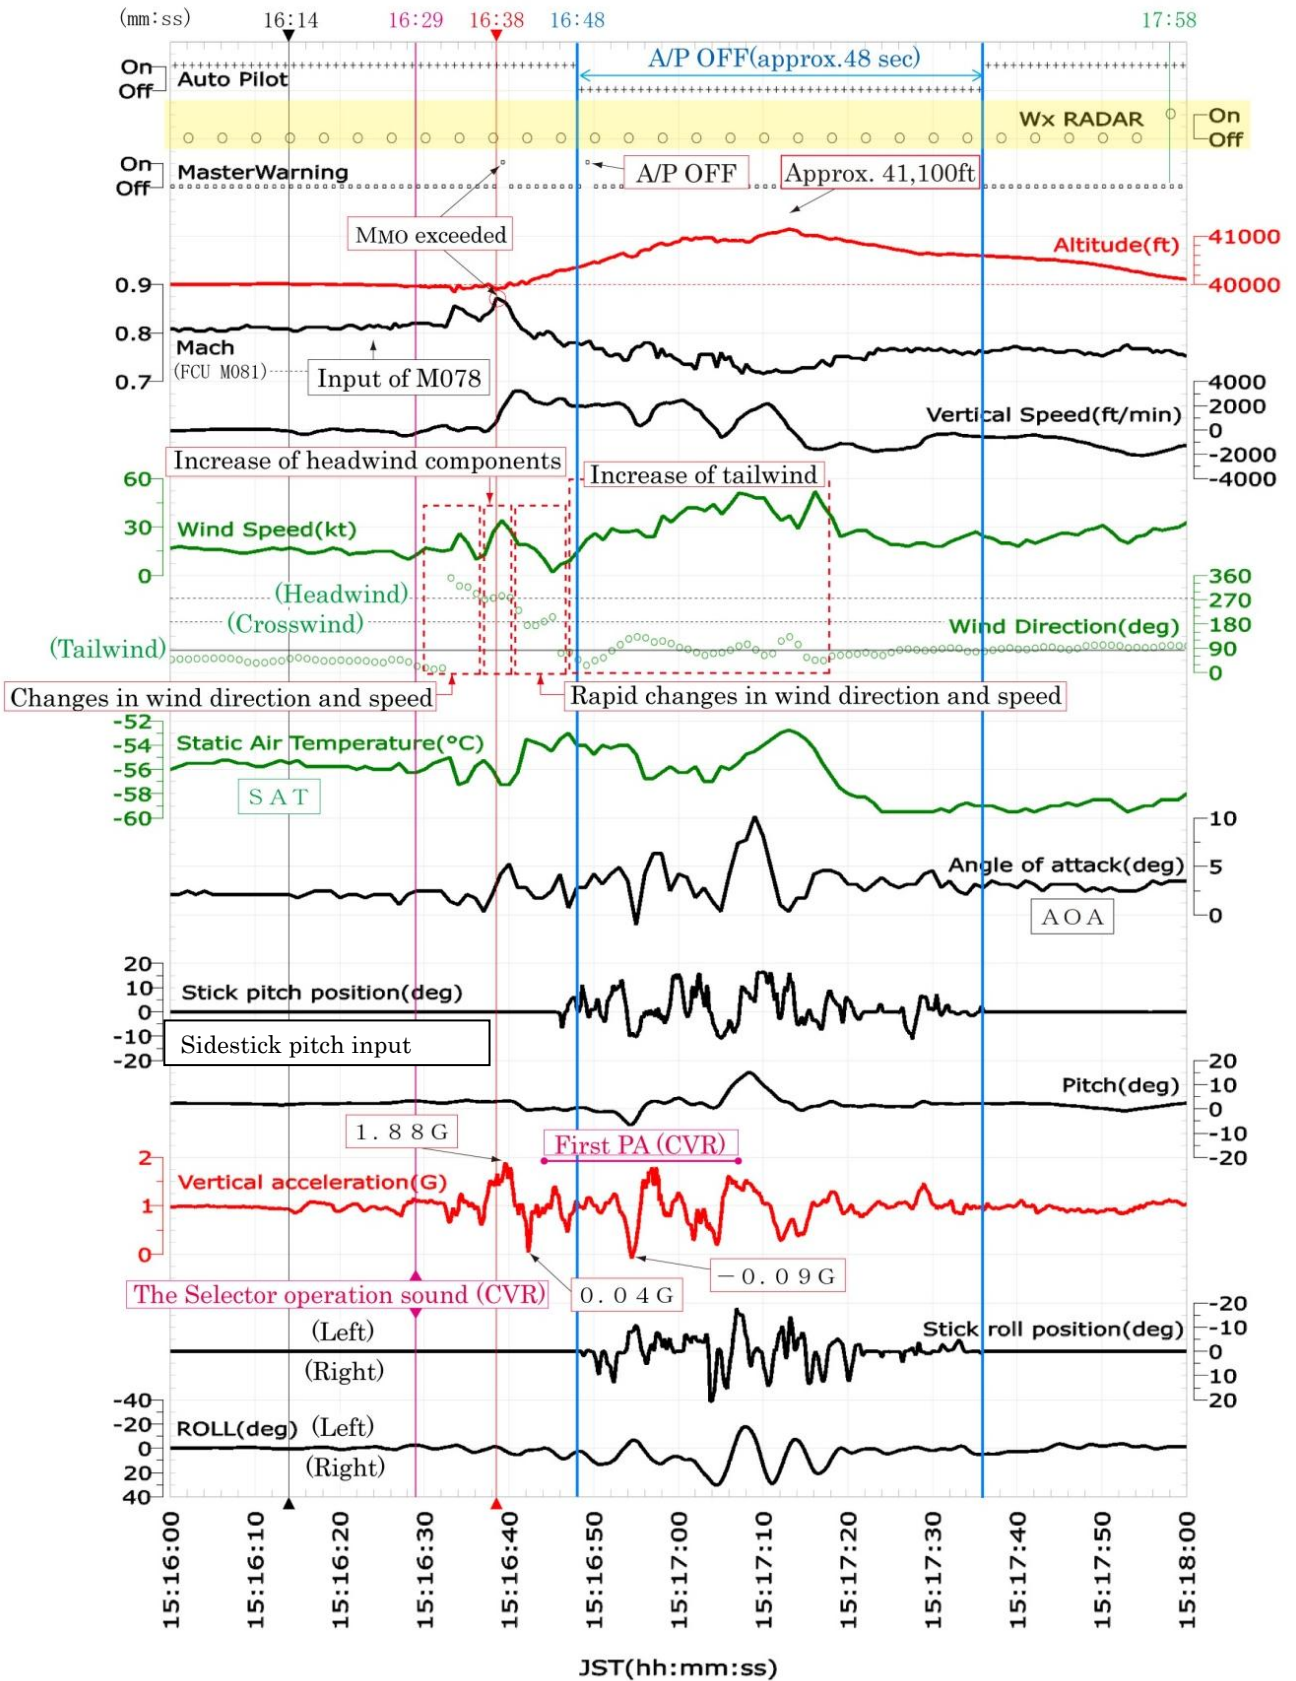
Figure 1: DFDR and CVR Records

15:16:14 A small change of the vertical acceleration started.

15:16:30 Until this time, the wind had been blowing from the right rear direction of the Aircraft at an average speed of 16 kt, it began to change in a counter-clockwise direction. Following this, a relatively large change in vertical acceleration began.

15:16:36 The wind direction changed to blow directly against the Aircraft. The Aircraft’s AOA*³ increased suddenly, but there was no change to the pitch angle.

15:16:38 The wind speed became 34 kt. The speed of the Aircraft became M0.872, temporarily exceeding the M_{MO} (maximum operating speed limit: M0.86) and causing the over speed warning to sound.
The altitude of the Aircraft increased.

15:16:40 The SAT increased rapidly by 4°C, and this high value was maintained for approximately 15 seconds. The vertical acceleration became 1.88G, the highest value for this flight. The wind began to change in a counter-clockwise direction.

15:16:42 The wind became a crosswind from the left, and the wind speed became 20 kt. The vertical acceleration became 0.04G, which was the greatest change during this flight.

15:16:54 The sidestick on the PIC side was pushed forward. The pitch angle of the aircraft changed rapidly to -6.3°, while the vertical acceleration became -0.09G, the lowest value during this accident.

15:17:58 Although the Aircraft's weather radar had been off until 15:17:54, it was on at this time.

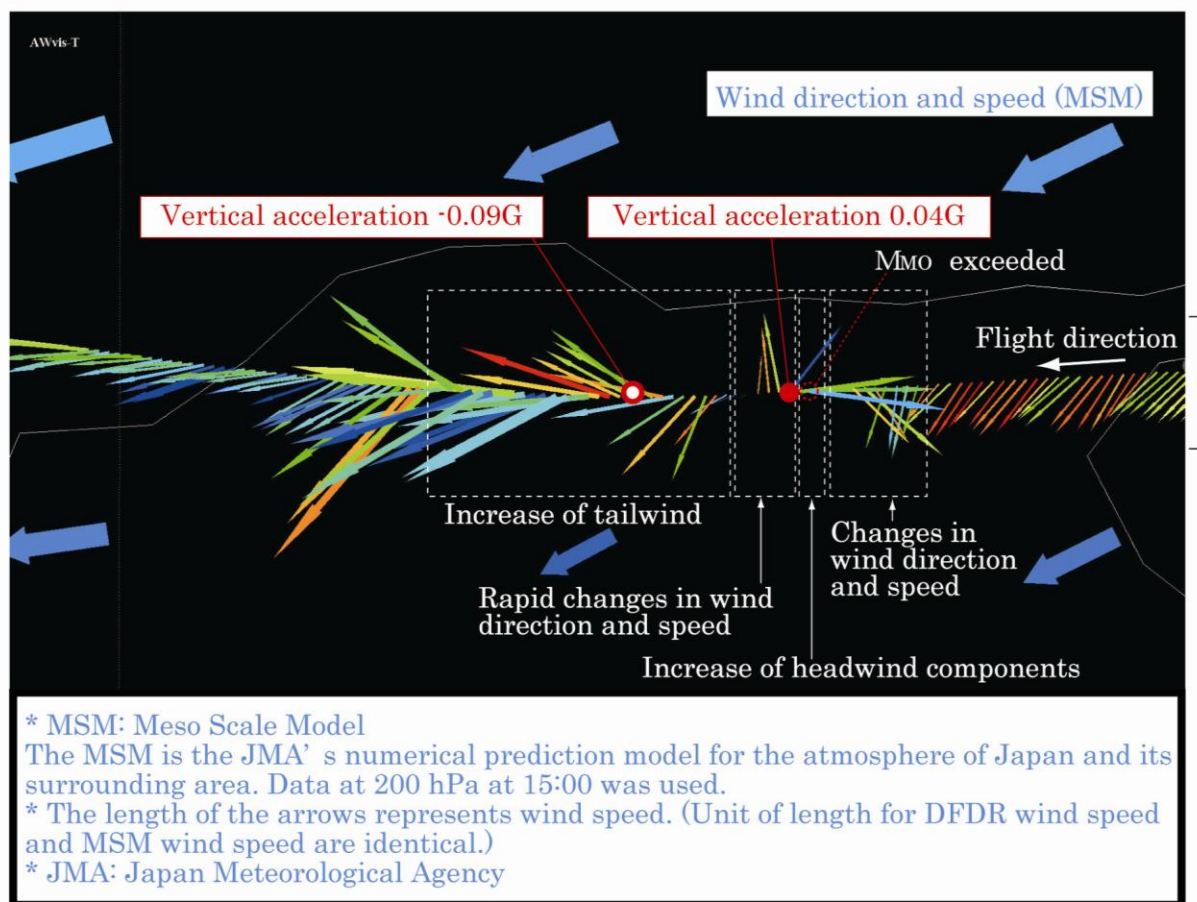
Figure 2: Status of Changes in Wind Direction and Wind Speed Recorded in DFDR

15:16:55 While remaining as a tailwind, the wind speed increased to a maximum of 52 kt, and as the roll angle varied within the range from 30.2° on the right side to 17.9° on the left side, the pitch angle reached

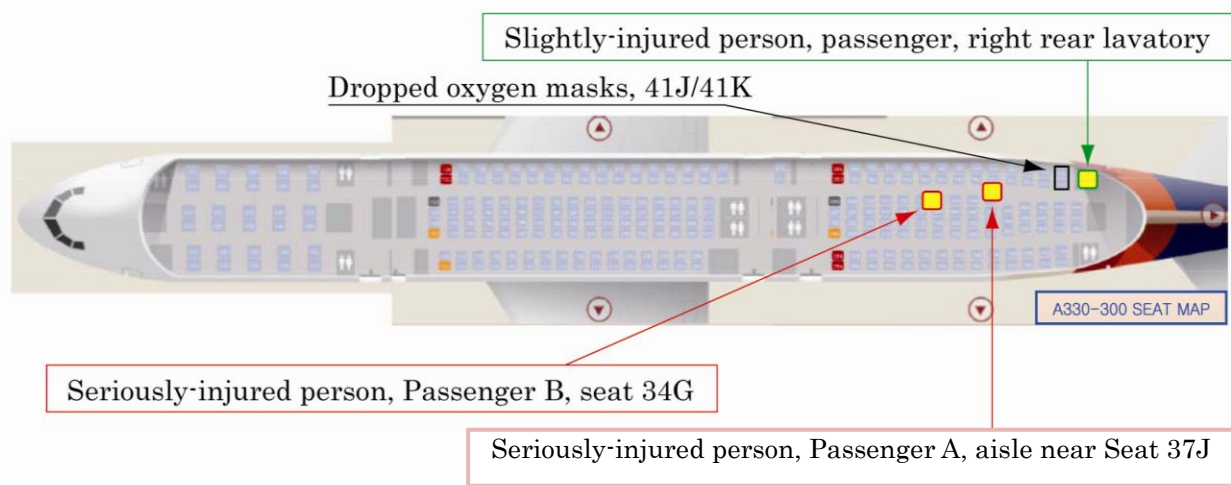
Figure 3: Locations of Injured Persons and others At the Time when the Accident Occurred

Cabin Attendant A observed Passenger A being thrown into the air and falling due to this shaking. During the shaking, the passenger in seat 40G helped Passenger A to stand, sit in the empty seat 38J, and then fasten the seat belt there. Later, when Cabin Attendant A moved closer to Passenger A to check on her condition, Passenger A stated that her leg was broken. Because Passenger A complained of severe pain when Cabin Attendant A placed an ice pack on the injured part, Cabin Attendant A believed that her leg was broken.

According to the statements in 2.1.3 and 2.1.4(1), the initial shaking caused Passenger A to be thrown into the air and sustain serious injury when falling to the floor, a situation which was observed by Cabin Attendant A. Since the Aircraft was lifted and shaken as described in 3.4.1, it is probable that the serious injuries sustained by Passenger A occurred at the time of the change in vertical acceleration from 0.04G, recorded when the aircraft experienced shaking as a result of encountering severe atmospheric disturbances.
