**AIRCRAFT SERIOUS INCIDENT  
INVESTIGATION REPORT**

**THAI AIRWAYS INTERNATIONAL PUBLIC CO., LTD.  
H S - T G X**

**EMERGENCY OPERATION TO AVOID CRASH INTO THE GROUND  
THAI AIRWAYS INTERNATIONAL PUBLIC CO., LTD.**

**BOEING 747-400, HS-TGX  
ABOUT 3.5 NM NORTHEAST OF  
TOKYO INTERNATIONAL AIRPORT, JAPAN  
AT ALTITUDE OF ABOUT 300 FT  
AROUND 23:52 JST, APRIL 11, 2018**

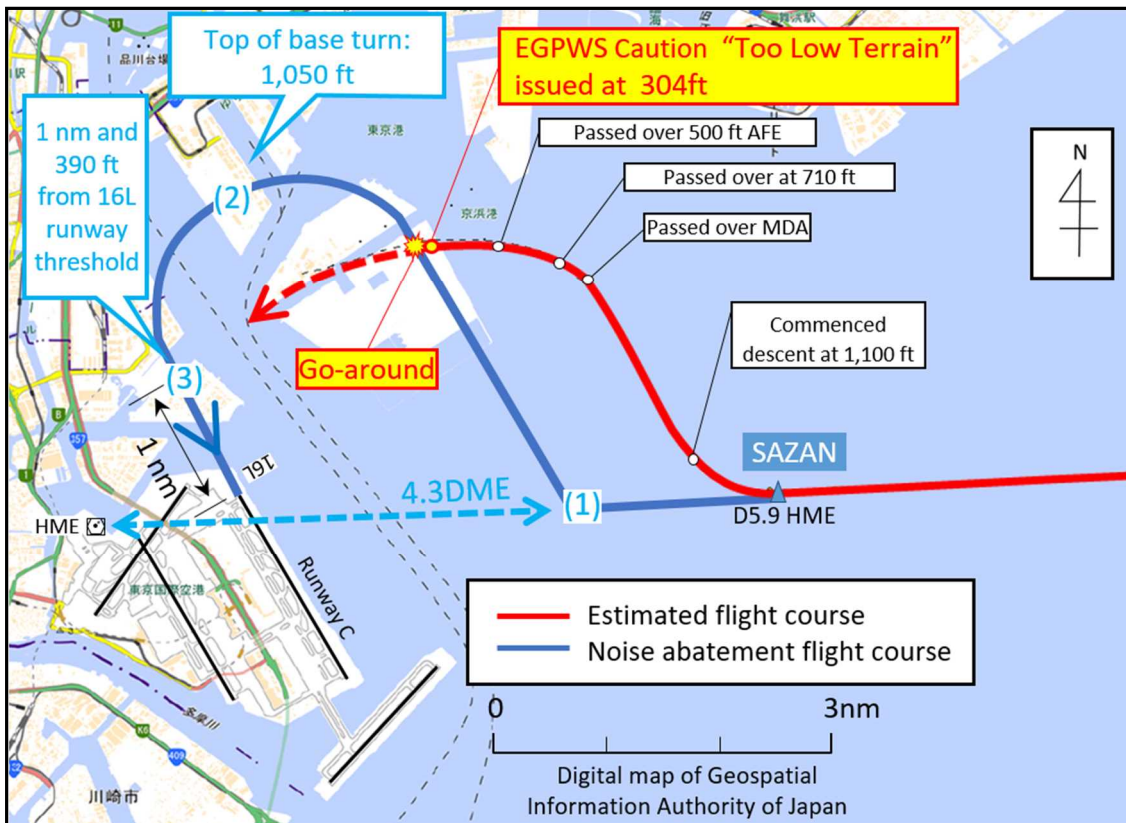
Figure 4: Estimated flight course of the aircraft and noise abatement flight course

As described in 2.1.2 (2), it is probable that the PIC concentrated on flying inside the noise abatement flight course and letting the Aircraft to fit into the final leg of Runway 16L, and continued descent changing the setting of AP descent rate between 200 and 500 fpm without paying an appropriate caution for the actual descent path. It is probable that this caused an excessive descent rate of the Aircraft leading to deviate from desirable flight path.

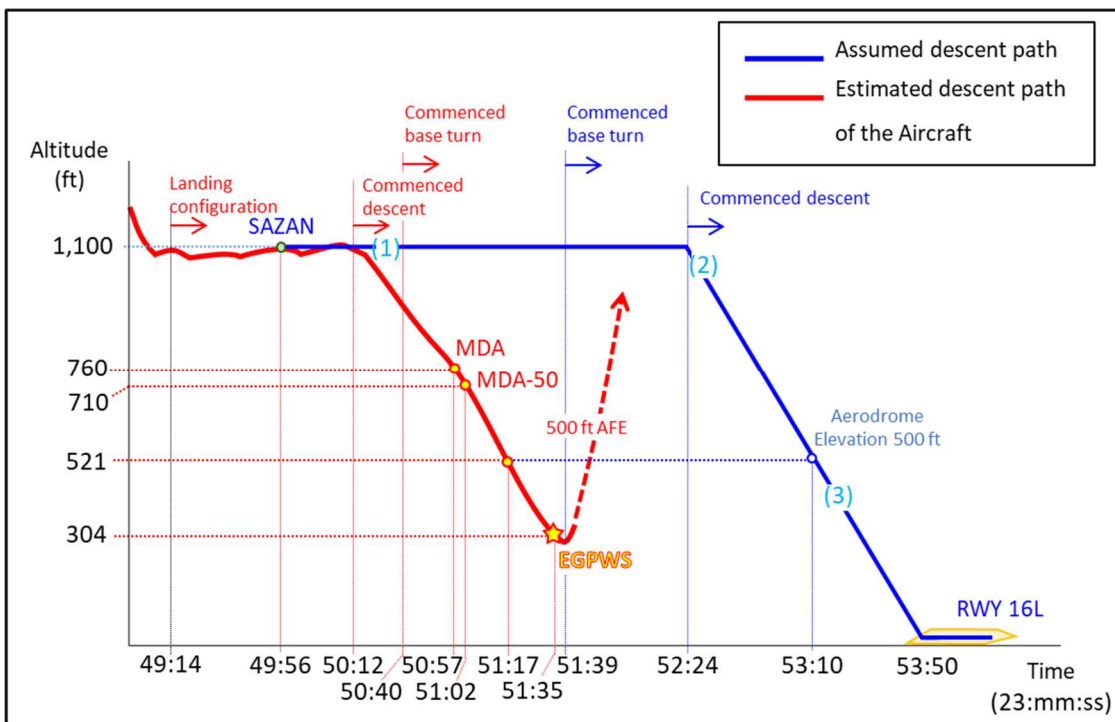
Figure 5: Comparison between assumed descent path and estimated descent path of the Aircraft

Conditions described below were established for descent flight path assuming the case of landing on Runway 16L by descending at the normal descent angle (3 °) after level flight along the noise abatement flight course (see Figure 4) (hereinafter referred to as “Assumed Descent Path”) for comparison with the estimated descent path of the aircraft. (See Figure 5)

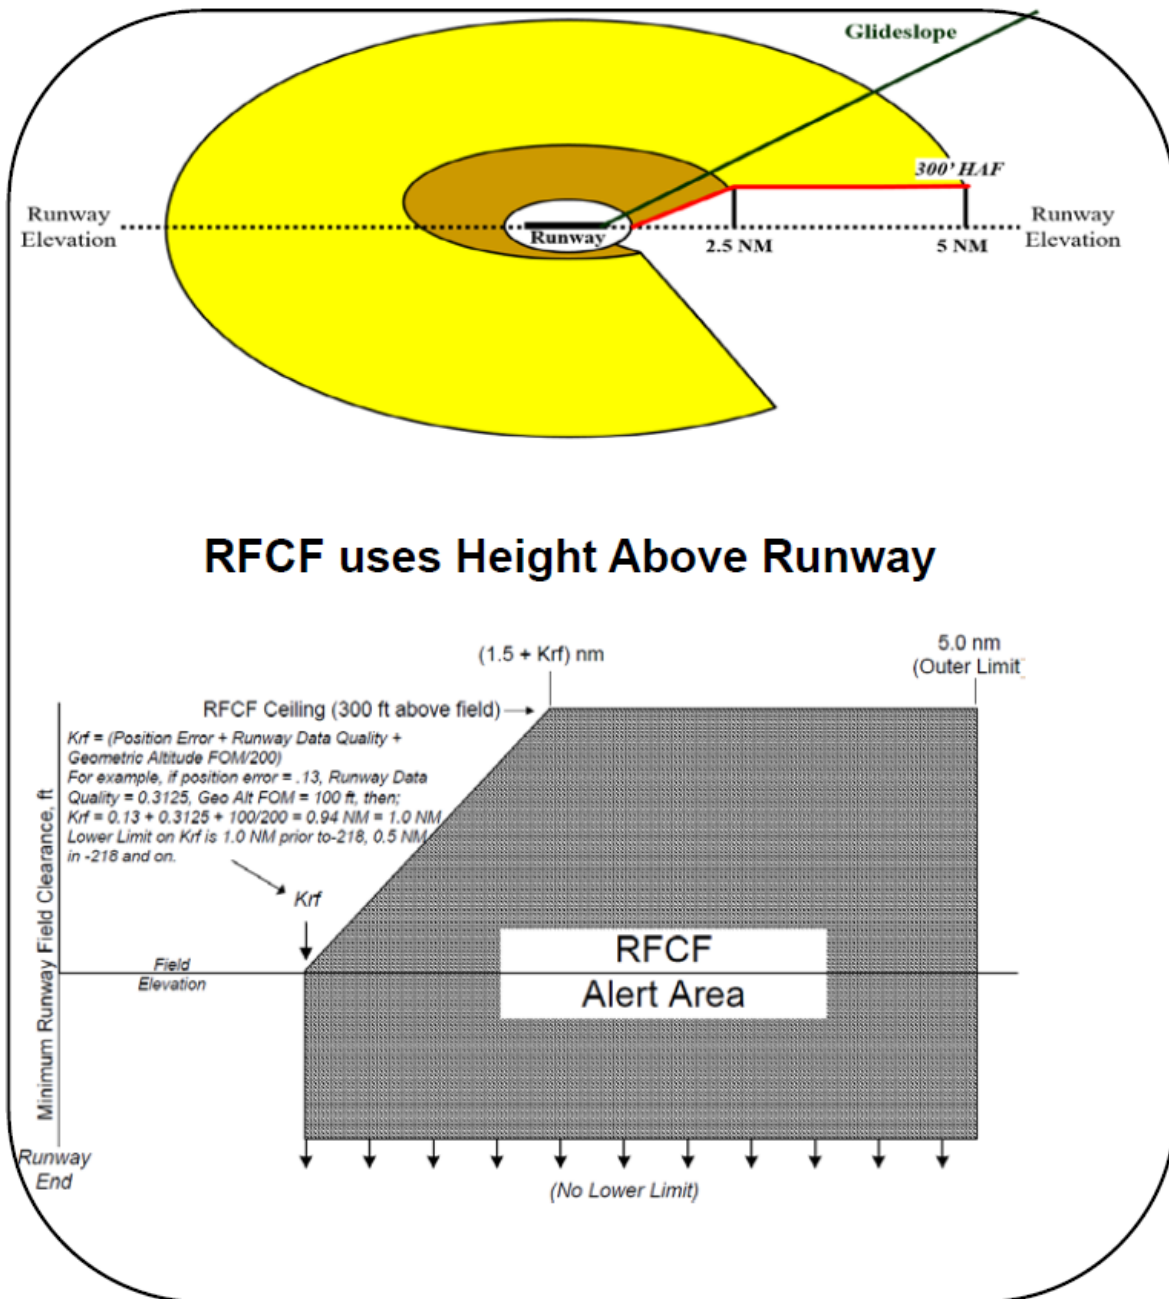
Figure 6: Schematic view of RFCF area

In this serious incident, “TOO LOW TERRAIN” caution was enunciated at an altitude of 304 ft by RFCF function of EGPWS.

RFCF is the function that illuminates “GPWS” of GPWS button on instrument panel and enunciates aural message of “TOO LOW TERRAIN” in the event that aircraft penetrates into RFCF area (see Figure 6 for RFCF Alert Area) in approaching, which is registered in database for each runway.

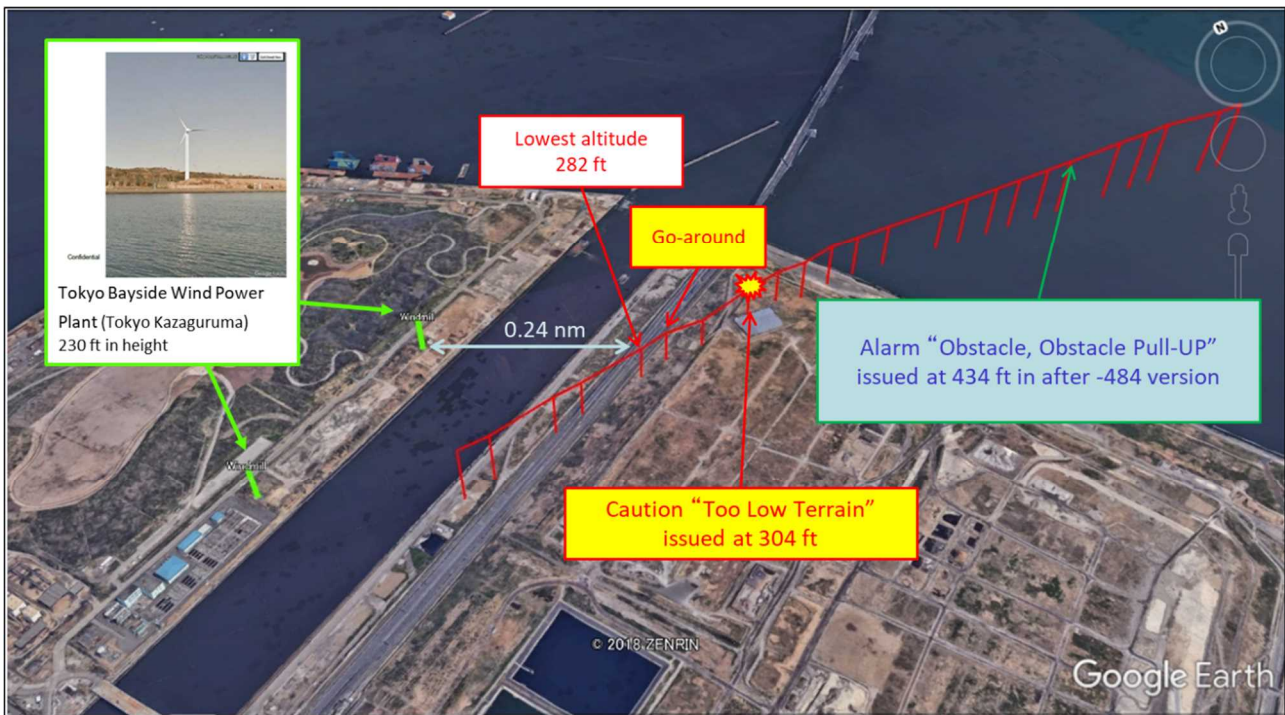
Figure 7: Flight track recorded in EGPWS

Man-made objects information in Japan contains only Tokyo Tower (Japan Broadcast Tower) in terrain database of EGPWS of the Aircraft. Information pertinent to Tokyo Skytree Tower was registered in versions after -460 (issued on February 28, 2011) and information pertinent to other man-made objects in Japan was registered in terrain database versions after -484 (issued on March 16, 2017). Analysis of operational situations in the event of flying the same path with the EGPWS updated to after -484 version obtained the result that warning “Obstacle Obstacle Pull-UP” was enunciated at an altitude of 434 ft in reaction to the man-made objects of Tokyo Bayside Wind Power Plant (“Tokyo Kazaguruma” (see Figure 7)) located ahead of the flight path.

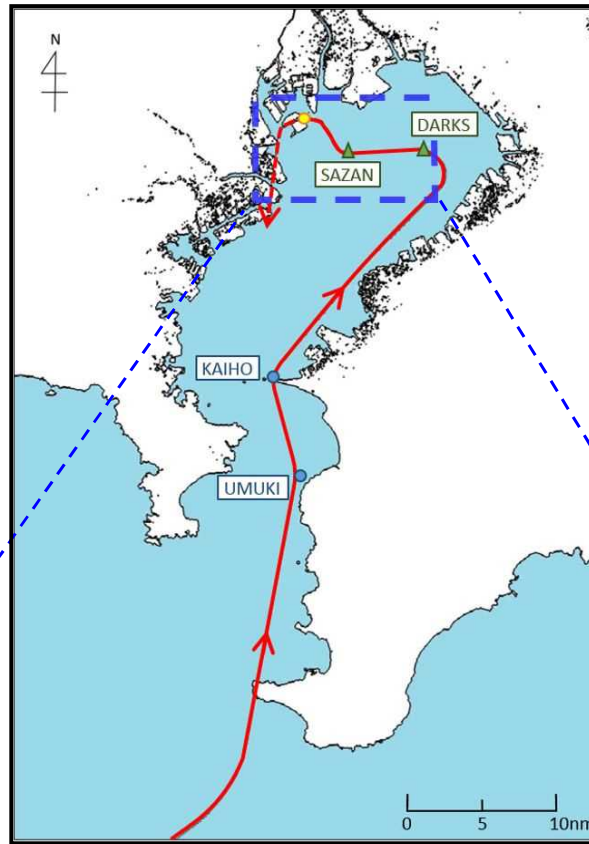
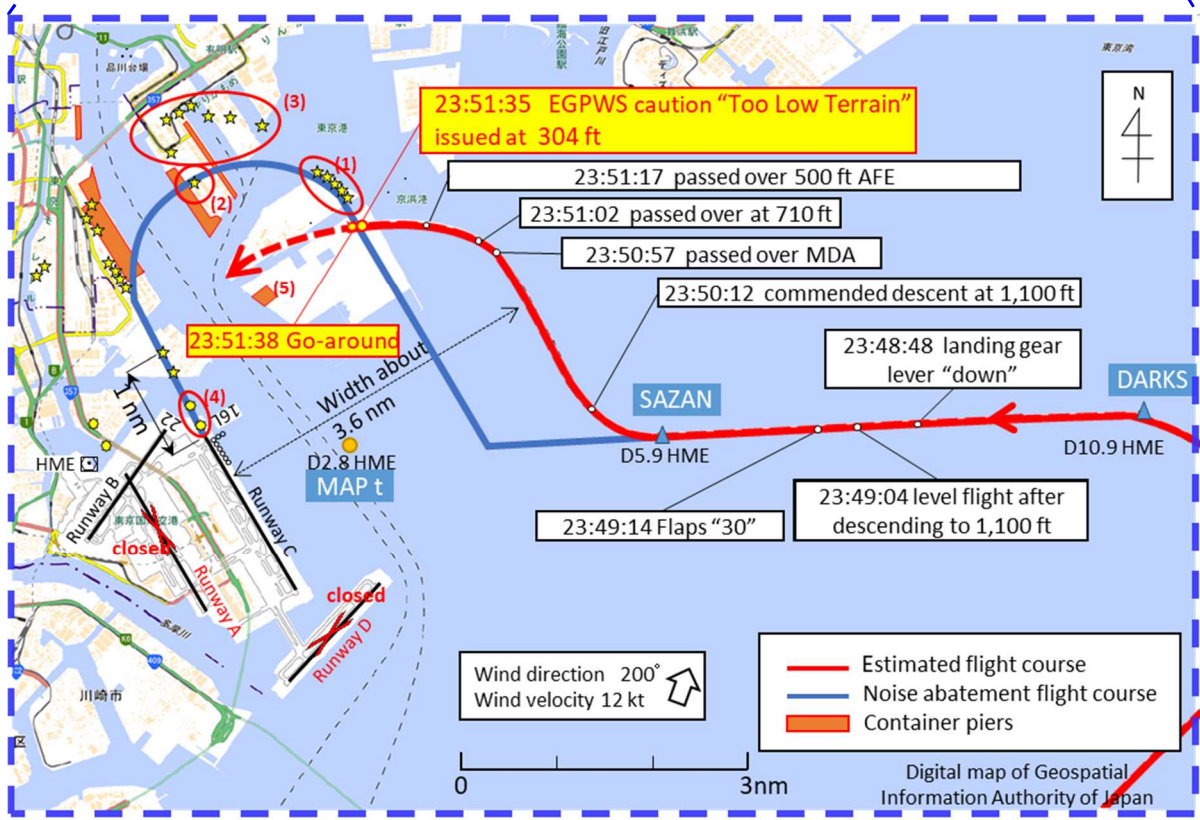
Appended Figure 1 : Estimated flight path

The PIC commenced base turn with turning left in an attempt to enter inside the designated course using the landmark beacon (Appended Figure 1-(2)) as a reference because the PIC realized that the Aircraft was off the designated course.

Due to a low altitude, the PIC could not visually recognize approach light beacon of Runway 16L ((4) in Appended Figure 1) blocked by the container piers ahead on the left and lost sight of Runway 16L.

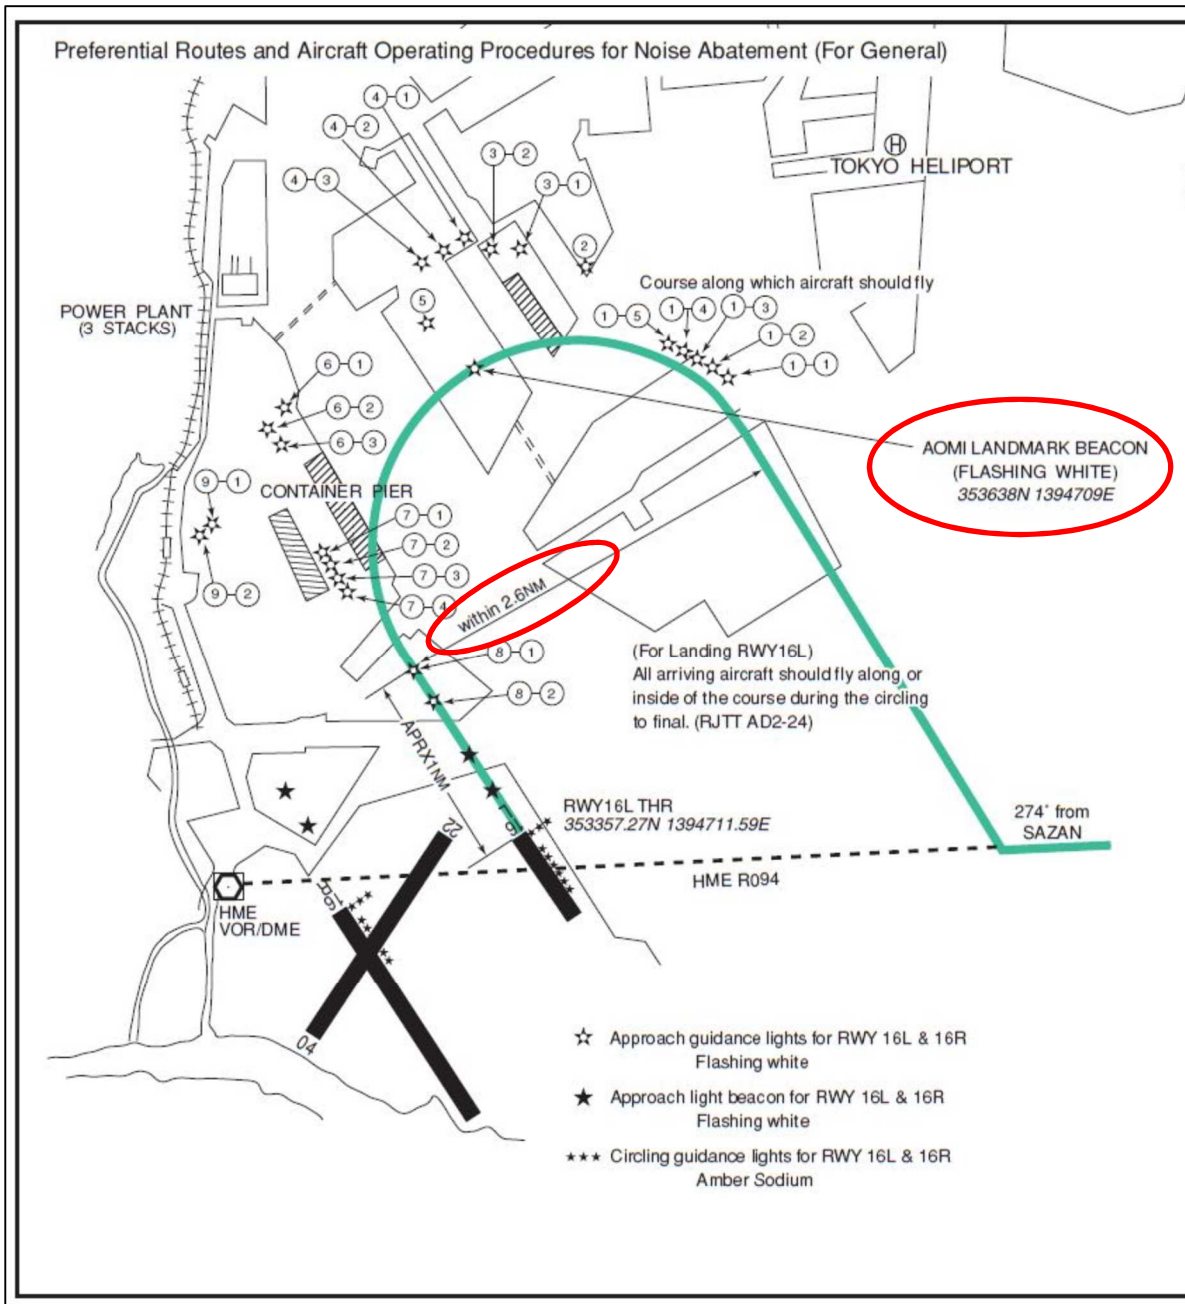
# Appended Figure 10: AIP Noise abatement flight course drawing (excerpt)

Major differences from Appended Figure 9 are supplemented in red circle
