AI2009-6

**AIRCRAFT SERIOUS INCIDENT
INVESTIGATION REPORT**

**JAPAN AIR COMMUTER Co., Ltd.
J A 0 0 1 C**

JAPAN AIR COMMUTER CO., LTD.
SAAB-SCANIA SAAB 340B, JA001C
AT ABOUT 11:26 JST, DECEMBER 18, 2007
NEAR THE RUNWAY AT IZUMO AIRPORT

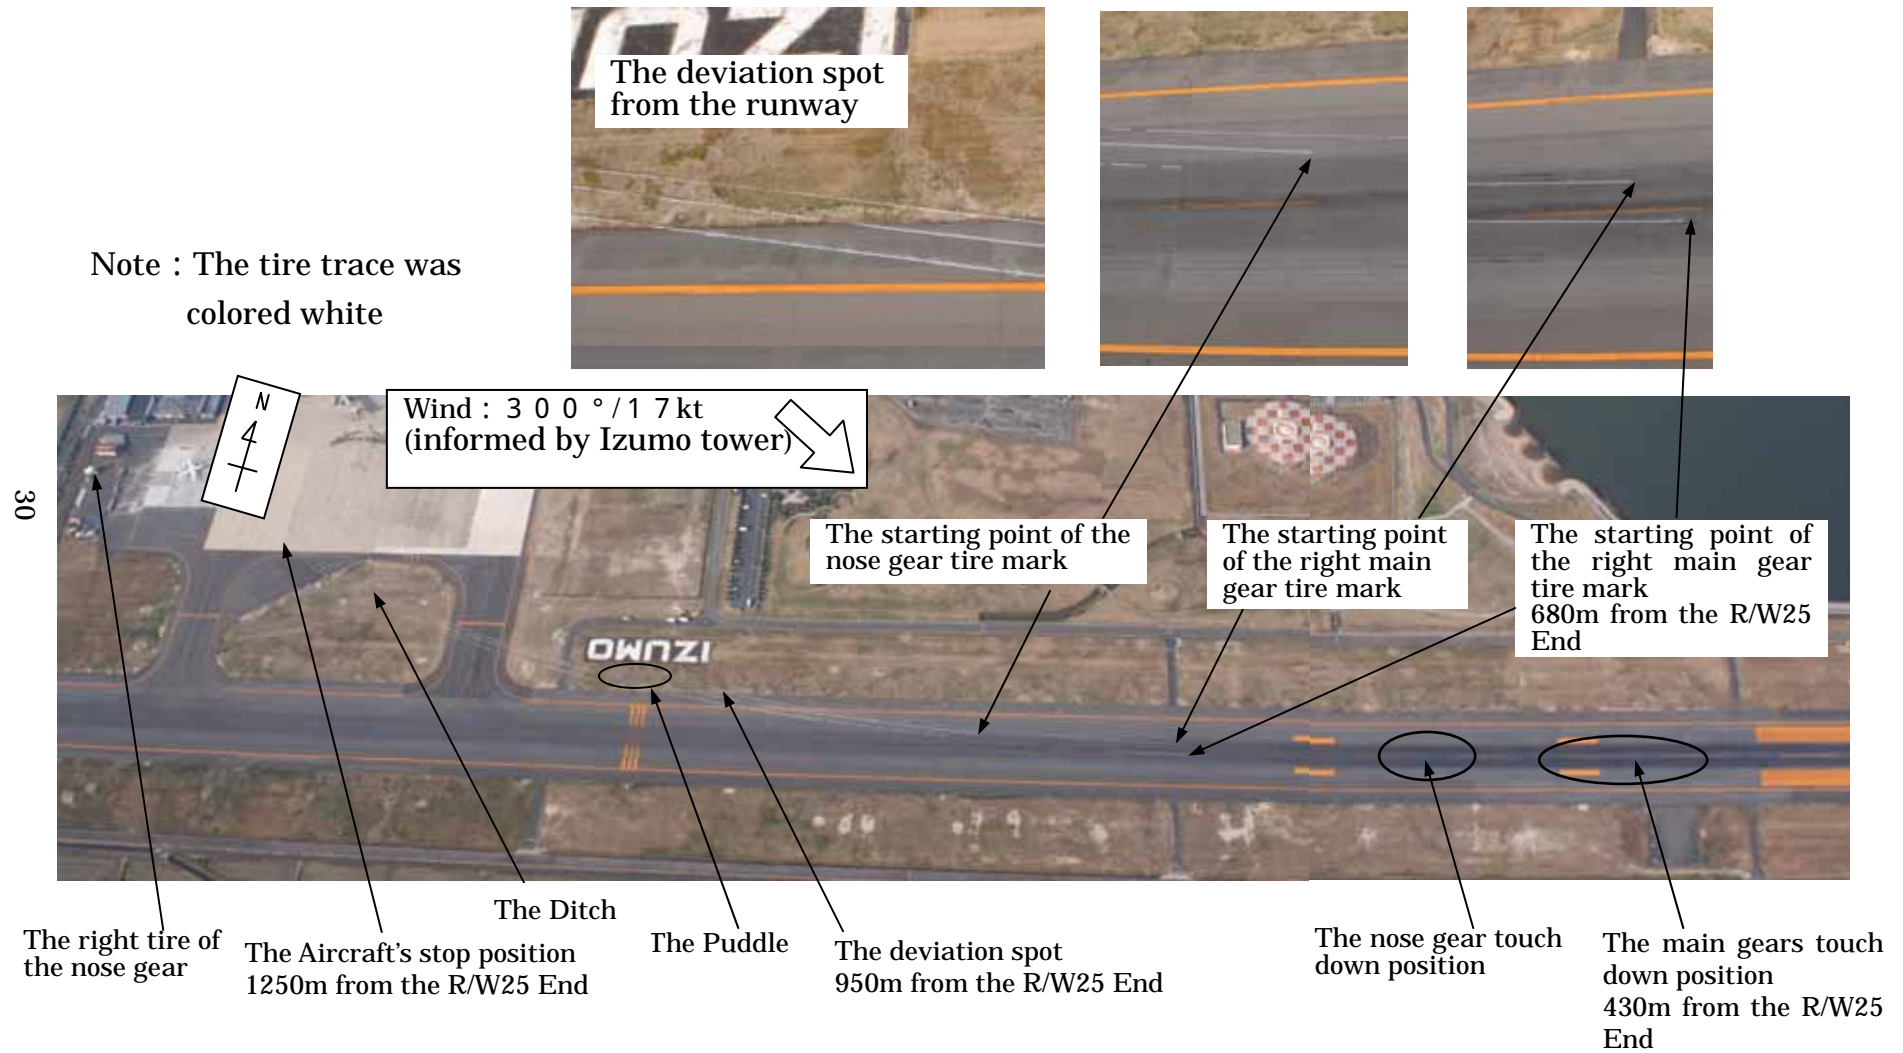
Figure 2 Touchdown Point & Ground Rolling Condition

At the top of the ditch were strike marks that would have been caused when the nose and main gear tires hit the edges. Broken pieces of the nose wheels were scattered over the trail stretching from that point of the ditch in the direction of the Aircraft's movement. The tire marks continued up to the apron, and scratch marks were left on the asphalt surface. The Aircraft came to a stop on the apron just north of Taxiway T1.

It is considered highly probable that the nose gear was broken when it hit the ditch that runs parallel to the runway.

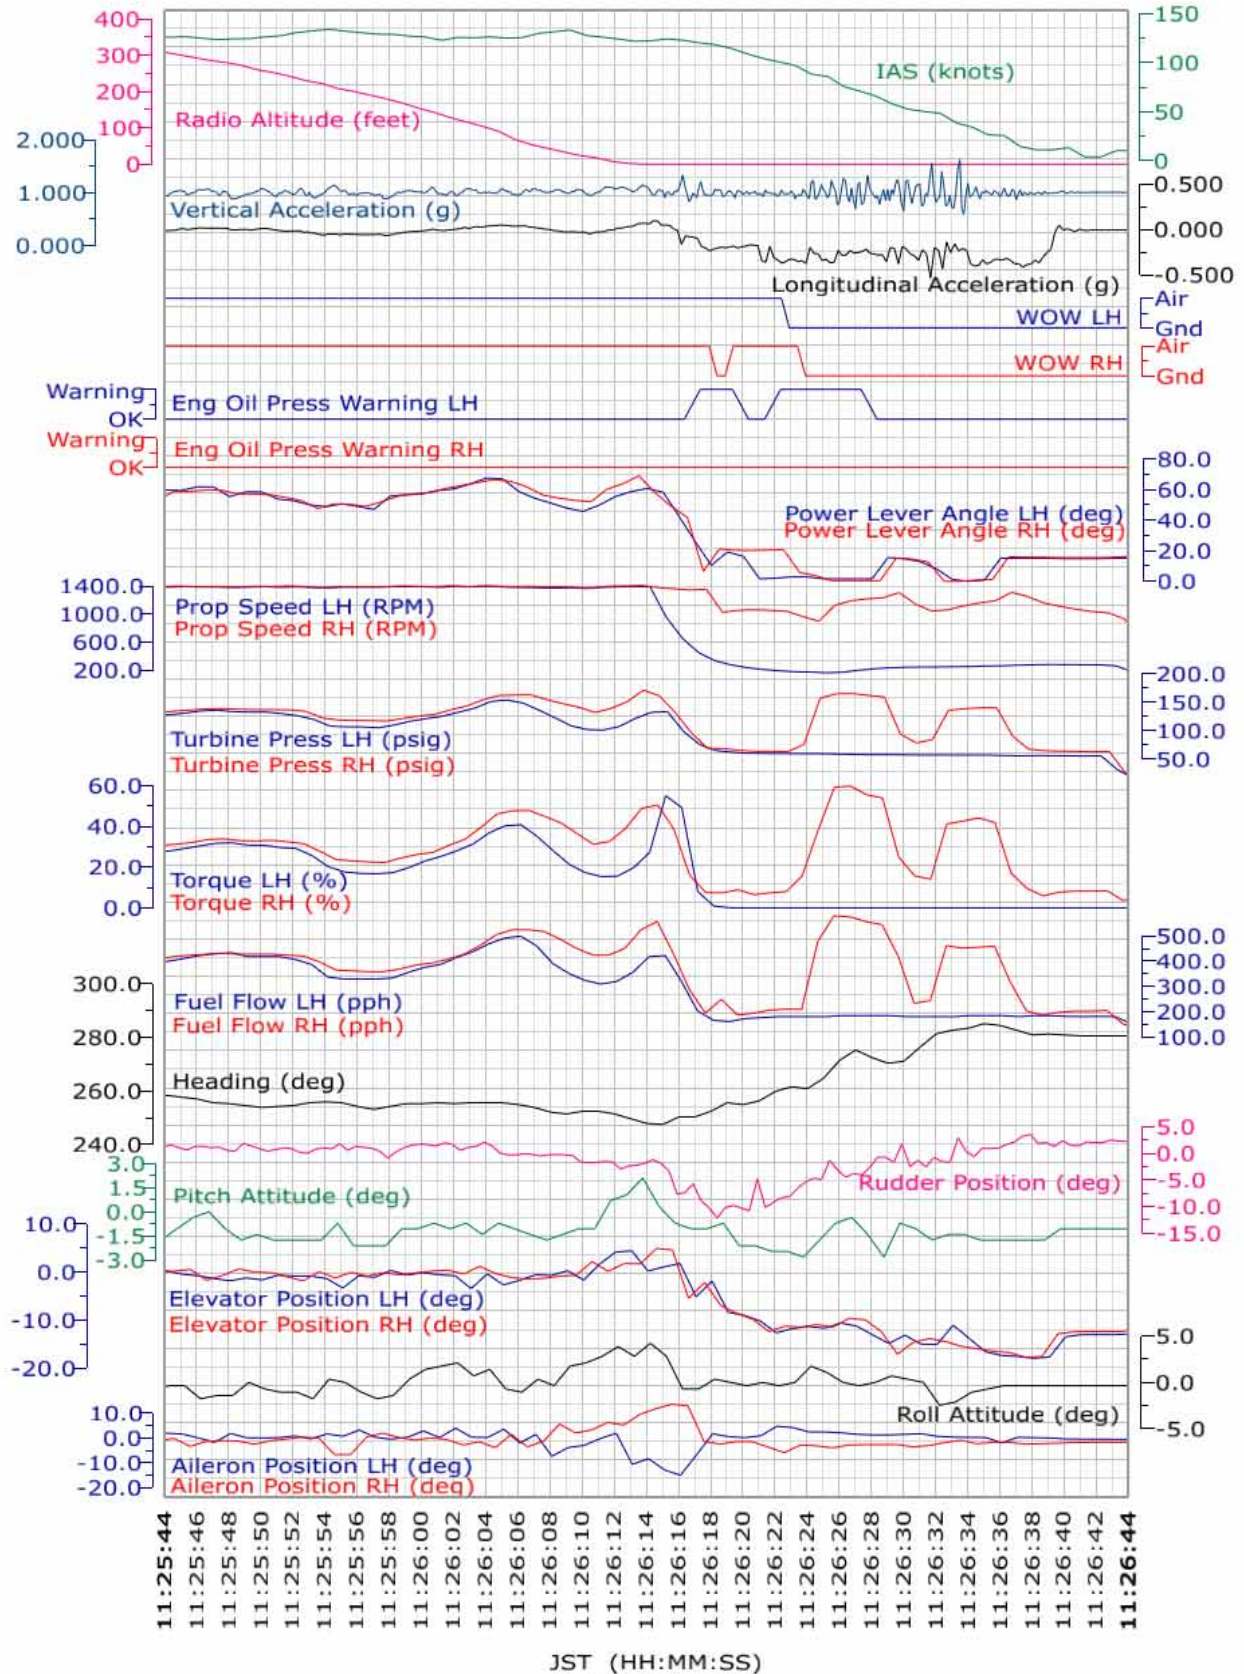
Figure 3 DFDR Records

11:26:14 The left propeller speed dropped sharply (from 1,387 rpm at 11:26:14 to 957 rpm at 11:26:15) with the eventual sound change being recorded.

- (2) During the period between 11:26:13 and 11:26:14, the left engine torque was below 50% while the right engine torque was above 50%. At 11:26:13, the torque differential between the engines was 29.1% although at 11:26:14 it was 23.2%, a level slightly below the autocoarsen activation threshold. It is therefore considered probable that the torque differential met the autocoarsen activation condition in this 11:26:13 to 11:26:14 period.

- (3) In the period between 11:26:12 and 11:26:14, the right engine P3 rose above 150 psi while the left engine P3 remained below 145 psi. It is therefore considered probable that the P3 sensor switch trip threshold (i.e., 145 psi maximum) for pressure rising condition described in 2.12 (2) was met.

As described above, it is considered highly probable that around the period between 11:26:13 and 11:26:14, the Aircraft's left engine met the autocoarsen activation conditions in HIGH POWER mode. This is also supported by a sharp rise in torque and a drop in propeller speed of the left engine in addition to a sound suggesting decreased propeller speed, which were recorded for this period by the DFDR and CVR, respectively. It is therefore considered highly probable that the left propeller was brought to the coarsen pitch at that timing.

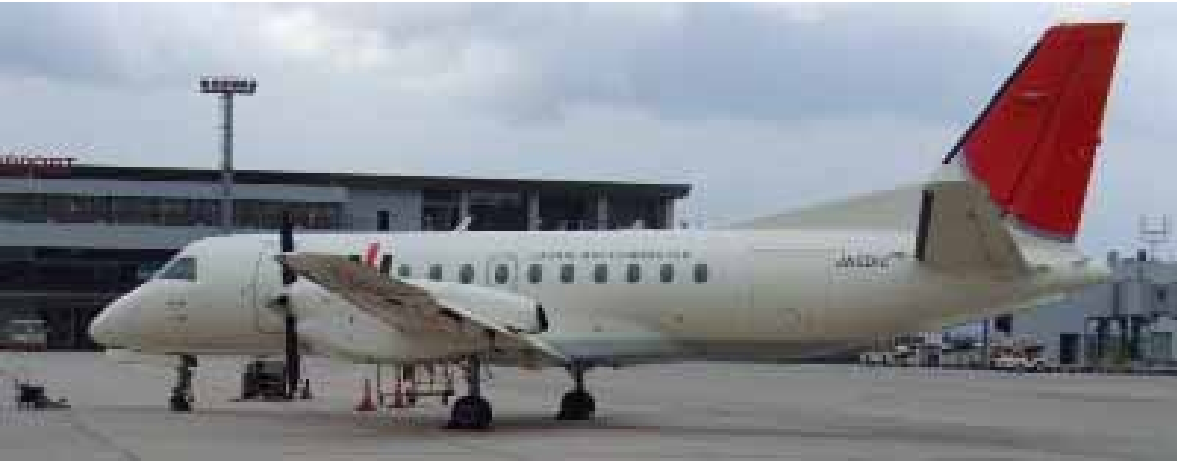
Photo 3 Serious Incident Aircraft

Nose landing gear:	Wheels broken and right tire detached
Right propeller:	Dented

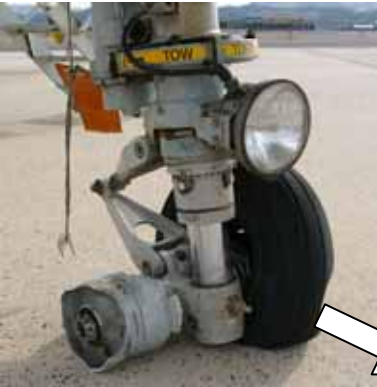
Photo 4 Damaged Nose Gear

Both the left and right tires of the nose gear were punctured, and the right tire was detached from the wheel. While both wheels remained on the nose gear spindle, the tire-retaining flanges were cracked and chipped due to the tireless running.

The right nose gear tire had cracks on its sidewalls and tread, and the cracks on the tread reached the inside of the tire. All the tires had strike marks caused by the edges of the ditch as described in 2.9.1.

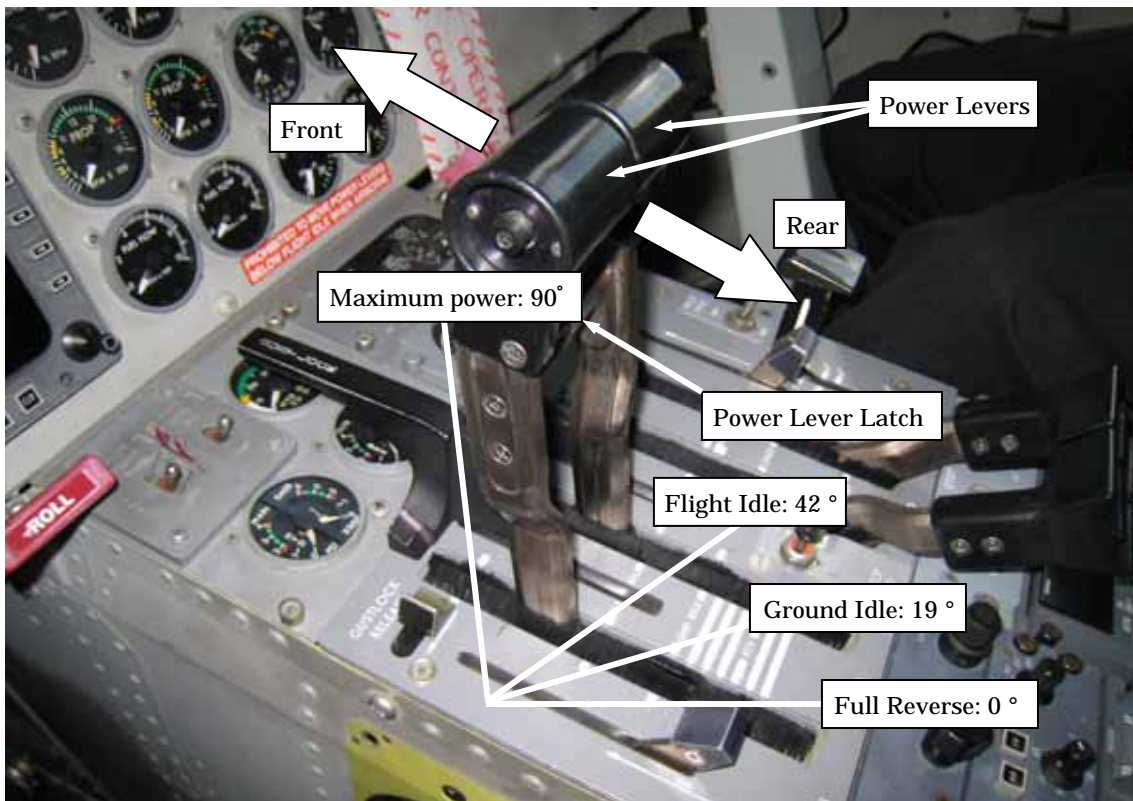
Photo 5 Power Levers

In normal operation, pilots may operate the left and right power levers somewhat differently as needed to equalize the torque level between both engines, but they do not control the levers in a manner that causes so large a torque differential as that experienced in this serious incident.

The test operation of the power levers conducted as part of this investigation found it rather difficult to move the levers while keeping a one-grip equivalent (or 38 mm) distance between them, as was done during this serious incident, due to the size of their grips, each measuring 38 mm in diameter.
