**AIRCRAFT SERIOUS INCIDENT
INVESTIGATION REPORT**

**NISHI NIPPON AIRLINES CO., LTD.
J A 0 0 3 W**

Company Name	Nishi Nippon Airlines Co., Ltd.
Aircraft Type, Registration Mark	Bell 412 EP (Rotorcraft) JA003W
Incident Class	Dropping of Object during External Cargo Sling Operation Article 166-4 (xv) of Ordinance for Enforcement of the Civil Aeronautics Act of Japan
Date and Time of the Occurrence	At about 13:22 Japan Standard Time (JST: UTC+9 hours, unless otherwise stated all times are indicated in JST on a 24-hour clock), October 20, 2018
Site of the Incident	Otoyo Town, Nagaoka County, Kochi Prefecture (33°45'14" N, 133°45'43" E)

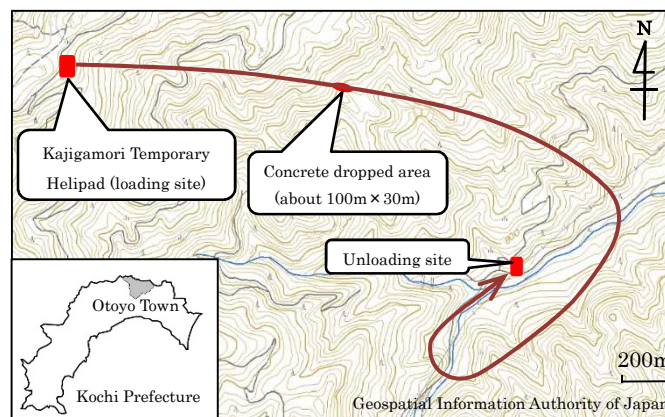
Figure 1: Estimated Flight Route

Around 13:20, the Aircraft departed the cargo loading site for the tenth transport. The Aircraft was severely shaken in a vertical direction several times due to rough air condition over the valley in the flight route. When the Aircraft approached the cargo unloading site, the bucket operator sitting in the left pilot seat noticed that, when he looked at the slung bucket to guide the Aircraft, the shutter was open and the fresh concrete (about 600 kg) was missing.

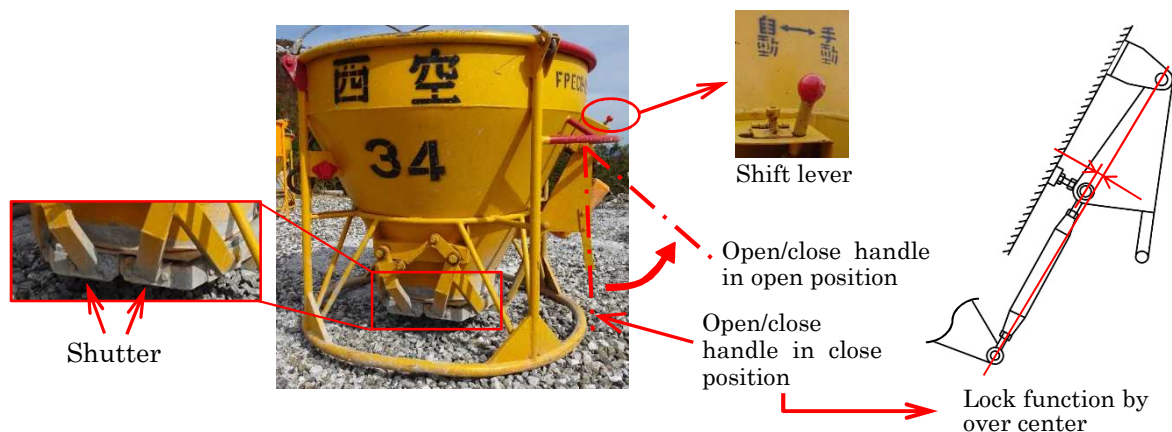
Figure 2: The bucket used at the time of the serious incident

There are two modes of “auto” and “manual” available for opening and closing the shutters. “Auto” is set when opening the shutter by operation from the cockpit and “manual” is set when a ground worker manually opens it by the open/close handle. When the open/close handle is in the completely closed position, the shutter is locked by the over center mechanism and cannot

open by the load of the fresh concrete. Besides, the actuator for opening and closing shutter can fix the position of the shutter by setting the shift lever to “auto” position and connecting it with opening and closing mechanism because it retains the contracted condition of the operating signal input when it is shut down.

It is highly probable that the shift lever was in “manual” position and the fixing function of the shutter by actuator did not work at the time of the tenth transport because the ground worker B at the cargo loading site manually closed the shutters without operating the shift lever when the Aircraft returned to the Temporary Helipad after the serious incident. Besides, it is highly probable that the locking by the over center mechanism did not work either at this time

It is highly probable that the shutter did not open immediately after the fresh concrete had been loaded into the bucket for the tenth transport under the situations that locking by the over center mechanism of the shutter did not properly work. However, it is probable that the shutter was forced to be opened by the load of the fresh concrete imposed on the shutter which increased by the downward inertia when the Aircraft was vertically shaken due to rough air condition in flight.

It is probable that the unintended opening of the shutter was caused by the increased load imposed on the shutter when the helicopter was shaken due to rough air condition and was flying in the situation that the locking by the over center mechanism of the shutter was not properly working.

- (1) “Lock/Unlock” placard has been additionally displayed to the shift lever of every bucket used by the Company.
- (2) The Company’s regulation for transport operations have been revised as described below and performed reeducation for all workers involved in transport operations.

- (i) To provide the methods for confirmation of locking by the over center mechanism and the shift lever position when operation the bucket by manual opening and closing.
