**AIRCRAFT SERIOUS INCIDENT
INVESTIGATION REPORT**

**Privately owned
JA 007Z**

AIRCRAFT SERIOUS INCIDENT INVESTIGATION REPORT
 DRAGGING DURING LANDING OF ANY OTHER PART OF
 THE LANDING GEARS OF THE AIRCRAFT
 PRIVATELY OWNED
 SOCATA TBM700, JA007Z
 YAO AIRPORT, YAO CITY, OSAKA PREFECTURE
 AT ABOUT 18:06, MARCH 6, 2022

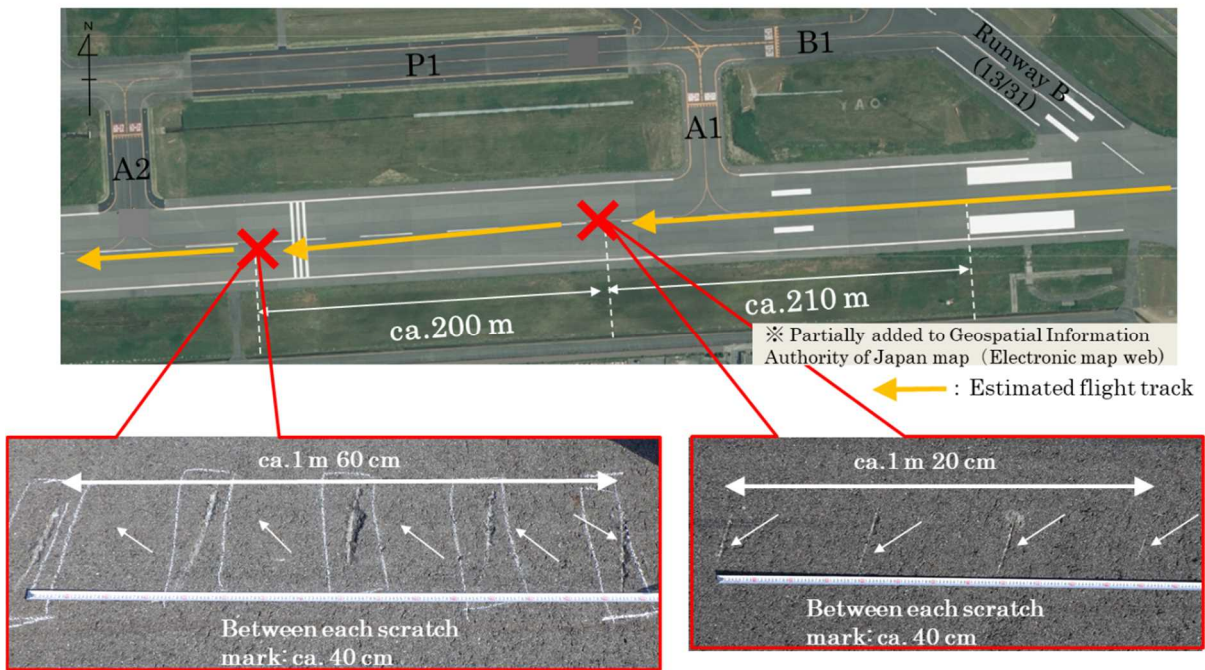
Figure 3: Scratch marks on the runway

There were scratch marks in two sections on Runway 27.

The four scratch marks on the east side were located on the runway centerline at equal intervals of about 40 cm, and the width of the scratches was about 3 mm to 21 mm, the length was about 50 mm to 170 mm, and the maximum depth was about 3 mm.

The five scratch marks on the west side were located about 200 m west of those on the east side, and about 2 m south from the runway centerlines. The five scratch marks were located at equal intervals of about 40 cm, the width of the scratches was about 29 to 52 mm, the length was about 220 to 270 mm, and the maximum depth was about 4 mm.

Comparing those scratch marks on both sides, the scratched size of the marks on the west side were larger than that of those marks on the east. (See Figure 3)

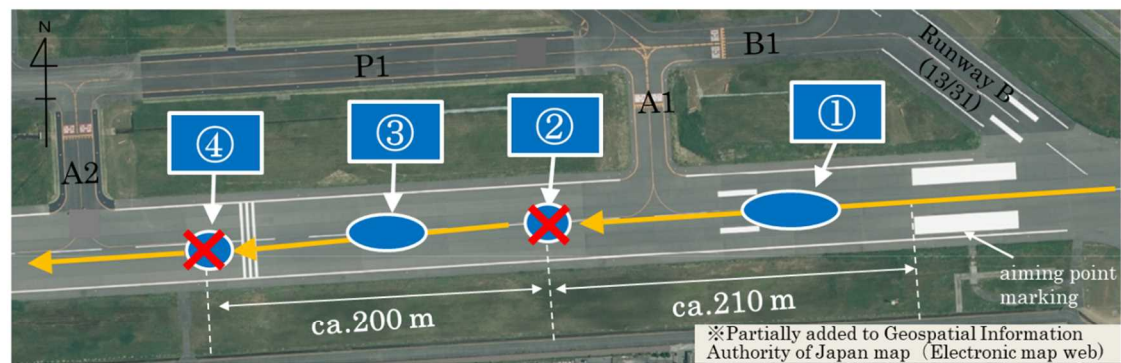
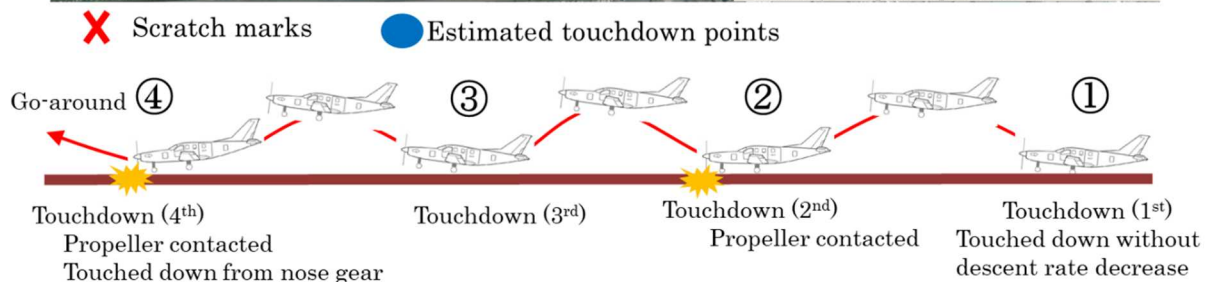
Figure 4: Touch down status (Estimation)

The JTSB concludes that the situation from the Aircraft’s first touchdown up to its go-around was more likely as shown in Figure 4.

The ground speed, which was calculated from the scratch marks generated by contact between the propeller blades and the runway surface, which were found in two locations in the east and the west (② and ④ in Figure 4), was about 78 kt for both of them. The distance between the scratch marks on the east side (② in Figure 4) and those on the west side (④ in Figure 4) was about 200 m, when the Aircraft flies at the ground speed as above, it would take about five seconds from the first contact with the propeller blades to the second contact with them. As the captain stated the Aircraft repeatedly touched down and lifted off at equal intervals of two to three seconds, it is probable that the Aircraft touched down once (③ in Figure 4) between the scratch marks on the east side and those on the west side, and lifted off.

On the other hand, the distance between the scratch marks on the east side (② in Figure 4) and the aiming point marking on the runway was about 210 m, therefore from the number of repeated touchdowns and lift-offs and intervals between them, the first touchdown position was more likely located about 100 m east (① in Figure 4) of the scratch marks on the east side (② in Figure 4). From this, the propeller blades more likely contacted with the runway surface for the first time at the second touchdown.

It is probable that the bouncing followed by the touchdown with a nose low attitude caused the propeller blades to contact with the runway, and as the size of scratch marks on the west side was deeper and larger than those on the east side, suggesting that the second propeller blade contact was more intense than the first, and the touchdown from the nose gear, which the captain recognized, was the fourth touchdown immediately before the go-around.

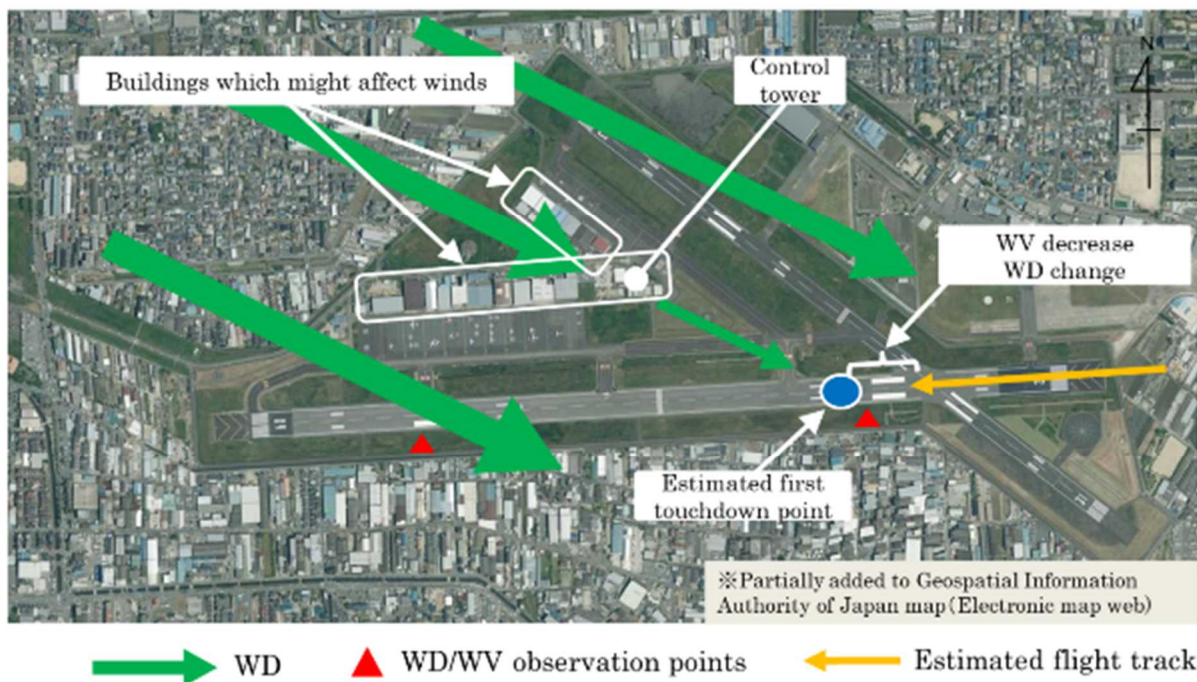
Figure 5: Wind conditions at the Airport

From observation results for the wind direction and velocity in the two locations on Runway A, the wind velocity in the vicinity of the touchdown point on Runway 27, when the Aircraft made the first approach, was 1 to 9 kt less than that measured by the anemometer on the west side. In addition, the wind direction measured by the anemometer on the east side was 4° to 43° norther (change in the direction of decreasing wind velocity from the front of the fuselage) than the value measured by the anemometer on the west side (see Table 1).

This was likely the local change that occurred when the northwesterly wind was affected by buildings such as the hangars, etc., (see Figure 5), and it is possible that during the final approach to runway 27, at a location which was not leeward of the building, the wind was not affected by the hangars, etc., and was equivalent to the value measured by the anemometer on the west side. Due to the reduction of the wind velocity and changes in the wind direction, the lift decreased after the Aircraft passed the runway threshold, which likely resulted in the touchdown with a greater than normal impact while the descent rate could not be reduced even with flare. (See Figure 5)

When landing on Runway 27 if a strong northwesterly wind is blowing in this way, in case there are differences in the wind direction and velocity values between the two locations, east and west, an aircraft may have a rapid descent in the vicinity of the touchdown point on Runway 27. At the time of landing on the runway, by confirming the wind conditions on both sides, east and west in advance, it is possible to expect the possibility of a rapid descent at the touchdown and avoid landing while the descent rate cannot be reduced. For this reason, when the wind blows strongly from the direction of the northwest to the north, it is recommended to confirm with air traffic controllers about both wind conditions before landing.
