AIRCRAFT SERIOUS INCIDENT INVESTIGATION REPORT

INABILITY TO OPERATE DUE TO DAMAGES OF THE LANDING GEAR OF THE AIRCRAFT

CIRRUS SR22, JA017C

AT ABOUT 11:30 JST, APRIL 17, 2020

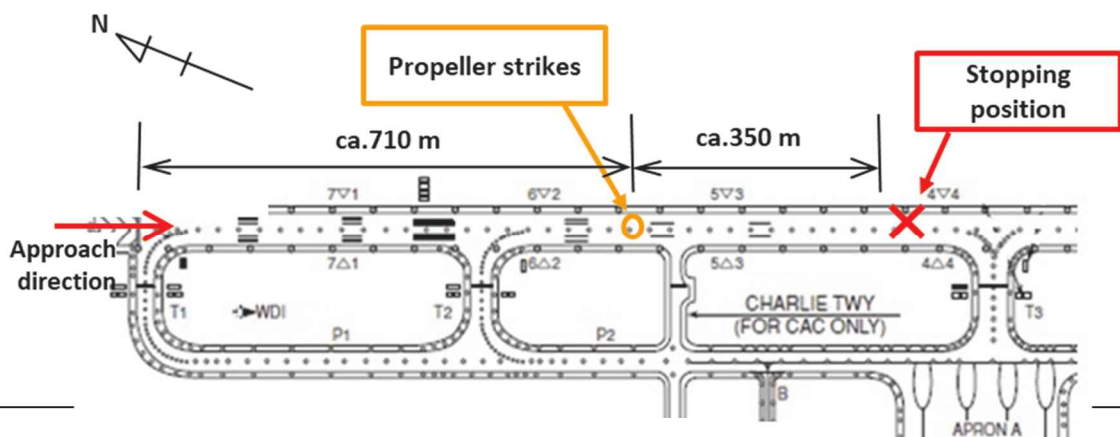
Figure 1: Condition of Runway

1.1 Summary of the Serious Incident	On Friday, April 17, 2020, when a Cirrus SR22, JA017C, operated by the Independent Administrative Institution Civil Aviation College, landed at Obihiro Airport, the nose landing gear was damaged and it stopped on the runway. After that, the aircraft became unable to continue its taxiing.

The aircraft finished the touch-and-go, and when it was piloted by the trainee and landed at Obihiro Airport, the aircraft attitude became suddenly tilted forward about four seconds after the nose landing gear (NLG) touchdown. Therefore, judging that there occurred some abnormality in the NLG, the captain shut down the engine promptly and stopped the aircraft on the runway by applying the brakes. The approach and touchdown were performed normally, and during this flight training including the landing, none of the occupants recognized any troubles in the aircraft.

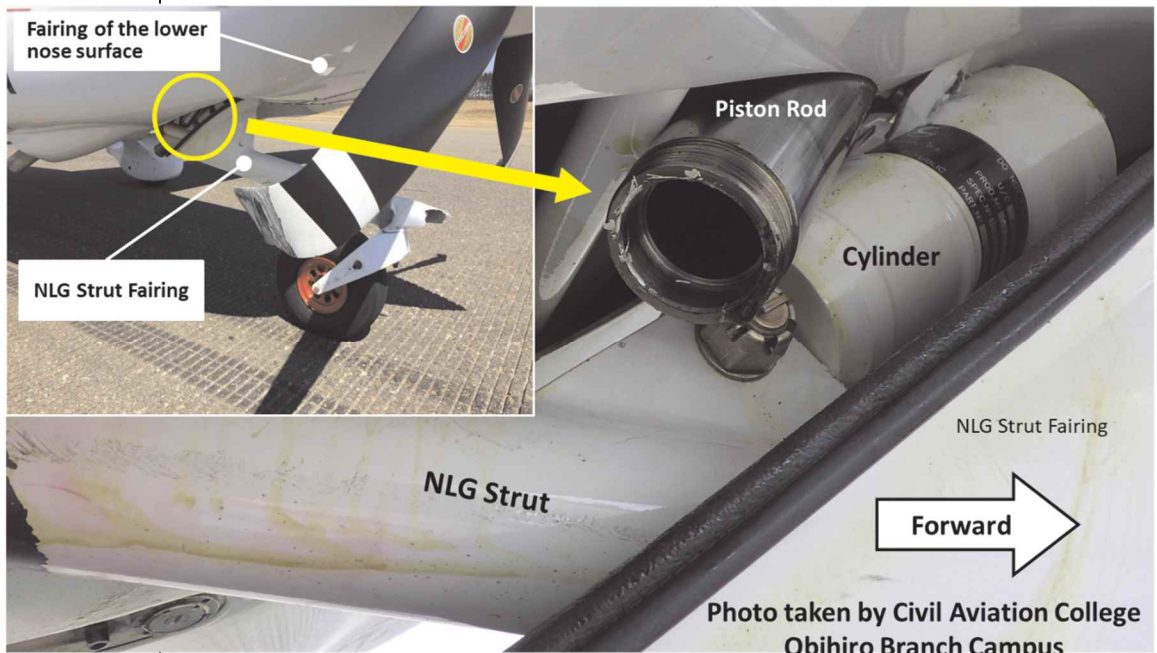
Figure 2-2: Oreo Separation Status

<p>2.2 Injuries to Persons</p>	<p>None</p>
<p>2.3 Damage to the Aircraft</p>	<p>The following damage was confirmed during the airframe inspection after the serious incident, (see Figure 2-2).</p> <ul style="list-style-type: none"> • NLG Oleo*¹ (shock absorber): Its piston rod was got out of the cylinder and separated. • Propeller blades: All the propeller blades' (three) tips were bent backward. • Fairing of the lower nose surface: It was deformed inward. • NLG strut fairing: its tip was broken. • Firewall*²: There were two dents on the lower end struck by the NLG strut. <div data-bbox="427 645 1385 1310" data-label="Image"> </div> <p>Figure 2-1: Normal Condition of the NLG (Cirrus SR22 Model) and structural drawing (with the NLG strut fairing removed)</p>

The detailed examination of the Oleo of the aircraft revealed that the Piston Rod Locknut was detached from the Piston Rod, the Grub Screw was not found during the aircraft examination and also from the inside of the Oleo. Besides, on the surface of the Piston Rod, no contact marks created when screwing the Grub Screw were confirmed, therefore it revealed that at the time of manufacturing, the Grub Screw had most likely not been installed.

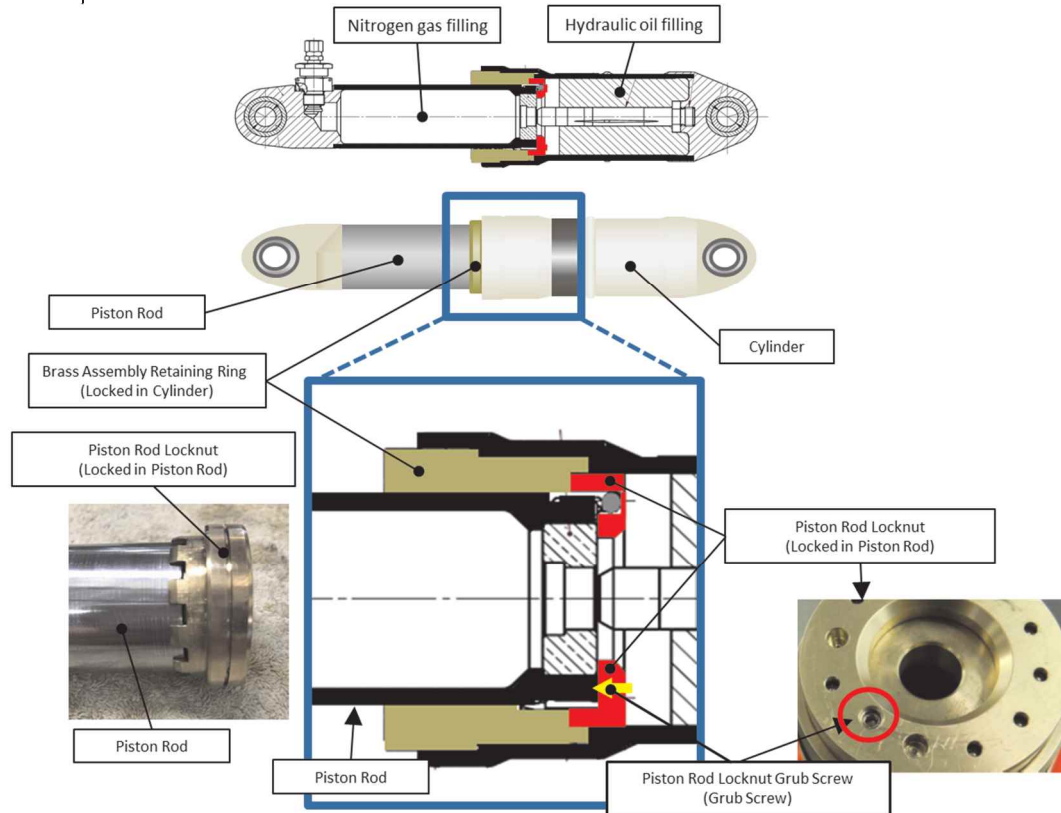
Figure 3-1: Structure of the Oleo

<p>2.7 Additional Information</p>	<p>(1) Structure of the Same Type Oleo and Failure Cases on Assembling</p> <p>The Oleo of the aircraft is designed to tighten the fittings (hereinafter referred to as “Piston Rod Locknut”) that prevents the Piston Rod from being got out of the cylinder and then fasten one Piston Rod Locknut Grub</p>

Screw (hereinafter referred to as “Grub Screw”) that prevents the Piston Rod Locknut from loosening due to its rotating. As being installed inside the Oleo, the Grub Screw was not visible from the outside unless the oleo was disassembled (see Figure 3-1).

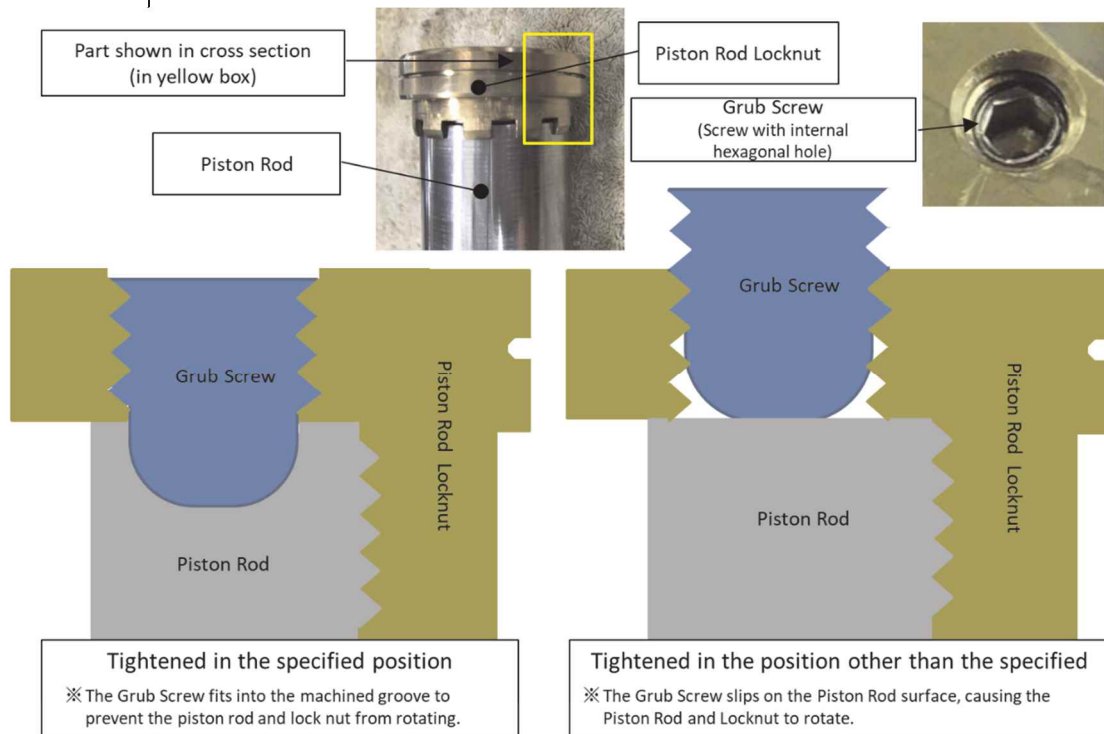
Figure 3-2: Mechanism for Grub Screw (Image)

On September 30, 2019, in the United Kingdom, there occurred a failure incident where a Piston Rod was got out of the cylinder of the same type of the Oleo, and the manufacturer of the Oleo conducted an investigation into the cause. As a result of the investigation, it was revealed that when the Piston Rod Locknut was tightened*³ into the Piston Rod in the Oleo’s assembly line, the Grub Screw was tightened while the positions of the dimple (1 place) machined on the Piston Rod and the Grub Screw hole in the Piston Rod Locknut was misaligned. Therefore, as their used repeatedly, the Piston Rod Locknut rotated, the Piston Rod Locknut was detached from the Piston Rod, and the Piston Rod was got out of the cylinder (see Figure 3-2).

There are four reports about the failure case where a Piston Rod was detached from the cylinder of the same type of the Oleo other than this serious incident, confirmed were a total of two failure cases same as that in the United Kingdom introduced in this chapter. These four failures occurred possibly due to the inappropriate tightening of the Grub Screw at the time of manufacturing, it was revealed that the Oleos manufactured in the same period as the failed Oleo would likely cause the same trouble. Therefore, the aircraft manufacturer issued the Service Bulletin to inform that the Oleos

The same type of the Oleos, whose Grub Screw was possibly not tightened at the specified position at the time of manufacturing, were shipped from February 28, 2014 to August 28, 2018, and the Oleo that had been installed in the aircraft (JA017C) was shipped on August 28, 2018.

manufactured in the same period as the failed Oleo should be replaced on December 11, 2020 after this serious incident occurred.

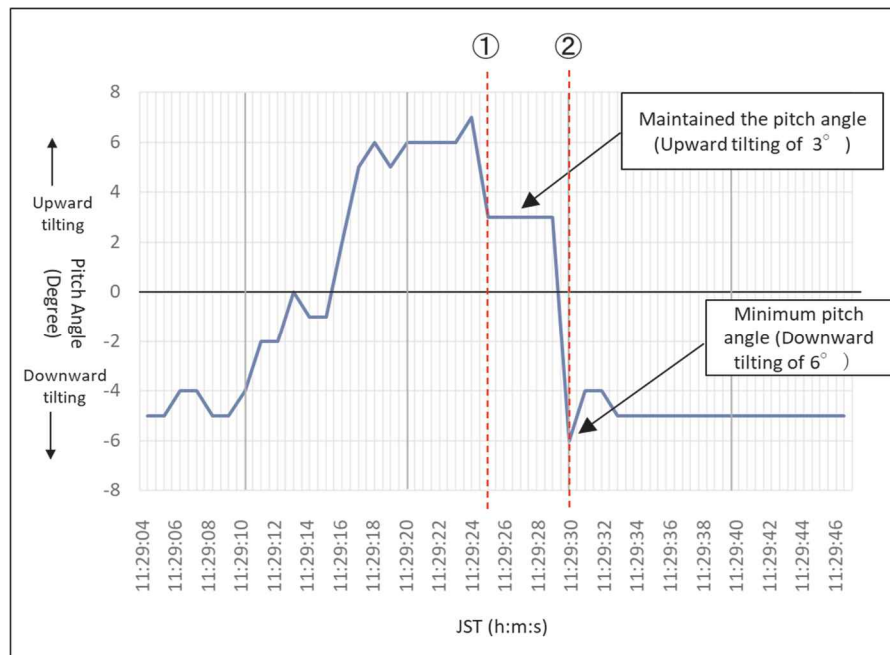
Figure 4: Changes in Pitch Angle

According to the records of the Recoverable Data Module on board the aircraft, the changes in the aircraft's pitch angle at the time of the occurrence of the serious incident were as shown in Figure 4.

The aircraft maintained its attitude tilted upward at 3° (an upward tilting of about 1° for a normal taxiing) for about four seconds from the time when the NLD seemed to have touched down (red dotted line ① in Figure 4), and then its nose became down radically and its attitude became tilted downward at the maximum angle of 6° (red dotted line ② in Figure 4). The aircraft was in an upward tilting attitude for about four seconds from the time when the NLG touched down, during which the NLG more likely supported the airframe. This is probably because the form was created where the Piston Rod separated at the time of the touchdown was on top of cylinder.

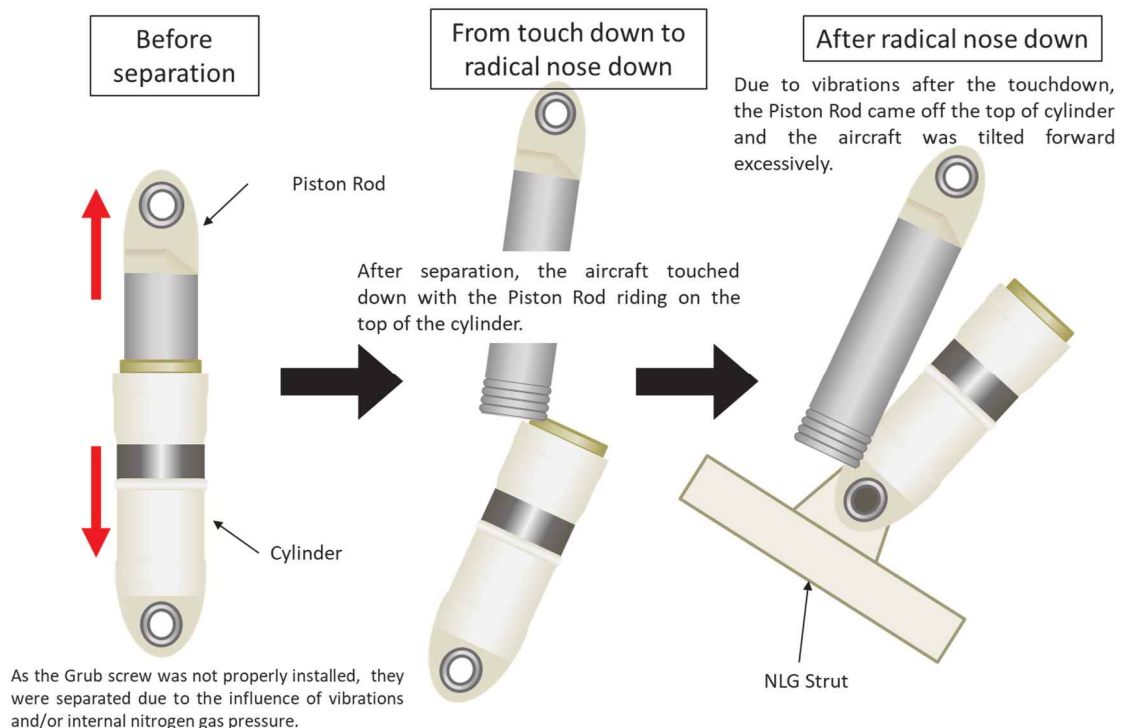
Figure 5: Separation Process of the Oleo

The radical nose down that occurred after the aircraft maintained its attitude tilted upward probably resulted from the Piston Rod riding on top of cylinder falling down, caused due to vibrations during the taxiing after the NLG touchdown and/or brake operational control (see Figure 5).

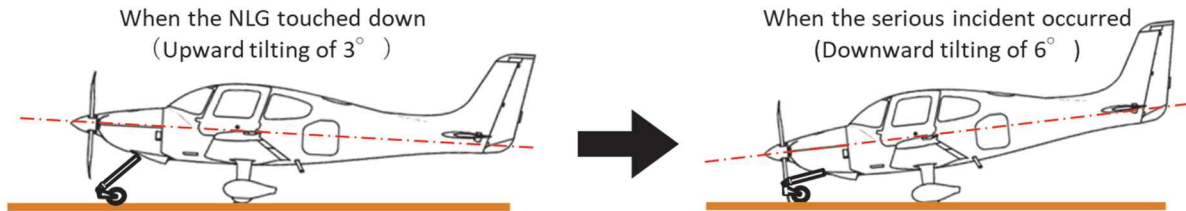
Figure 6: Aircraft Attitude at the Time of the Serious Incident (Estimate)

The JTSTB concludes that it is highly probable that from the flight data records, the aircraft attitude became radically tilted downward at the maximum angle of 6° after its NLG touched down (red dotted line ② in Figure 4), and when the aircraft became in this attitude, the tip of NLG strut fairing, which was pushed forward due to the runway surface and the excessive downward tilting attitude, came in contact with the propeller blades, resulting in the damage to the propeller blade tips and the NLG fairing tip (see Figure 6).

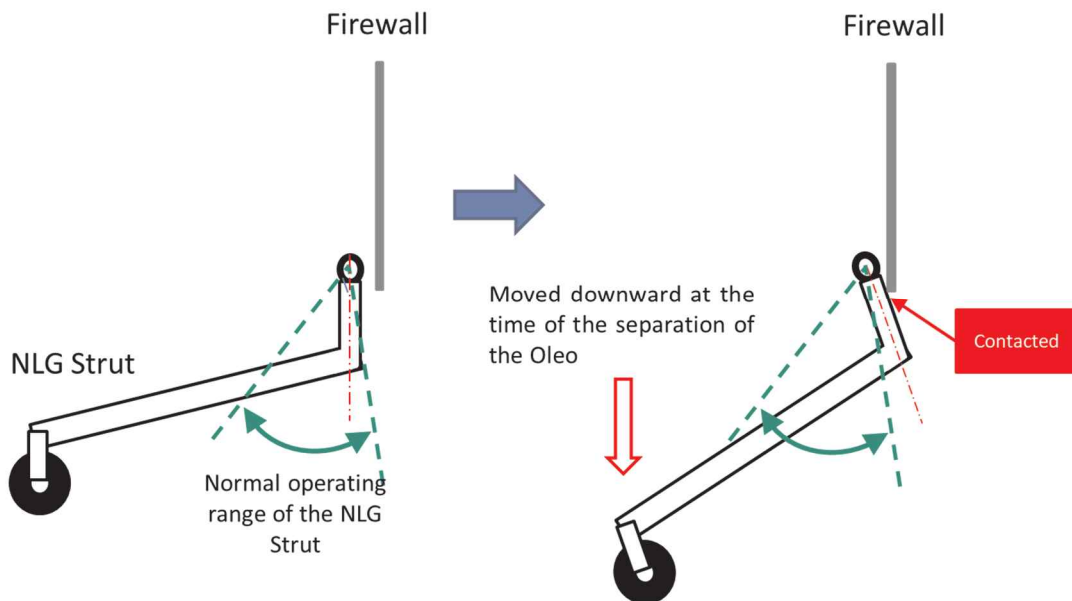
Figure 7: Contact between Firewall and NLG Strut (Image)

- No abnormality was confirmed until the take-off conducted on the touch-and-go just before the occurrence of this serious incident.
- The dents on the firewall (see (3) in this Chapter) were more likely created when the NLG strut moved downward beyond normal operating range, the NLG strut came in contact with the lower part of the firewall. Such NLG strut movement would not occur during taxiing.

In addition, the dents on the firewall were more likely created when the NLG strut moved downward beyond normal operating range (see Figure 7) as the Oleo was separated during the flight, and the damage to the fairing of the lower nose surface were probably sustained due to interference with the NLG fairing when the aircraft was excessively tilted downward after the landing, respectively.
