AIRCRAFT ACCIDENT INVESTIGATION REPORT

THE HELICOPTER DAMAGE FROM A FALL DURING HOVERING TAKUMI ENTERPRISE HELICOPTER & AIRPLANE CO., LTD. ROBINSON R44 (ROTORCRAFT), JA01CG AT JPD KYOTO OPERATION SITE KYOTO CITY, KYOTO PREFECTURE AT ABOUT 12:15 JST, DECEMBER 18, 2023

Adopted by the Japan Transport Safety Board

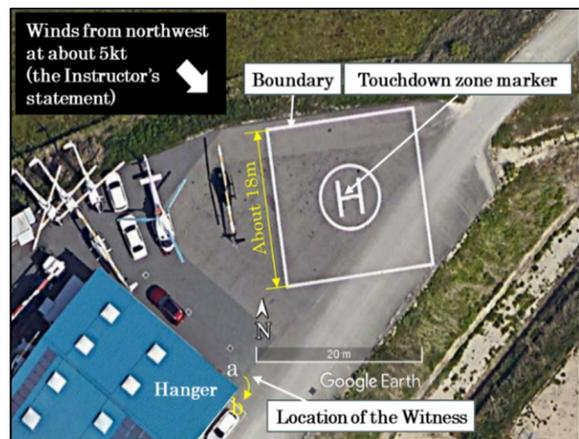
Figure 1: Situation at the Operation Site

Furthermore, when the helicopter was about to cross the square boundary indicating the helipad at the operation site (hereinafter referred to as “the Boundary”) while the Trainee was flying the helicopter, the Instructor would take over the control and move it to the center of the touchdown zone marker, stabilizing the helicopter before handing control back to the Trainee. This process was repeated (see Figure 1).

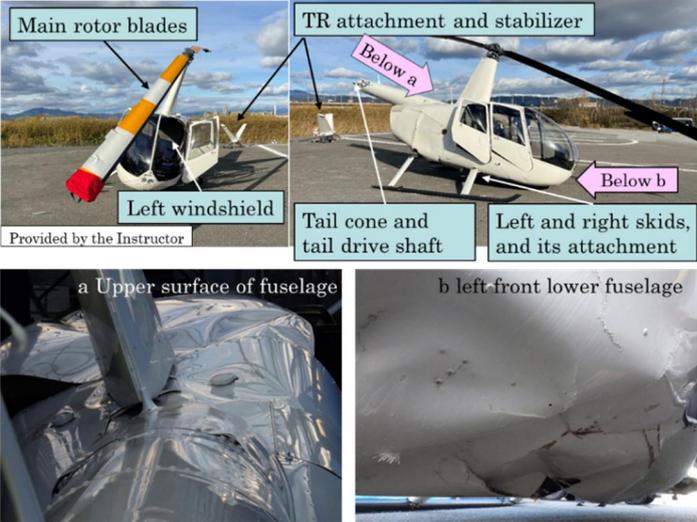
<p>Figure 2: The Helicopter after the Accident</p>

<p>the main rotor had stopped rotating before moving, as there was a risk of being struck by the rotating main rotor blades.</p> <p>After the main rotor had stopped rotating completely, the Witness moved towards the helicopter, disconnected the fuel supply, and shut down the battery power, and moved the instructor and the Trainee to a safe location.</p> <p>In addition, the company's pilot in the hanger confirmed that the helicopter's Emergency Locator Transmitter (ELT*¹) had been activated following the accident. The company's pilot went to the helicopter, then turned off its ELT's power supply.</p> <p>The accident occurred at about 12:15 on December 18, 2023, at JPD Kyoto Operation Site in Kyoto City, Kyoto Prefecture (34° 54' 55" N and 135° 44' 38" E).</p>
<p>2.2 Injuries to Persons</p>	<p>None</p>
<p>2.3 Damage to the Aircraft</p>	<p>(1) Extent of Damage of Helicopter: Destroyed</p> <p>(2) Damage Situation of the Accident Helicopter (See Figure 2 and Figure 3)</p> <p>Fuselage outer skin and structural component: Deformed and damaged</p> <p>Main rotor blades: All two blades damaged</p> <p>TR blades: All two blades broken</p> <p>Tail cone and tail drive shaft: Fractured at two points</p> <p>TR attachment and stabilizer: Broken and deformed</p> <p>Left and right skids, and its attachment: Buckled</p> <p>Left windshield: Detached and damaged</p>

At that time, it is most likely that the aircraft was subjected to a significant vertical load (G), causing deformation and damage to structural components, and, due to inertia upon ground impact, the main rotor blades drooped downward, fracturing the tail cone and tail drive shaft.

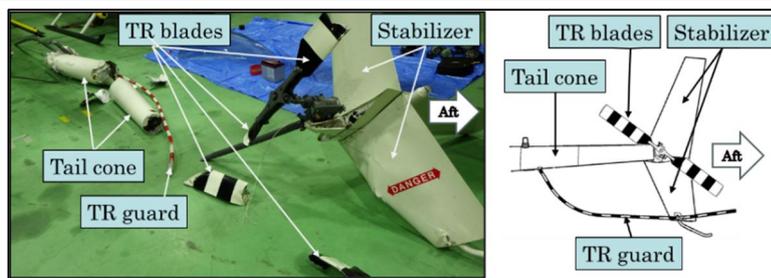
Figure 3: Damage to the Aft Portion of the Helicopter

The JTTSB concludes that that it was highly probable that the helicopter fell while spinning to the right due to damage to the TR blades.

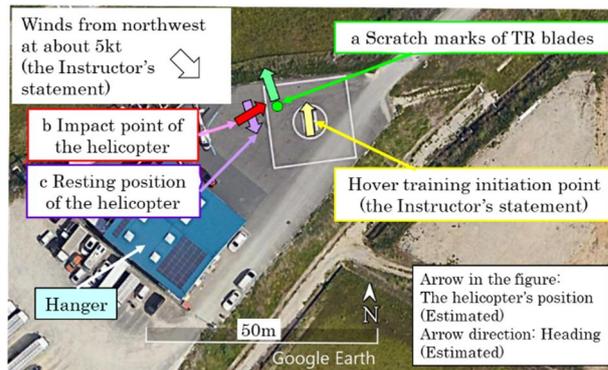
Figure 4: Situation at the Operation Site after the Accident

On the ground surface about 9 m northwest of the center of the touchdown zone marker, there were three Scratch marks made by the TR blades of the helicopter. The maximum depth of these marks was about 1 cm. Judging by the shape of these TR blade contact marks, the heading of the helicopter when the TR blades contacted with the ground was about 340° (see Figure 4, a, and Figure 5).

On the paved surface outside the western Boundary, there were contact marks left by the helicopter upon touchdown, as well as scratch marks caused by its right yaw after landing, were observed. Based on the condition of the contact marks observed at the time of touchdown, the helicopter's heading upon ground contact was approximately northeast. After coming to rest, the heading was approximately 170°, as indicated by the helicopter's directional gyro checked after the accident (see Figure 4 b. and 4 c.).

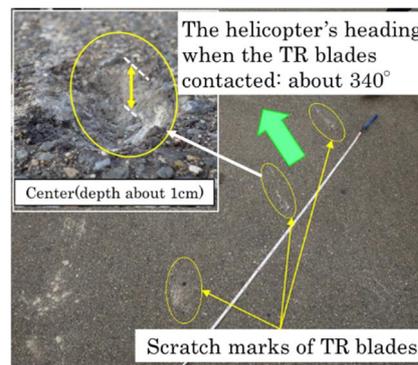
Figure 5: Scratch Marks of TR Blades

The JTTSB concludes that the helicopter had most likely pitched its nose-up excessively causing the TR blades to contact with the ground, based on the statements of the instructor and witness, as well as the scratch marks on the ground.

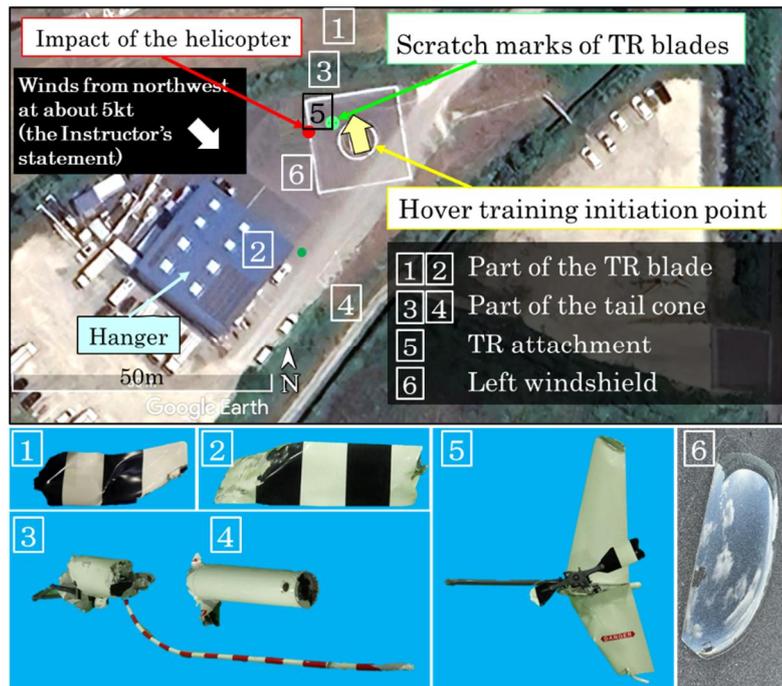
Figure 6: Scattering Condition of the Main Wreckage of the Helicopter

- a. Part of the TR blade
On the bank on the north side of the operation site (Figure 6 [1]) and on the roof of hanger located next to the operation site (Figure 6 [2])
- b. Part of the tail cone
In the grass area on the northern edge of the operation site (Figure 6 [3]) and on the bank on the south side of the operation site (Figure 6 [4])
- c. TR attachment and stabilizer

Near the northwestern Boundary (Figure 6 [5])

Outside the southwestern Boundary (Figure 6 [6])

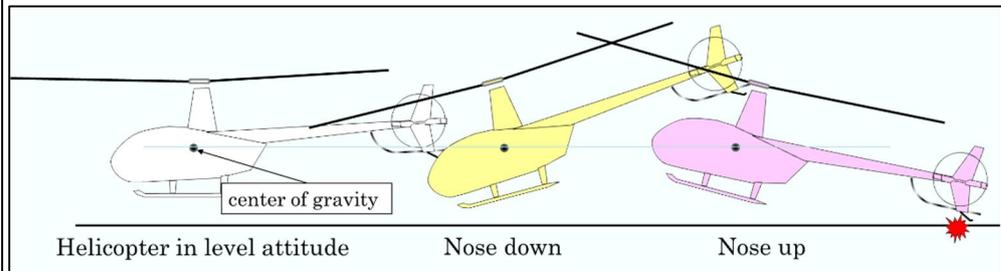
Figure 7: Changes in Clearance from the Ground depending on Differences in Nose Pitch Position

The center of gravity of the helicopter is located near the main rotor mast, and the tail section is positioned farther from the center of gravity compared to the front of the helicopter. Therefore, when pitch attitude changes around the center of gravity, even with the same angle of change, the clearance between the lowest part of the helicopter and the ground becomes narrower during nose-up attitude than during nose-down attitude. (see Figure 7). Additionally, during a nose-up attitude, the cockpit position becomes elevated, making it difficult for the pilot to recognize that the clearance between the helicopter and the ground has become narrower.

The helicopter pitched its nose-up excessively because it is highly probable that the Instructor's corrective operation after taking over the control was inappropriate. In addition, the helicopter's nose-up characteristics have possibly affected the TR blades' contact with the ground.

When allowing a student pilot who has not mastered hover operations to touch the controls, flight instructors should consider the helicopter's nose-up characteristics by establishing a sufficient hover altitude and others.

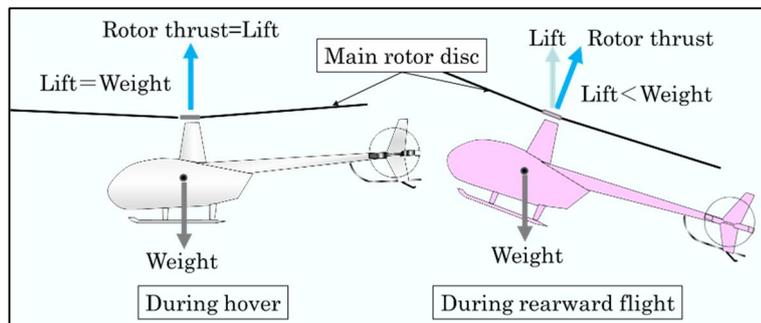
Figure 8: Effect of the Tilting of the Main Rotor Disc

During hover, the lift generated by the helicopter is equal to the thrust produced by the rotating main rotor. However, when the helicopter enters a nose-up attitude, the rotor disc tilts rearward, causing the thrust vector of the main rotor to also tilt backward. As a result, the vertical component of lift acting perpendicular to the ground decreases, leading to a reduction in altitude (see Figure 8).
