AIRCRAFT SERIOUS INCIDENT INVESTIGATION REPORT

March 13, 2026

Adopted by the Japan Transport Safety Board

Company	SKYNET ACADEMY Co., Ltd.
Type, Registration Mark	Cessna 172S, JA01DC
Incident Class	Deviation from a runway (limited to when an aircraft is disabled to perform taxiing) item (iv), Article 166-4 of the Regulation for Enforcement of the Civil Aeronautics Act
Date and Time of the Occurrence	At about 15:33 Japan Standard Time (JST: UTC+9 hours), August 5, 2024
Site of the Incident	Ryugasaki Airfield, Ibaraki Prefecture (35° 54' 24" N, 140° 14' 35" E)

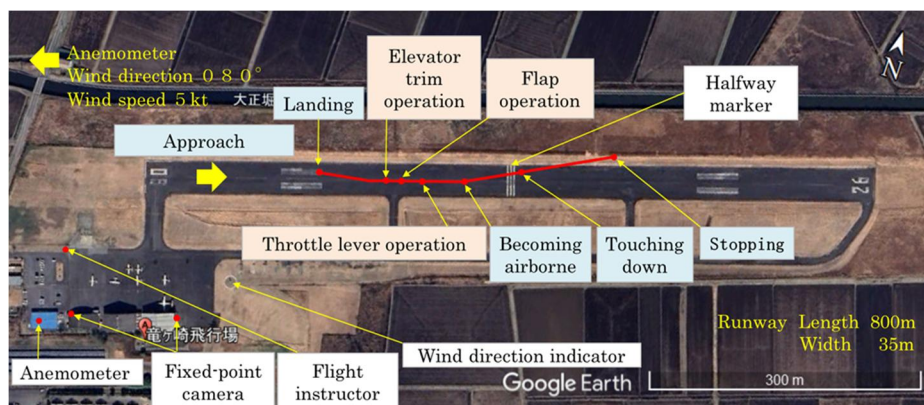
Figure 1: Estimated Flight Route

The aircraft took off from Chofu Airfield and flew to Ryugasaki Airfield (hereinafter referred to as “the airfield”), piloted by the student pilot, for the flight training required to obtain a private pilot certificate, with two people on board the aircraft: the flight instructor, who was acting as captain and the student pilot. After landing at the airfield, with only the student pilot on board, the aircraft began touch-and-go trainings in solo flights, using Runway 08 at the airfield.

After the landing of the third touch-and-go, the student pilot took off by operating the flap lever and elevator trim control in that order, in accordance with the procedures. When raising the nose for take-off, the student pilot felt as if the aircraft had become airborne earlier than usual, then confirmed the position of the elevator trim control after take-off and noticed that it was set to a nose-up position rather than the "TAKE OFF" position. Wanting to confirm whether the timing of the aircraft becoming airborne would change if the elevator trim control position was set correctly to the "TAKE OFF" position during the landing of the next touch-and-go, the student pilot decided to set the elevator trim control to firmly the "TAKE OFF" position and then raise the flaps. Therefore, after the landing of the fourth touch-and-go, the student pilot first visually confirmed that the elevator trim control had been set to the TAKE OFF" position and then operated the flap lever. Regarding this operation, the student pilot stated that the student pilot had moved the flap lever from the full down position to the full up position. After that, the student pilot started to press the right rudder pedal, and next operated the throttle lever to the full power position. However, the student pilot did not confirm the flap position after operating the flap lever.

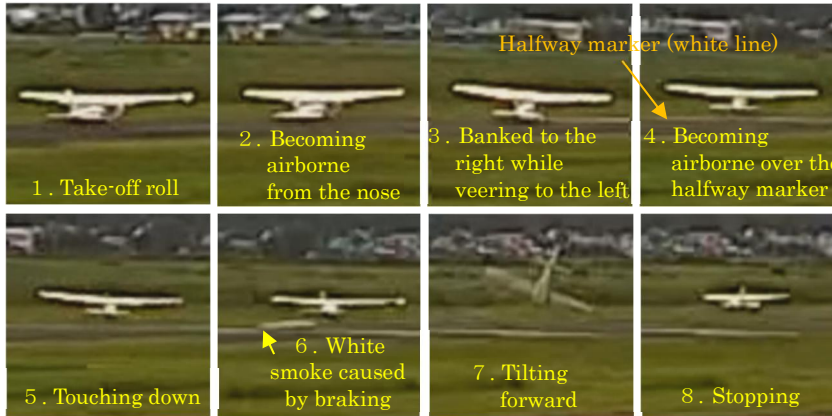
Figure 2: Video from Fixed-point Camera

According to the video footage from the fixed-point camera installed at the airfield, the aircraft's movements from when it was taxiing on the runway after landing until it came to a halt in a grassy area on the left side of the runway are as shown in Figure 2. During the take-off roll, the aircraft became airborne from the nose, touching down with its nose veering to the left. It took about eight seconds for the aircraft to land and for its nose to rise. Besides, the wind direction indicator (windsock) was pointing at around 090°, indicating a consistent wind direction. The aircraft deviated from the runway, entered the grassy area on the left side of the runway, tilting

forwards significantly as if it had gotten stuck on the ground. It then came to a stop in an almost horizontal position. At the serious incident site, the aircraft's tire marks were still visible. Three tire marks were left in the grassy area, extending from the direction in which the aircraft had been travelling. Furthermore, the aircraft's nose wheel and both main wheels were buried in the grass, preventing the aircraft from taxiing.

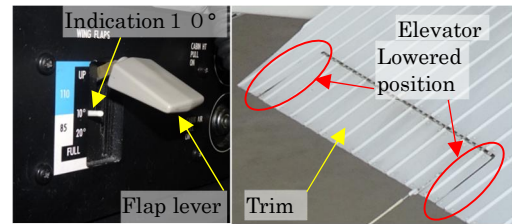
Figure 4: Flap Lever and Elevator Trim

Although the flap lever in the cockpit was in the full up position, the flap position, and the value on the flap control indicator in the cockpit were both set to 10°. When the electrical power was turned on in this condition, the flaps began to operate, moving to the same position as the flap lever (full up), and then stopped. Subsequent checks revealed that the flaps operated following the flap lever with no difference arising between the lever's position and that of the flaps. The flaps stopped operating six seconds after the lever was moved from the full down position to the 10° position. As shown in Figure 4, the elevator trim installed on the right elevator was set to the nose-up position (trim down position). In addition, no anomalies were observed in the operation of the rudder pedals and brakes.

The JTSA concludes that since the student pilot had raised the flap lever after the aircraft landed and before it became airborne from the nose, it is most likely that when the aircraft became airborne, the flaps were in a higher position than the full down position used for landing. In addition, the airframe examination after this serious incident that revealed that the position of the flaps was at 10°, therefore, when the aircraft became airborne, it is highly probable that the flaps were not in the full up position intended by the student pilot, but rather in a position upper than the full down position but lower than the 10° position. When the aircraft became airborne,

the flaps were most likely in a position upper than the full down position but lower than the 10° position, and the aircraft was taxiing at the indicated airspeed exceeding the stall speed, therefore, it is highly probable that the aircraft was in a state where it could be able to become airborne.

There was a discrepancy between the flap lever position and the flap position, possibly because, according to the flap position for take-off during the company's training (specified to set to full up or 10°, depending on the airfield) and the operation procedures after landing, the student pilot set the flap lever to the 10° position when operating the flap lever during the take-off roll, however, the aircraft came to a halt, and then the aircraft's power supply was shut down after the flap lever was set to the full up position.

The flap lever operation should be performed at the time specified in the flight instructor's procedures.

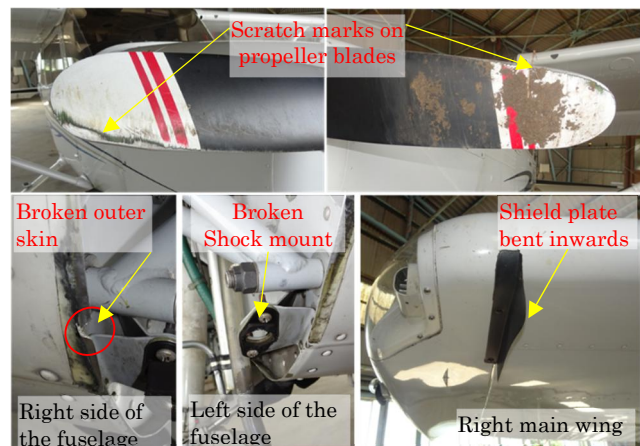
Figure 5: Main Damage Areas

Propeller blades: Scratch marks were found on the tips of both blades. One of the blades had bent backwards.

Main wings: Scratch marks were found on the leading edge of the left main wing. The shield plate at the tip of the right main wing was found to be bent inwards.

Right side of the fuselage: The outer skin of the lower engine cowl attachment was broken.

Left side of the fuselage: The shock mount for the lower engine cowl attachment was broken.
