AIRCRAFT SERIOUS INCIDENT INVESTIGATION REPORT

CASE WHERE AIRCRAFT OPERATION IS IMPEDED BY FAILURE IN AIRCRAFT EQUIPMENT PRIVATELY OWNED AGUSTA A109E (ROTORCRAFT), JA02KG OVER YACHIYO TOWN, YUKI COUNTY, IBARAKI PREFECTURE AT ABOUT 14:55 JST, JULY 28, 2024

November 27, 2025

Adopted by the Japan Transport Safety Board

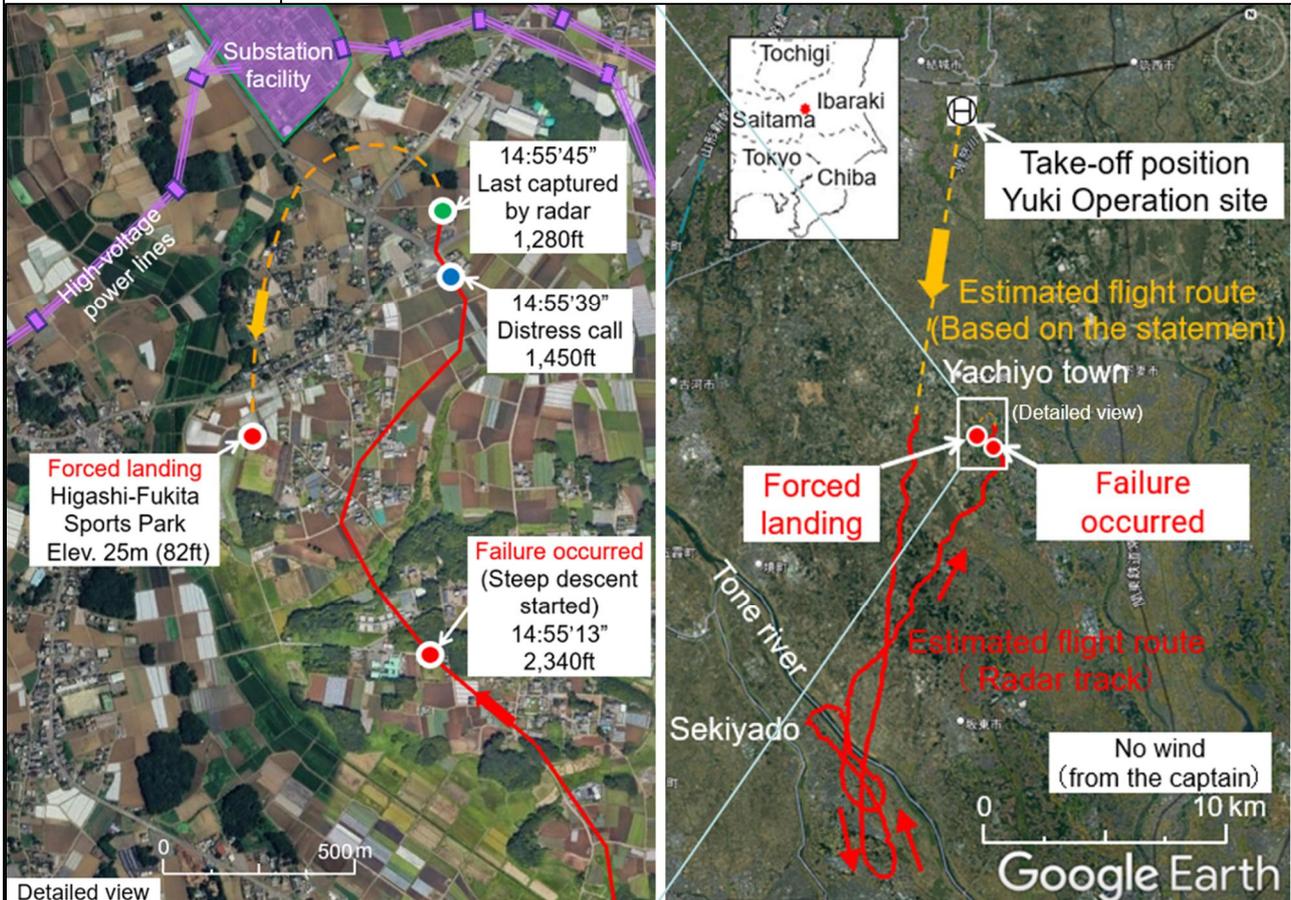
Figure 2: Estimated flight route
 The serious incident occurred at an altitude of about 2,340 ft over Yachiyo Town, Yuki County, Ibaraki Prefecture (36° 09' 09" N, 139° 54' 24" E) at about 14:55 on July 28, 2024.

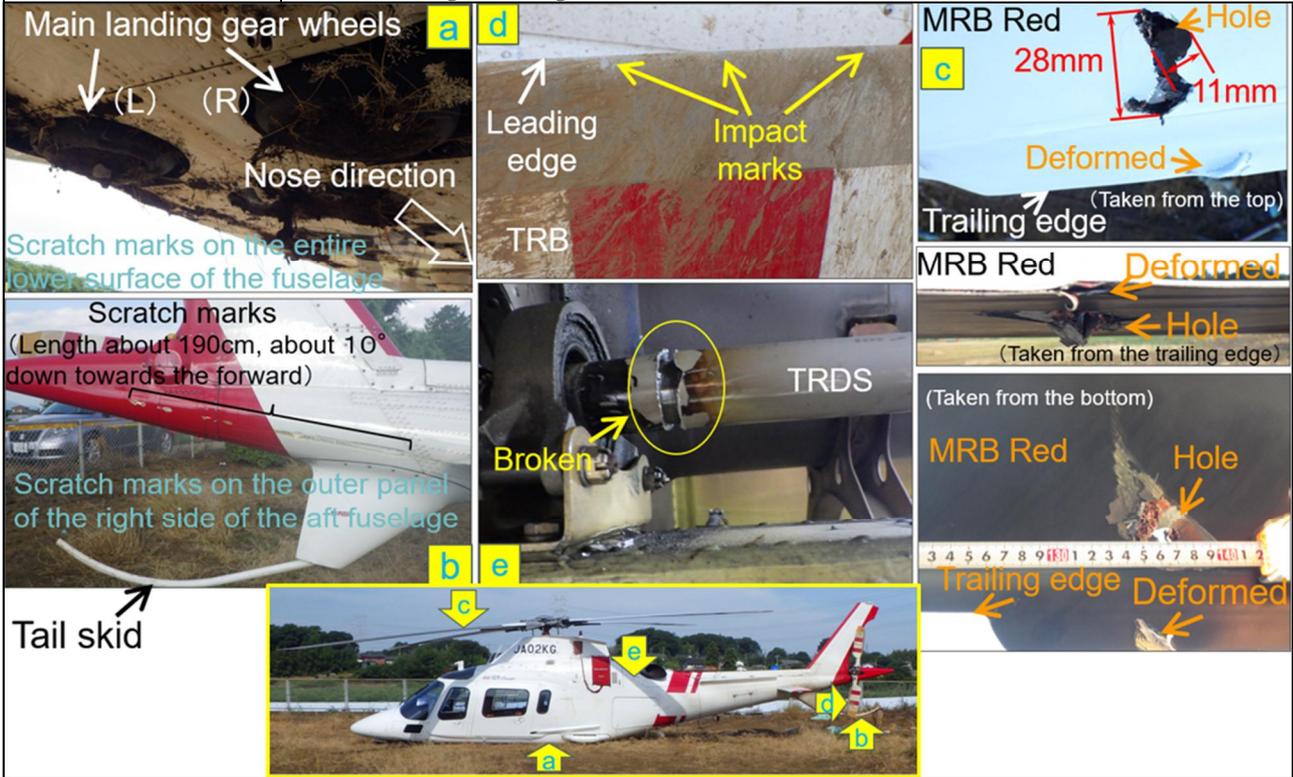
Figure 3: Damage to the helicopter

(1) Helicopter Damage: Minor damage
 (2) Damage to parts of the Helicopter
 Lower surface of the fuselage and outer panel of the right side of aft fuselage: Scratch marks
 One MR blade (MRB) (Red: All four MRBs are color-coded into Red, Blue, White and Yellow, respectively.) Hole and deformed
 Two tail rotor blades (TRB) (All two blades): Dents on the leading edge
 Tail rotor drive shaft (TRDS): Broken
 Loudspeaker (Lower surface of the fuselage) Detached
 The lower link of scissors had become detached from the stud bolts of the upper swashplate. The cotter pin, nuts and washers that had been installed

were missing (see Figures 4 and 8).

Mud was on the tail skid, and scratch marks on the outer panel of the right side of aft fuselage extended about 190 cm in a straight line about 10° downward towards the helicopter's forward.

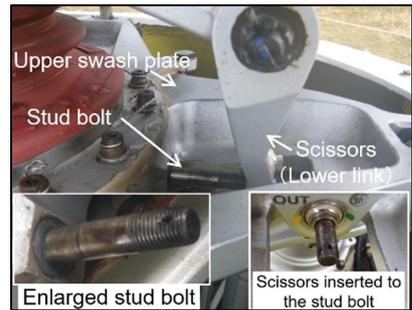
Figure 4: Detached scissors

lower link had become detached from the stud bolts of the upper swashplate (see 2.7(2) below).

The JTSB concludes that the sudden banging sound during the flight most likely occurred when the scissors lower link of the scissors detached from the upper swashplate stud bolt, causing the nuts and other components to hit and penetrate the MRB Red. Based on the fracture of the MRB Red, it is most likely that the nut penetrated it from the top to the bottom.

The JTTSB concludes that the scissors lower link most likely became detached from the upper swashplate stud bolt, together with the nut and washers, because the self-locking nut and the cotter pin had eventually lost their function. The following are possible reasons why the self-locking nut and the cotter pin lost their function.

- a. The tightening torque of the self-locking nut was insufficient.
- b. Just as with the upper scissors' cotter pin, the lower scissors' cotter pin was not installed correctly, with insufficient bending and no anticorrosive substance applied. This caused the scissors lower link to detach or break during the five-hour flight.
- c. The cotter pin was not installed.

However, the self-locking nut and the cotter pin were not found, and there was insufficient information regarding their installation status. Therefore, it could not be determined. In any case, it is likely that the self-locking nut and the cotter pin lost its function because the scissors were not installed correctly.

5.1 Safety Actions Required	Including the scissors' cotter pin installation, which was described in "3 ANALYSIS", it is important that maintenance staff shall conduct the aircraft maintenance procedure appropriately and confirm this upon completion.
--	---

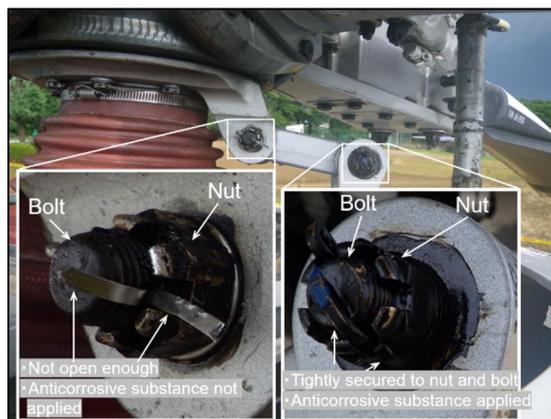
Figure 7: Cotter pin of the scissors of the helicopter

In comparison with the cotter pin installed in the linkage between the upper link (44 in Figure 8) and the lower link (43 in Figure 8) that would not be disassembled during installation of the scissors, the upper cotter pin of the helicopter's scissors was installed in such a way that it was not bent sufficiently towards both the bolt and nut, nor was it tightly secured to either of them. Furthermore, it was not coated with an anticorrosive substance. (see Figure 7, lower left).

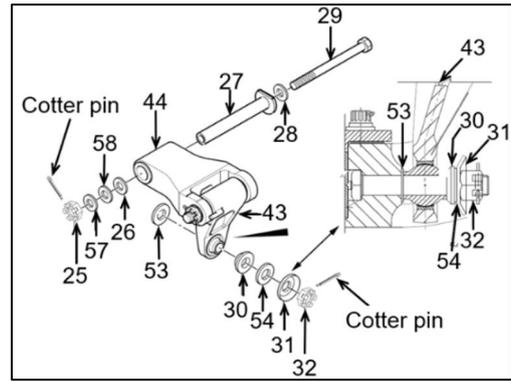
Figure 8: Components around the Scissors

The nut (32) in Figure 8 is a self-locking nut that incorporates a non-metallic (nylon) insert that deforms along the threads when the nut is tightened, preventing loosening. The nut (32), together with the cotter pin, acts to prevent the scissors from falling off.
