# AIRCRAFT SERIOUS INCIDENT INVESTIGATION REPORT

CASE WHERE A SLUNG LOAD CARRIED EXTERNAL TO THE  
AIRCRAFT WAS RELEASED UNINTENTIONALLY  
SAITAMA DISASTER PREVENTION AIR SQUADRON  
(ENTRUSTED OPERATIONS BY HONDA AIRWAYS CO., LTD.)  
AGUSTA AW139 (HELICOPTER), JA03FD  
IN HONDA AIRPORT,  
KAWAJIMA TOWN, HIKI COUNTY, SAITAMA PREFECTURE  
AT ABOUT 10:24 JST, FEBRUARY 17, 2024

May 16, 2025

Adopted by the Japan Transport Safety Board

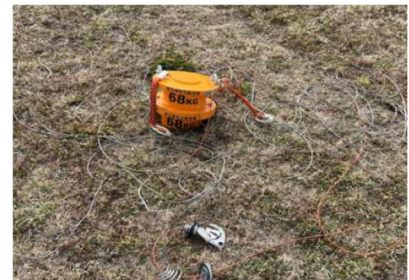
Figure 1 Dropped Weight

The Air Squadron Officer reeled out the cable, about the time to stop automatically, the weight fell to the ground along with the cable. (Fig. 1)

The position of the weight and cable drop was grass area near Taxiway E4 of Honda Airport and there was no damage to ground objects. As ground crew had evacuated about 30 m from the drop position so no one was injured.

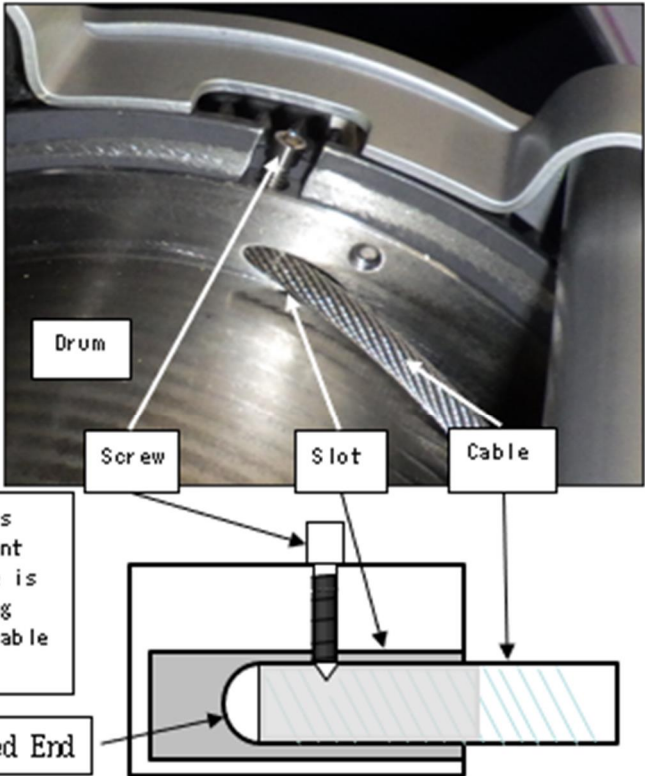
<p>Drum</p> <p>Screw</p> <p>Slot</p> <p>Cable</p> <p>Welded End</p> <p>The cable end is welded to prevent fray, and cable is fixed by placing screw against cable strand.</p> </div> <p>Figure 4 Cable End Attachment (Image)</p> <p>(2) Replacement to the New Cable (hereinafter referred to as "new cable") which dropped in the Serious Incident.</p> <p>There was unacceptable bird caging on the cable (hereinafter referred to as "old cable"), old cable was replaced.</p>

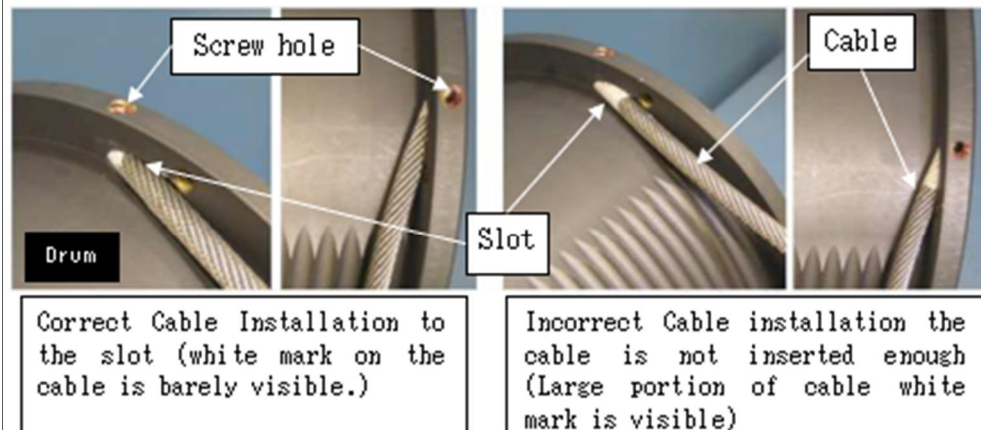
Figure 6 Precautions for Inserting Cable End (from AMP)

Make sure that the screw engages sufficiently the cable end to safety the cable correctly into the drum shoulder. To do this, you can see only a small part of the cable white mark that goes out of cable housing in the drum shoulder (Figure 6). Carefully obey the given precautions before you install the applicable screw to prevent unwanted loss of cable.

was also confirmed that when the cable was inserted into the slot, the cable came in contact with the protruding tip and could not insert any further, and that a large portion of the cable white mark was visible. (Figure 6).

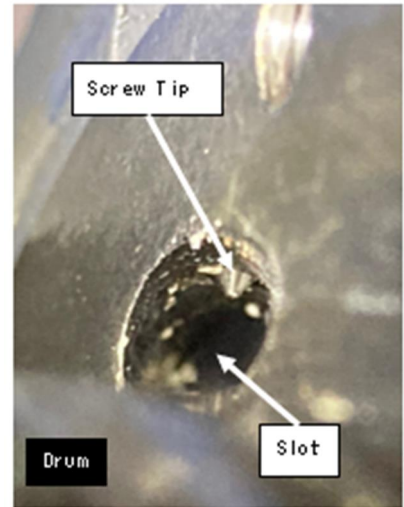
Figure 7 Screw tip condition at the Serious Incident

The screw condition at the time of the serious incident was observed from the slot and the tip of the screw protruding in the slot (Figure 7). It

Next, the screw was removed and it was confirmed that the screw had been screwed for six turns. When the cable was correctly fixed with the screw tip on the strand following the procedure described in AMP, with the specified torque value was reached at eight turns.

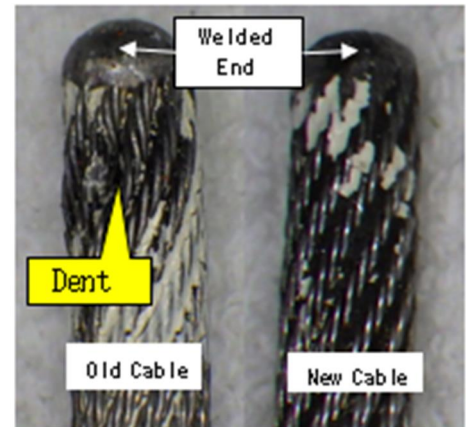
Figure 8 Difference on Cable Ends

When the new and old cable ends were compared, on the old cable, there was a conical dent where the old screw seemed to have been tightened on the strands, but there was no such dent on the new cable end. (Figure 8).

In addition, it was confirmed that the same dent found on the strands of the old cable was also found on the strands of the new cable, after specified torque value had been applied at eight turns.

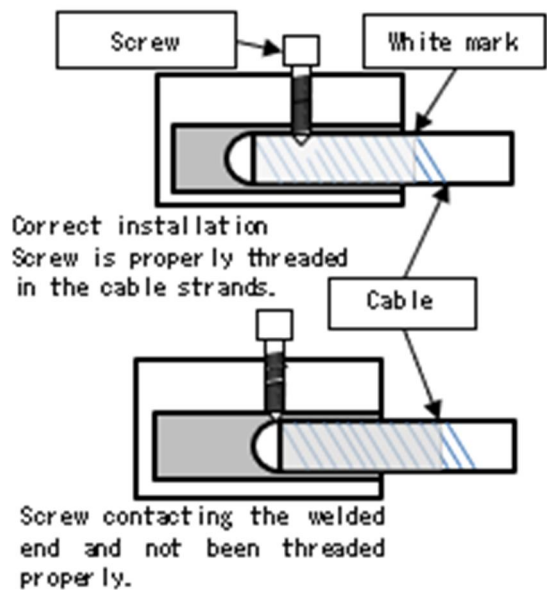
Figure 9 Failure in cable installation

Based on these results, it is most likely that the new screw was not properly screwed to the new cable strands and came in contact with the welded end of the new cable. (Figure 9)

Therefore, it is most likely that the new cable was not properly fixed to the drum and when the new cable was fully unwound during the load test, the new cable detached from the drum and fell along with the weight. At the end of the cable replacement, the Mechanics pulled the new cable to check that it would come loose, but it is possible that the new cable was tightened by new screw against the welding area and could not easily pulled out. It is probable that the new screw, which was not properly fixed, loosened while the various operational tests and the new cable detached with the load during the load test.

The JTSB concludes that the probable cause of this serious incident was that the load test was conducted most likely without the cable properly attached to the drum when it was replaced, causing the cable to come loose from the drum when it was fully unwound the cable detached from the drum and fell with the weight.

The reason why the cable was not properly attached to the drum probably because the cable had not been replaced in accordance with specified maintenance procedure.

<b>Required</b>	<p>cable replacement, it is required to check and precisely follow the work procedures.</p> <p>In addition, to firmly secure the cable, mechanic is required to ensure the cable visually through the screw hole in addition to checking the insertion length, in accordance with the revised AMP.</p>
<b>5.2 Safety Actions Taken after the Serious Incident</b>	<p>(1) Safety Actions Taken by Honda Airways Co. Ltd. after this Serious Incident</p> <ul style="list-style-type: none"> <li>a This case was introduced within the company, and the mechanics were reminded to follow the maintenance procedures for all work.</li> <li>b The task card for the cable replacement have been revised in line with the revised AMP, and mechanics was requested to strictly follow the newly added procedure.</li> <li>c In addition to specified maintenance procedure, original check procedures were added to ensure that the cable is secured firmly.</li> </ul> <p>(2) Safety Actions Taken by the Manufacturer</p> <p>After this serious incident, the helicopter manufacturer revised AMP and added a Caution note to ensure that the cable is inserted correctly by looking through the screw hole when the cable is attached to the drum.</p>
