**AIRCRAFT ACCIDENT
INVESTIGATION REPORT**

**SPRING AIRLINES JAPAN CO., LTD.
JA03GR**

CABIN ATTENDANT INJURY BY THE SHAKING OF THE AIRCRAFT OVER ASO CITY, KUMAMOTO PREFECTURE, JAPAN AT ABOUT 13:38 JST, OCTOBER 22, 2017

SPRING AIRLINES JAPAN CO., LTD.
BOEING 737-800, JA03GR

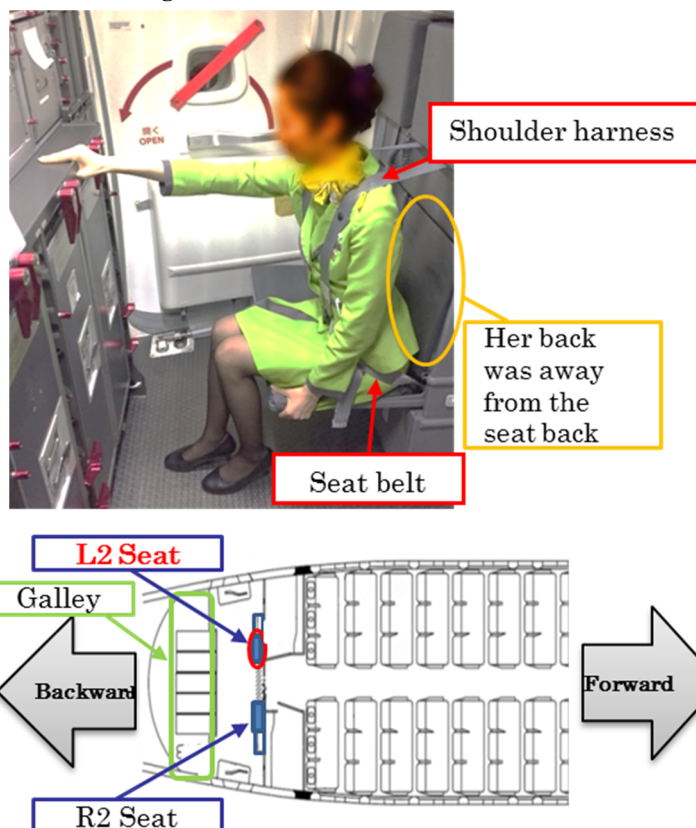
Against the intense shaking, the Cabin attendant A grabbed the bottom of the seat with her left hand and planted her feet firmly on the floor to prevent her body from floating, in addition, she grabbed the frame of the galley with her right hand so that she would be able to confirm the safety of the passengers if looking backward. (See Figure 1.)

Figure 1 Seating posture (posed by a cabin attendant of the same physical build with the Cabin attendant A)

<p>forward and her back off the seat back. (See Figure 1.)</p> <p>Because the Cabin attendant A was seated in such a posture, it is somewhat likely that when an upward impact was inflicted upon her buttock due to the strong shaking, which increased the stress on her lumbar spine, resulting in a lumbar compression fracture.</p> <p>(5) Action taken by the Cabin attendant A</p> <p>The Cabin attendant A continued her duties on board the next flight despite her injury suffered at the Flight, however, it is probable that she should have promptly reported her injury to the Chief Cabin Attendant in accordance with the Company's Cabin Attendant Manual.</p>
--	---

seat or you are in such a condition that your back has to be off the back of the seat in order to confirm the conditions of the cabin and others.

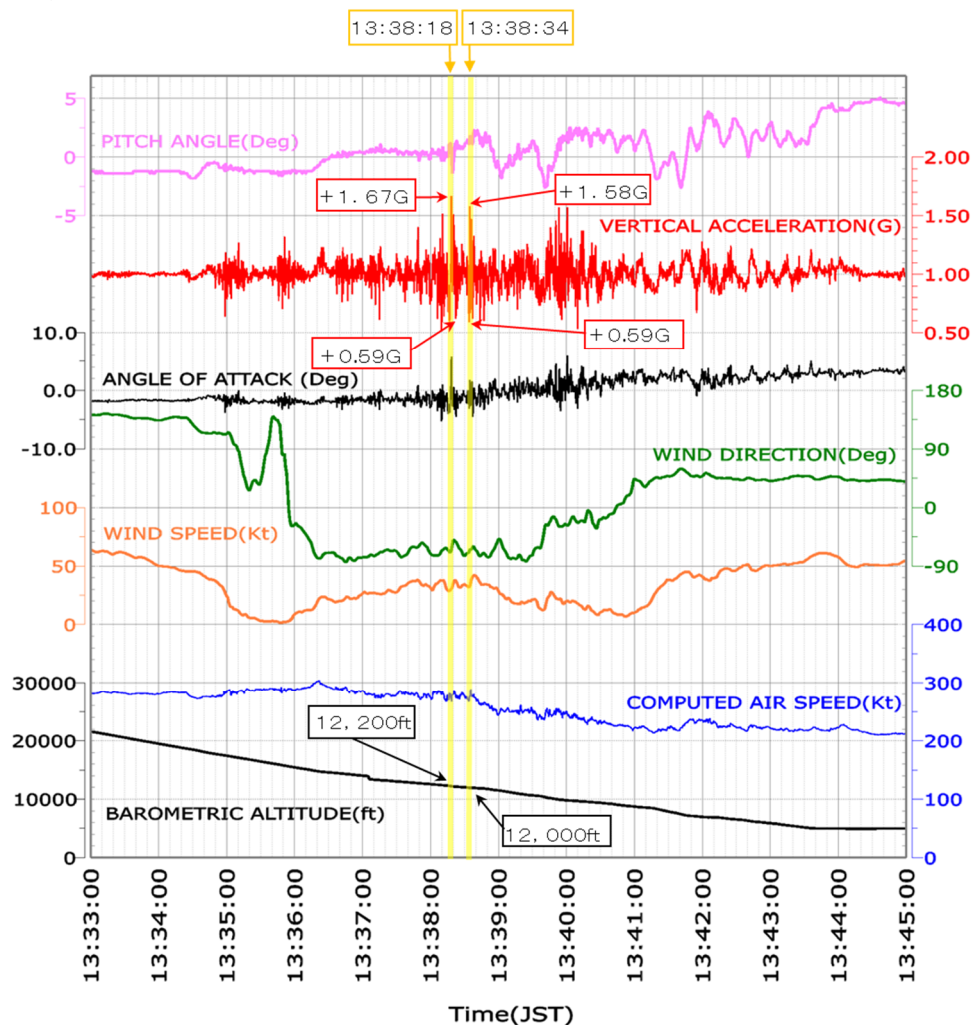
<p style="text-align: center;">Figure 2 QAR records</p>

2.7 Additional Information	<p>(1) According to the QAR records, after the Aircraft initiated the descent, around the time when passing around FL160, the vertical acceleration began to fluctuate in a short cycle. Especially, at 13:38 when passing an altitude of around 13,000 ft, the fluctuation range of the vertical acceleration was wide, from 13:38:16 to 13:38:18 when passing around an altitude of 12,200 ft, it fluctuated between +0.59 G and +1.67 G, and at 13:38:34 when passing an altitude of around 12,000 ft, it fluctuated between +0.59 G and +1.58 G. The fluctuation in a short cycle continued until at an altitude of around 7,000 ft.</p> <p>(2) The Company’s Manual for Cabin Attendant stipulates that when cabin attendants are injured or become sick during flight duties, they shall report it to the Chief Cabin Attendant, who shall report it to the PIC including such information as the location where they have got injured or become sick, specific part of body in terms of injury or sickness body, the extent of injury and illness, and probable causes of the injury and illness.</p>

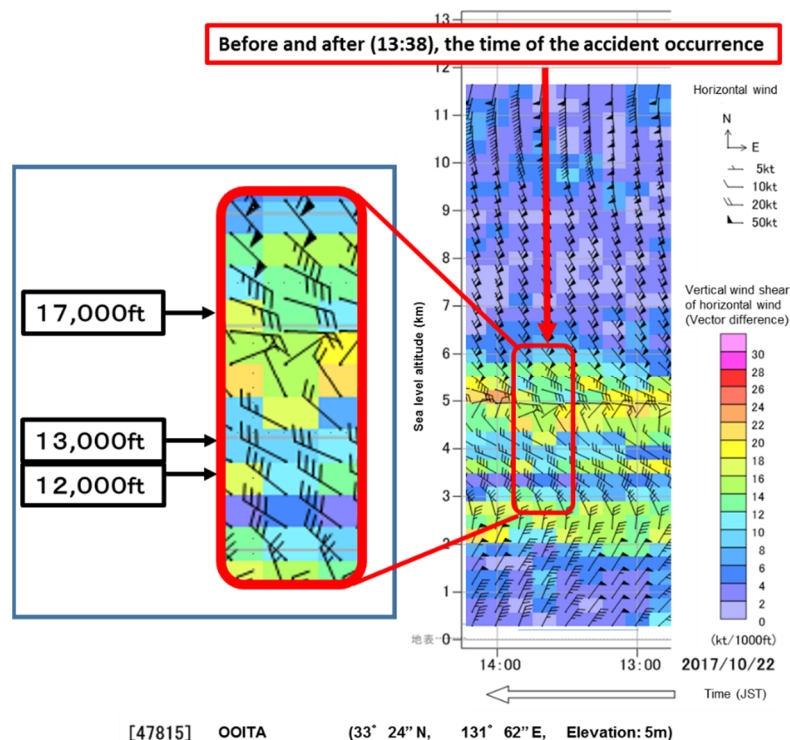
Figure 5 Excerpt from the wind profiler at Oita as of October 22, 2017

According to the excerpt from the wind profiler (time elevation cross section, 10 minutes observation data, elements, vertical wind shear*4) at Oita in the vicinity of the accident site (See Figure 5), the wind direction and speed had changed from an east-southeast at a speed of 30 kt to a north-northwesterly wind at a speed of 30 kt between an altitude of around 17,000 ft and around 13,000 ft.

The vertical wind shear of the horizontal wind was observed to have changed about 10 kt to 12 kt per 1,000 ft at an altitude of around 12,000 ft.
