AA2023-7

**AIRCRAFT ACCIDENT  
INVESTIGATION REPORT**

**Japan Transocean Air Co., Ltd.  
JA 07R K**

## CABIN CREW MEMBER INJURY BY SHAKING OF THE AIRCRAFT JAPAN TRANSOCEAN AIR CO., LTD. BOEING 737-800, JA07RK AT AROUND 11,300 M (FL 370) ABOUT 56 KM SOUTHEAST OF MIHO AIRPORT AT ABOUT 12:55 JST, OCTOBER 3, 2022

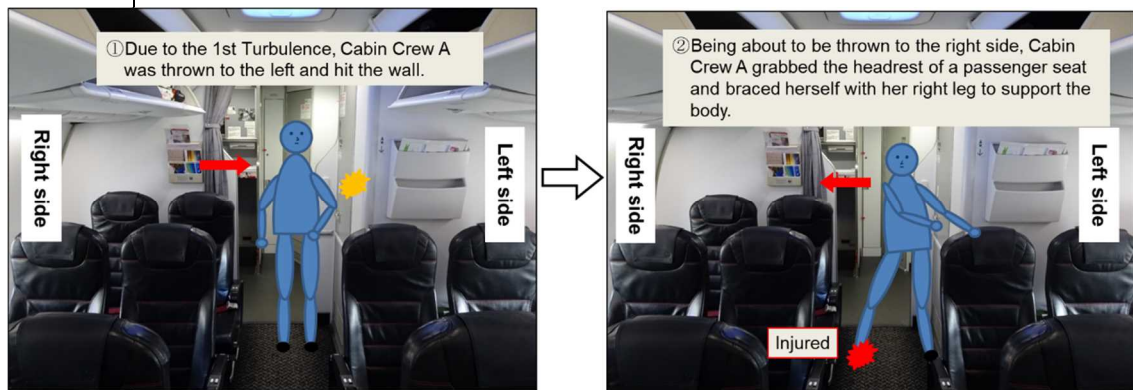
Figure 3: Cabin Crew A's Situation at the Time of the Accident  
(Image Based on the Statement)

At about 12:55, when Cabin Crew A came to the aisle, the aircraft encountered significant shaking, being shaken from left to right (lateral tremor) again (hereinafter “the 2<sup>nd</sup> Shaking”). Due to this shaking, after hitting the wall on the left side of the aisle, Cabin Crew A was about to be thrown to the right side. Cabin Crew A grabbed the headrest of a passenger seat on the left side so as not to fall down to the right side, stood the ground with the right foot, and avoided falling down (see Figure 3).

<p>(1) Injury to Cabin Crew Member</p>	<p>The JTSTB concludes that it is probable that while the seat belt sign was turned off and Cabin Crew A was walking in the aisle to attend to passengers, the 2<sup>nd</sup> Shaking was encountered, when Cabin Crew A, who was about to be thrown to the right. Cabin Crew A stepped hard on her right leg to keep from falling down to the right, but a heavy load added with the vertical acceleration and lateral acceleration caused by the aircraft shaking was momentarily placed on the sole of the right foot, resulting in the injury to Cabin Crew A. From the QAR records, this shaking was caused by a combination of changes in bank angle of the aircraft and nose heading (yaw (heading) movements of the aircraft), and the aft cabin section, where Cabin Crew A had been, was the place that would be significantly affected by lateral inertia caused due to yaw movements of the aircraft as being far from the rotation center of the yaw movements of the aircraft. Therefore, lateral acceleration larger than the recorded acceleration on QAR had probably occurred around the place where Cabin Crew A was.</p> <p>Cabin Crew A was able to avoid falling down or hitting passenger seats, etc. by grabbing the headrest of a passenger seat quickly was because disseminating information on how to respond to shaking in the regular campaigns and trainings in the Company more likely made a difference to it. It is desirable for the Company to continue to implement the ongoing preventive measures against the injuries due to shaking.</p>

<b>5.1 Safety Actions Required</b>	As described in ANALYSIS, it is desirable for the Company to continue to implement their ongoing preventive measures against similar accidents.
<b>5.2 Safety Actions Taken after the Accident</b>	<p>The Company took following safety actions after the accident.</p> <p>(1) Issuing alerts to the Company’s cabin crew members and thoroughly reimplementing the measures</p> <p>The Company issued the cabin safety information that described the following contents (dated on October 21, 2022) to all cabin crew members, as well as issued alerts and implemented again the measures thoroughly in the “Injury Prevention Campaign for Passengers and Cabin Crew Members” (from November 1 to 30 in 2022), in which the flight crew members, cabin crew members, and Airport operation department collaborated.</p> <ul style="list-style-type: none"> <li>① Overview of this accident</li> <li>② Points to protect yourself at the time of encountering unexpected shaking in the cabin</li> <li>③ Judgement about the suspension / discontinuation of in-flight services under unstable condition.</li> <li>④ Importance about the specific communication and conversation of confirmation to recognize the situation properly</li> </ul> <p>(2) All cabin crew members shall be mandatorily required to receive the practical training about how to hold their bodies at the time of encountering unexpected shaking in the cabin crew member initial</p>

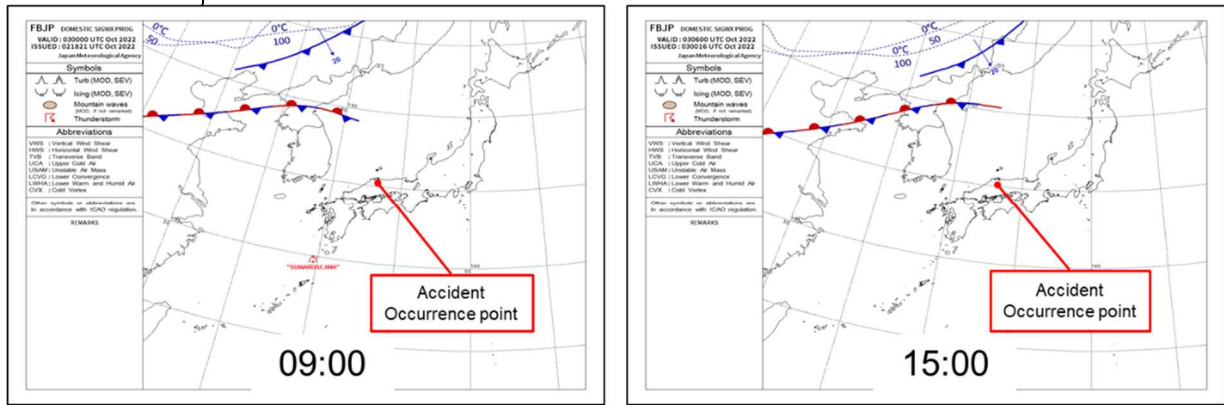
Figure 4: Domestic Significant Weather Prognostic Chart on October 3, 2022 (FBJP)  
(Partially added to the weather data provided by the JMA)

Aircraft type:	Boeing 737-800																										
Serial number:	61485																										
Date of manufacture:	March 6, 2018																										
Certificate of airworthiness:	No.2018-006																										
Validity:	Period during which the Maintenance Management Manuals (Japan Transocean Air Co., Ltd.) approved pursuant to permissions under Article 113-2, Civil Aeronautics Act are applied.																										
Total flight time:	10,139 hours 50 minutes																										
<b>2.6 Meteorological Information</b>	<p>(1) Weather Data the Flight Crew Members Confirmed before the Flight</p> <p>① Domestic Significant Weather Prognostic Chart</p> <p>According to the forecasts at 09:00 and 15:00 on October 3, 2022 confirmed by the flight crew members before the flight, no weather phenomena that would cause the aircraft to be shaken such as turbulence greater than moderate one, were forecasted around the planned flight route including near the accident occurrence point (see Figure 4).</p>

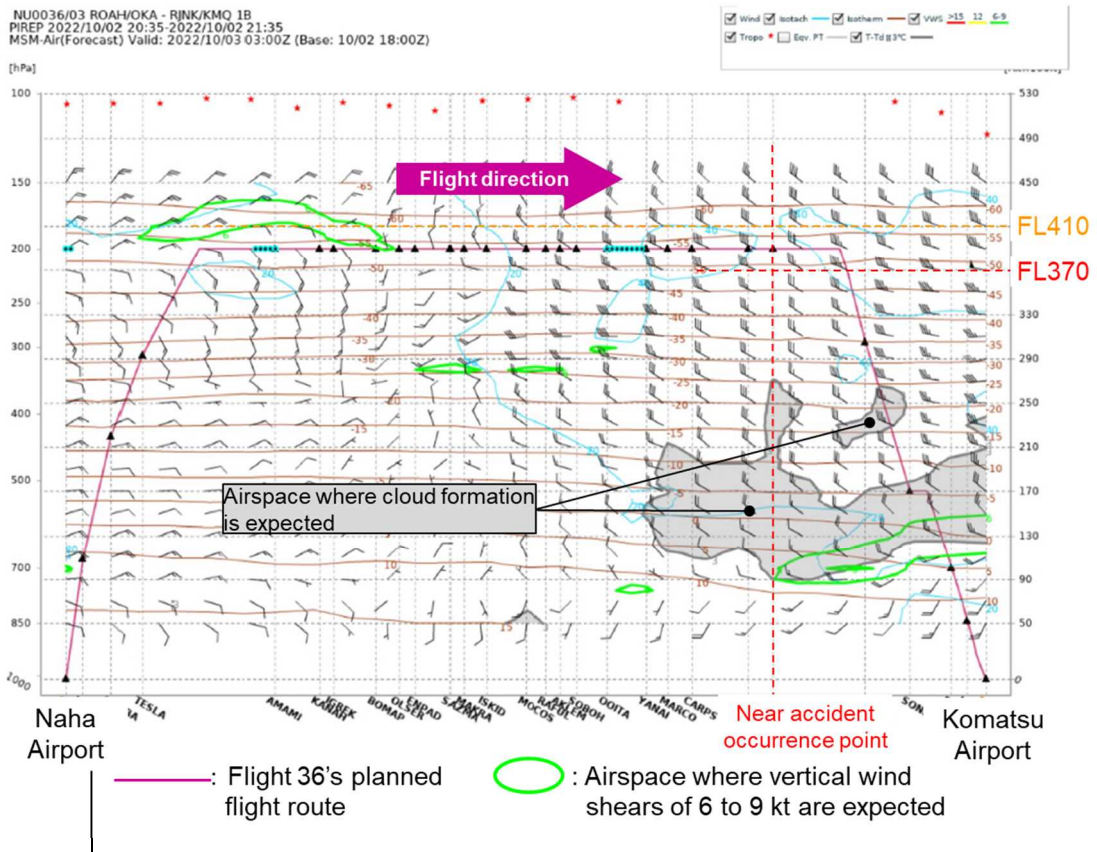
Figure 5: Flight Route Forecast Cross Section Chart at 12:00 on October 3, 2022  
(Partially added to the data provided by Japan Transocean Air Co., Ltd.)

According to the flight route forecast cross section chart at 12:00 on the day of the accident, neither the occurrence of vertical wind shear nor clouds that might cause the aircraft to be shaken were forecasted (see Figure 5).

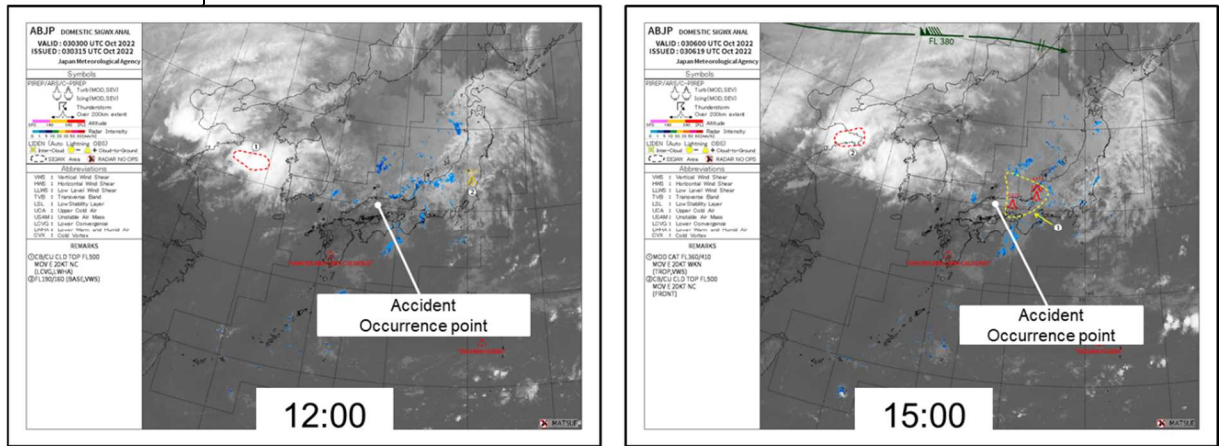
Figure 6: Domestic Significant Weather Analysis Chart on October 3, 2022 (ABJP)  
(Partially added to the weather data provided by the JMA)

According to the domestic significant weather analysis charts at 12:00 and 15:00 on October 3, 2022, no weather phenomena that would cause the aircraft to be shaken were analyzed around the accident occurrence point (see Figure 6).

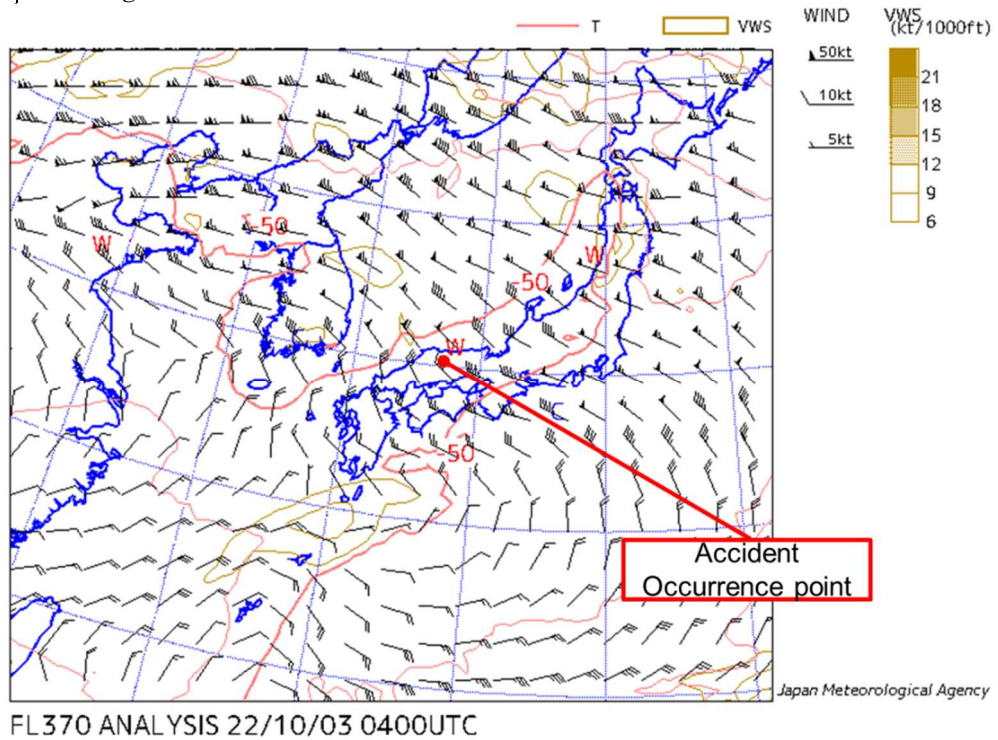
Figure 7: Hourly Analysis Chart Horizontal Cross Section (FL 370) at 13:00 on  
October 3, 2022  
(Partially added to the weather data provided by the JMA)

According to the hourly analysis chart vertical cross section for FL 370 at 13:00 on the day of the accident, around the accident occurrence point, vertical wind shear (the area enclosed by the light brown line in the figure) that might produce moderate turbulence was not analyzed (see Figure 7).

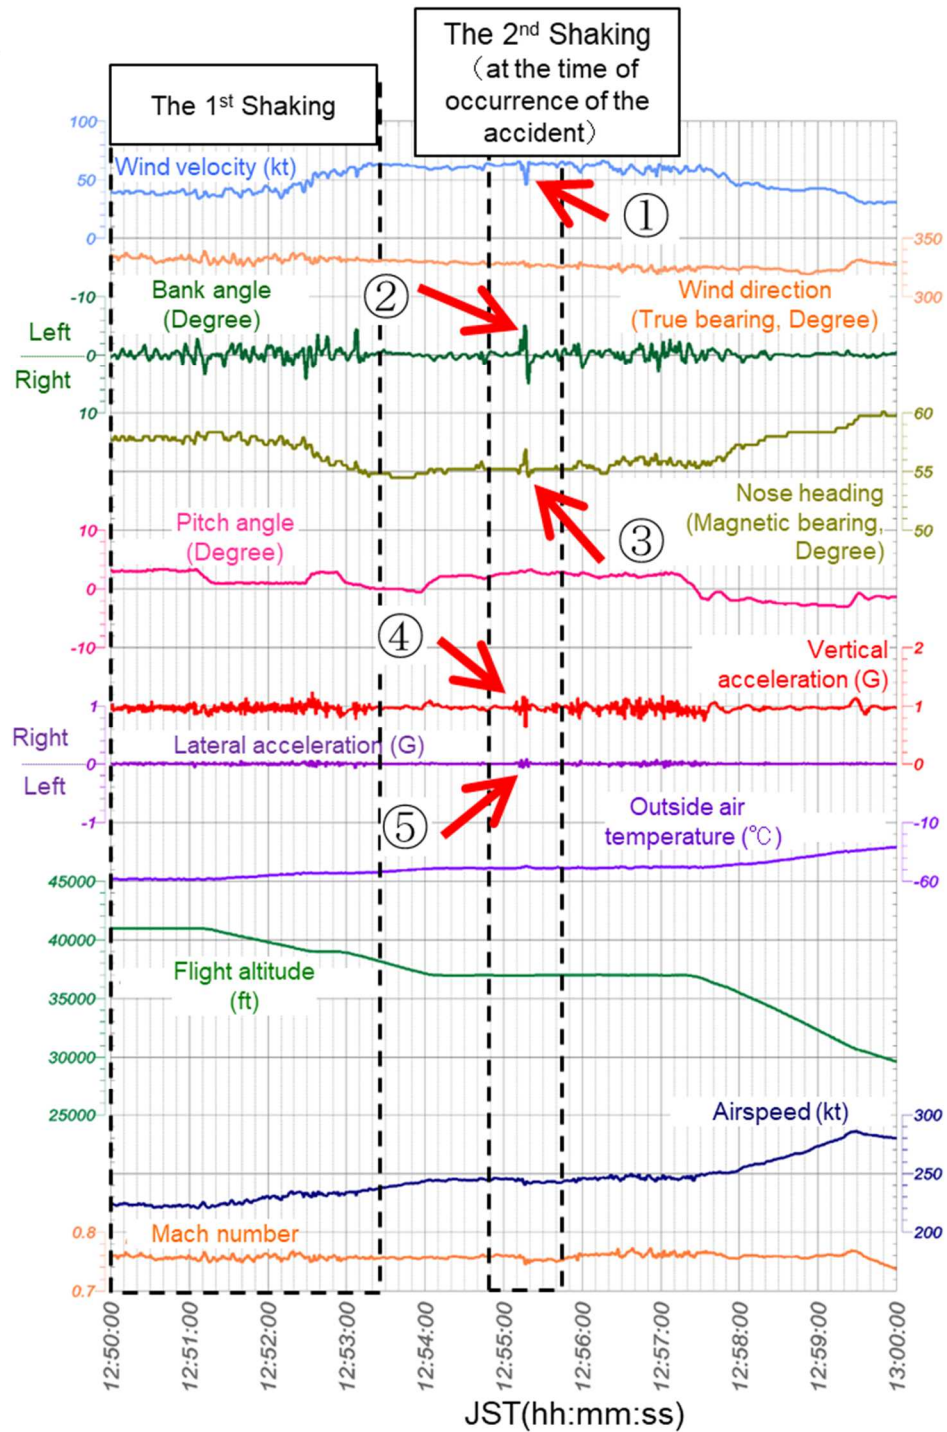
Figure 8: Information Recorded on QAR

<p>③ Others</p> <p>Before the time of the accident, there was no report about encountering turbulence from other aircraft to the air traffic control facility which had been in charge of the accident aircraft. In addition, according to the statement of the PIC, when the accident occurred, the aircraft was flying outside clouds, there were no clouds that could produce turbulence around the flight route, and in the cockpit of the aircraft, neither the flight instrument display nor clouds area on the airborne weather radar that would be a sign of turbulence were observed.</p>
<p><b>2.7 Additional Information</b></p>	<p>(1) QAR Records</p> <p>According to the QAR records of the aircraft, the wind velocity before the accident was approximately 65 kt, from 12:55:15 to 12:55:17, it decreased from 56 kt to 46 kt, and then at 12:55:18, then, it increased to 65 kt (Figure 8①). During this period, the wind direction was stable with a true bearing of about 330°.</p> <p>The bank angle remained roughly at 0°, but it changed to 2.8° to the left at 12:55:13, to 0.7° to the left at 12:55:14, to 1.1° to the left at 12:55:15, to 5.3° to the left at 12:55:16, to 4.6° to the left at 12:55:17, to 3.5° to the right at 12:55:18, to 5.1° to the right at 12:55:19, and to 1.6° to the right at 12:55:20, then it remained generally between 1° to the left and 1° to the right (Figure 8②).</p> <p>As to the nose heading, a magnetic bearing of 055° had been maintained until 12:55:15, it temporarily became a magnetic bearing of 057° between 12:55:16 and 12:55:17, then at 12:55:18, it became a magnetic bearing of 055° (Figure 8③).</p> <p>Repeated were small changes in vertical acceleration within the range of 0.9 to 1.1 G, the vertical acceleration changed within the range of 1.0 to 1.2 G from 12:55:15 to 12:55:16, and it changed from 0.6 G → 1.0 G → 0.6 G → 1.1G → 1.0 G between 12:55:16 and 12:55:18 (See Figure 8④).</p> <p>The lateral acceleration relative to the aircraft was maintained nearly 0 G until 12:55:13. After that, at 12:55:14, it changed to 0.04 G to the right, at 12:55:15, to 0.07 G to the left, between 12:55:16 and 12:55:17, to almost 0 G, and at 12:55:18, to 0.02 G to the right (Figure 8⑤).</p> <p>The outside air temperature (SAT) gradually increased while the aircraft was decreasing its flight altitude, but no significant change was found.</p> <p>The flight altitude was maintained at FL 410 until 12:51:11, then the aircraft started the descent. After maintaining FL 390 for 20 seconds from 12:52:35, the aircraft descended again, reached FL 370 at 12:54:06, maintaining FL 370 until 12:57:19.</p>

<p>(2) Occurrence of the 2<sup>nd</sup> Shaking</p>	<p>The JTSTB concludes that according to the QAR records, when the 2<sup>nd</sup> Shaking occurred, the wind velocity temporarily decreased, and at the same time, changes in bank angle and nose heading occurred, therefore, the aircraft shaking at this time was probably caused due to fluctuations in wind velocity.</p>
<p>(3) Predictability about Encountering Turbulence</p>	<p>The JTSTB concludes that the flight crew members highly probable failed to predict the 2<sup>nd</sup> Shaking for the following reasons.</p>
