AIRCRAFT ACCIDENT INVESTIGATION REPORT

HARD LANDING UPON LAUNCHING

ALEXANDER SCHLEICHER ASK13 (GLIDER, TWO-SEATER), JA100K

AT ABOUT 12:09, NOVEMBER 3, 2021

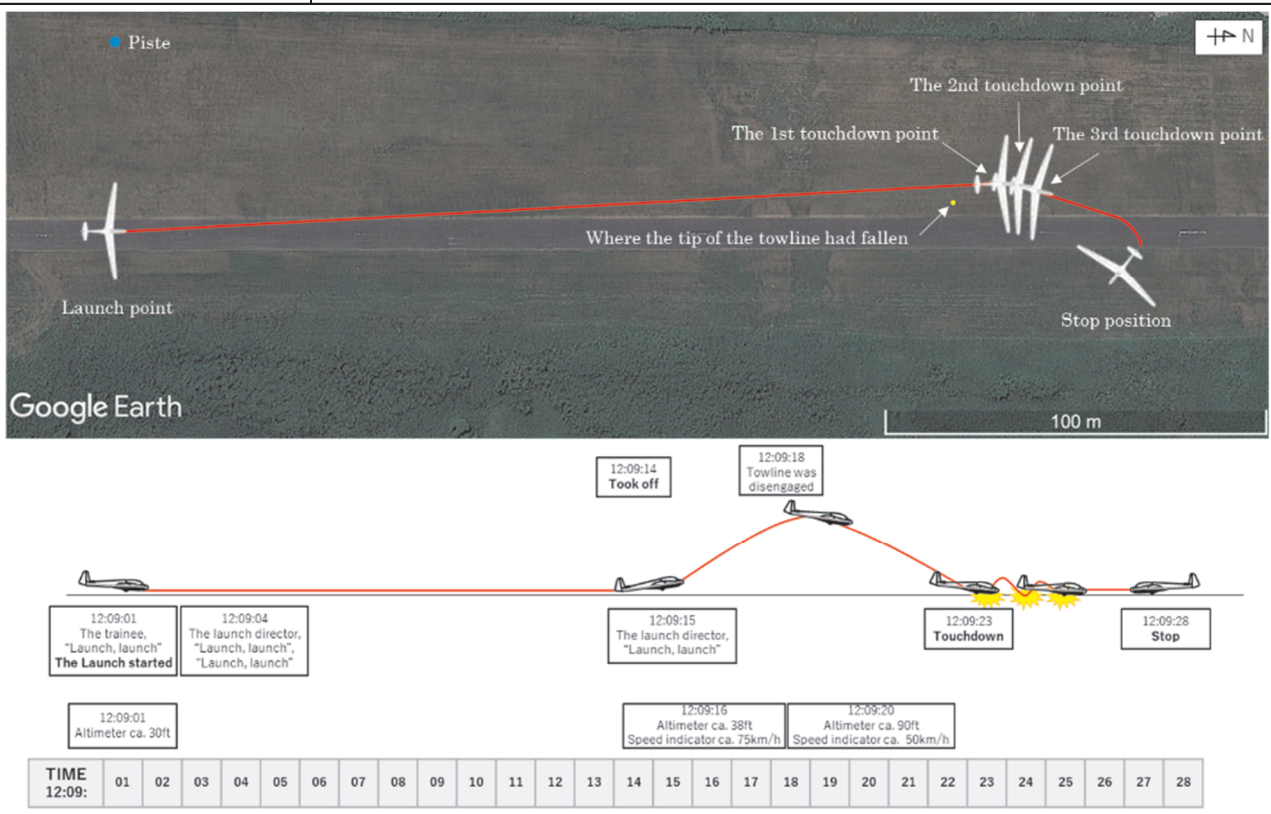
Figure 3: Estimated flight route

12:09:16	The altimeter indicated about 38 ft, the speed indicator was at about 75 km/h. (The altimeter was set at 30 ft, an elevation of the Gliding Field, before the take-off, thus, the altitude above the ground level (AGL) would be at about 8 ft (about 2.4 m). (See Figure 4)
12:09:18	After a "clack" sound, the captain stated "It got disconnected, disconnected."
12:09:19	The nose went down.
12:09:20	The altimeter indicated about 90 ft (the AGL was at about 60 ft (about 18 m)), and the speed indicator was at about 50 km/h. (See Figure 5)
12:09:23	There was an impact sound along with the touchdown.
12:09:24	There was an impact sound along with the touchdown.
12:09:25	There was an impact sound along with the touchdown.
12:09:26	The glider was taxiing while turning to the right.
12:09:28	The glider came to a stop.
