**AIRCRAFT ACCIDENT  
INVESTIGATION REPORT**

**OSAKA AVIATION INC.**

**ROBINSON R22 BETA (ROTORCRAFT)**

**JA102D**

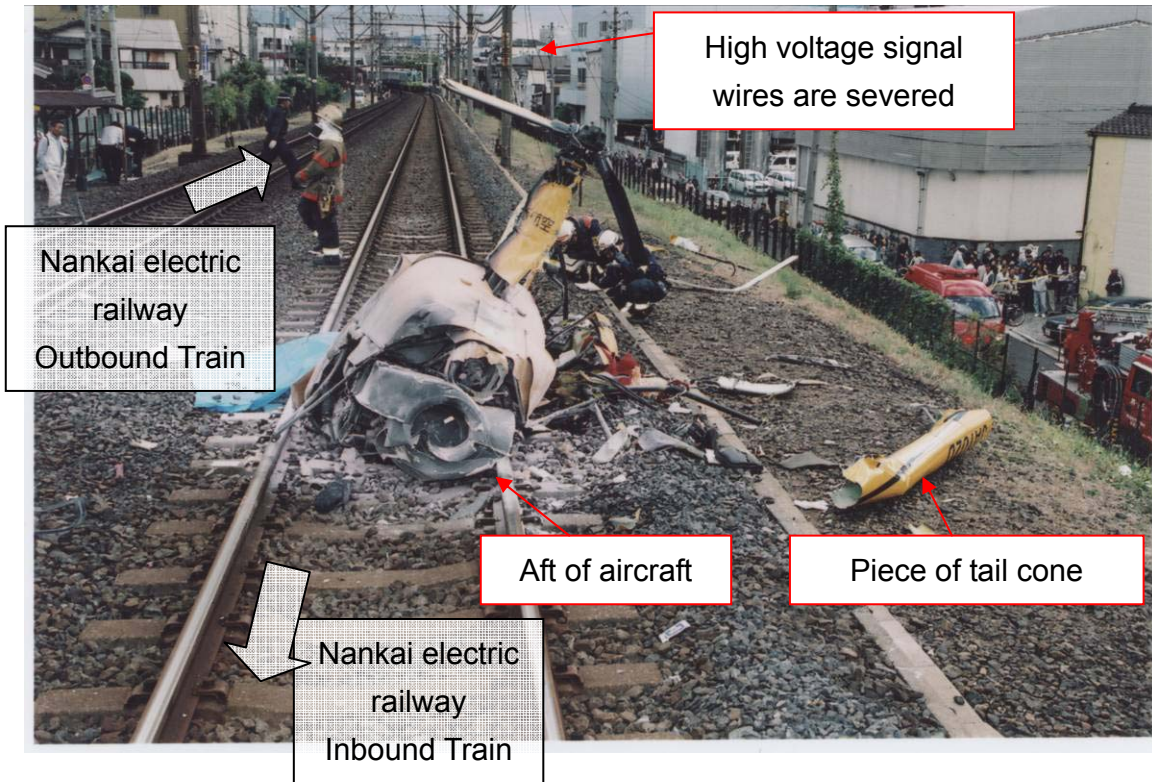
Photo 1 Accident aircraft 1

The burned Aircraft lay on the railway tracks in almost parallel alignment, with the nose in the direction of about 180° and the airframe tilted about 40° to the right. Fragments of the airframe were found scattered within an about 20m radius surrounding the crash site.

The nose of the Aircraft was severely broken and the instrument panel had also broken off.

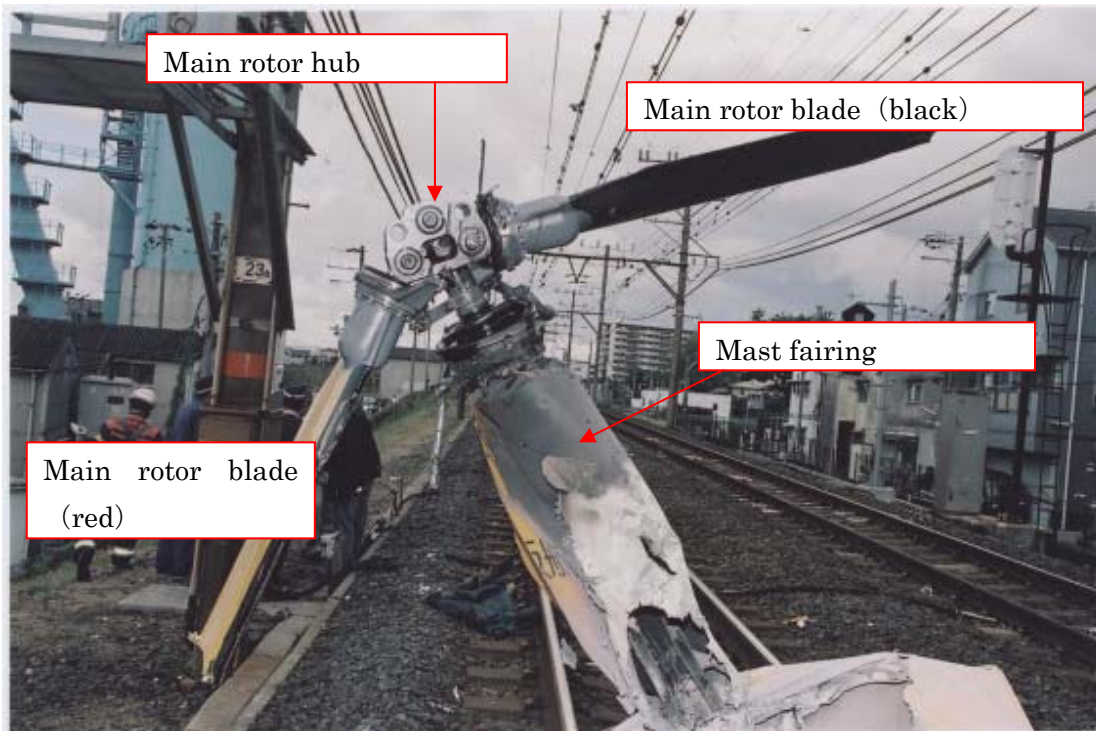
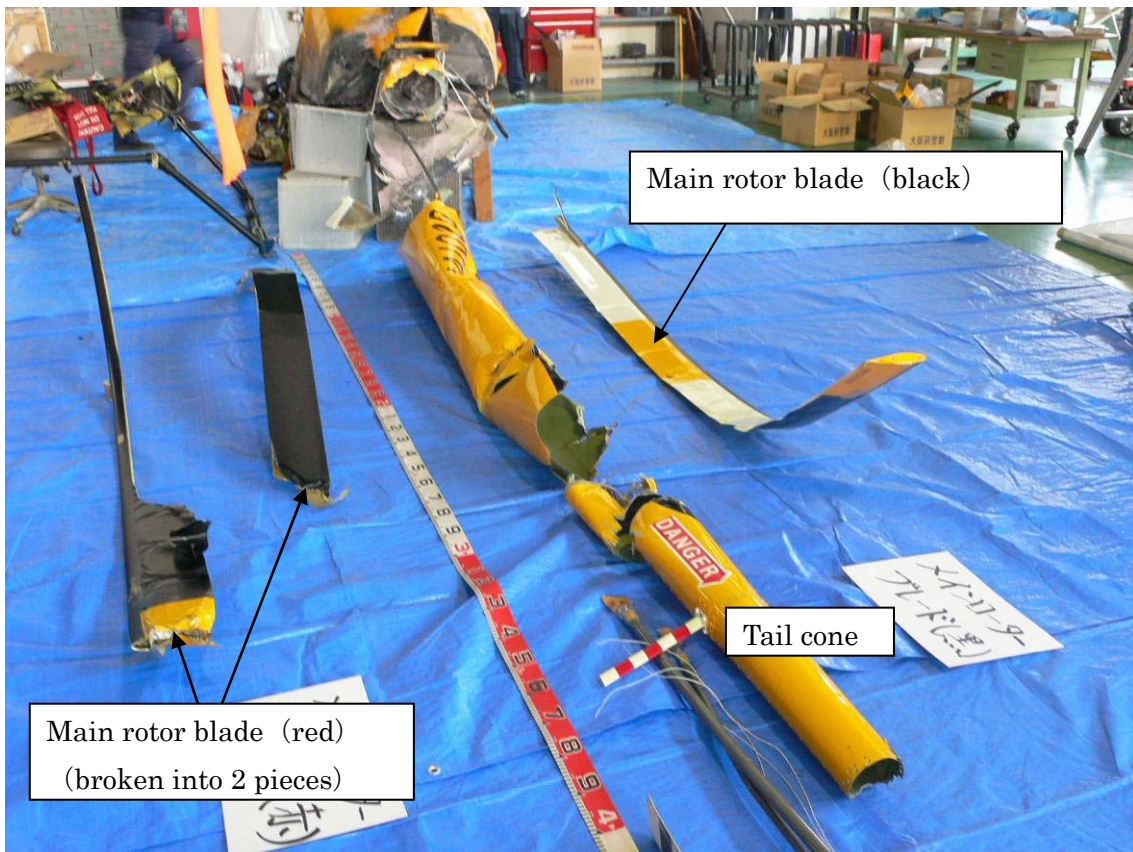
- The red blade had broken off at about 60 cm from the root and the black blade at about 70 cm from the root.
- The red blade further broke into the leading edge portion and the honeycomb-structured trailing edge portion. The leading edge portion had been bowed downward while the trailing edge portion was bowed upward.

- The black blade had been bowed upward.
- The spindle end (tongue-shaped portion) on the red blade side had broken off. The top end of the droop stop had broken off and adhered to the main rotor hub by fusion.

Photo 3 Main rotor blade

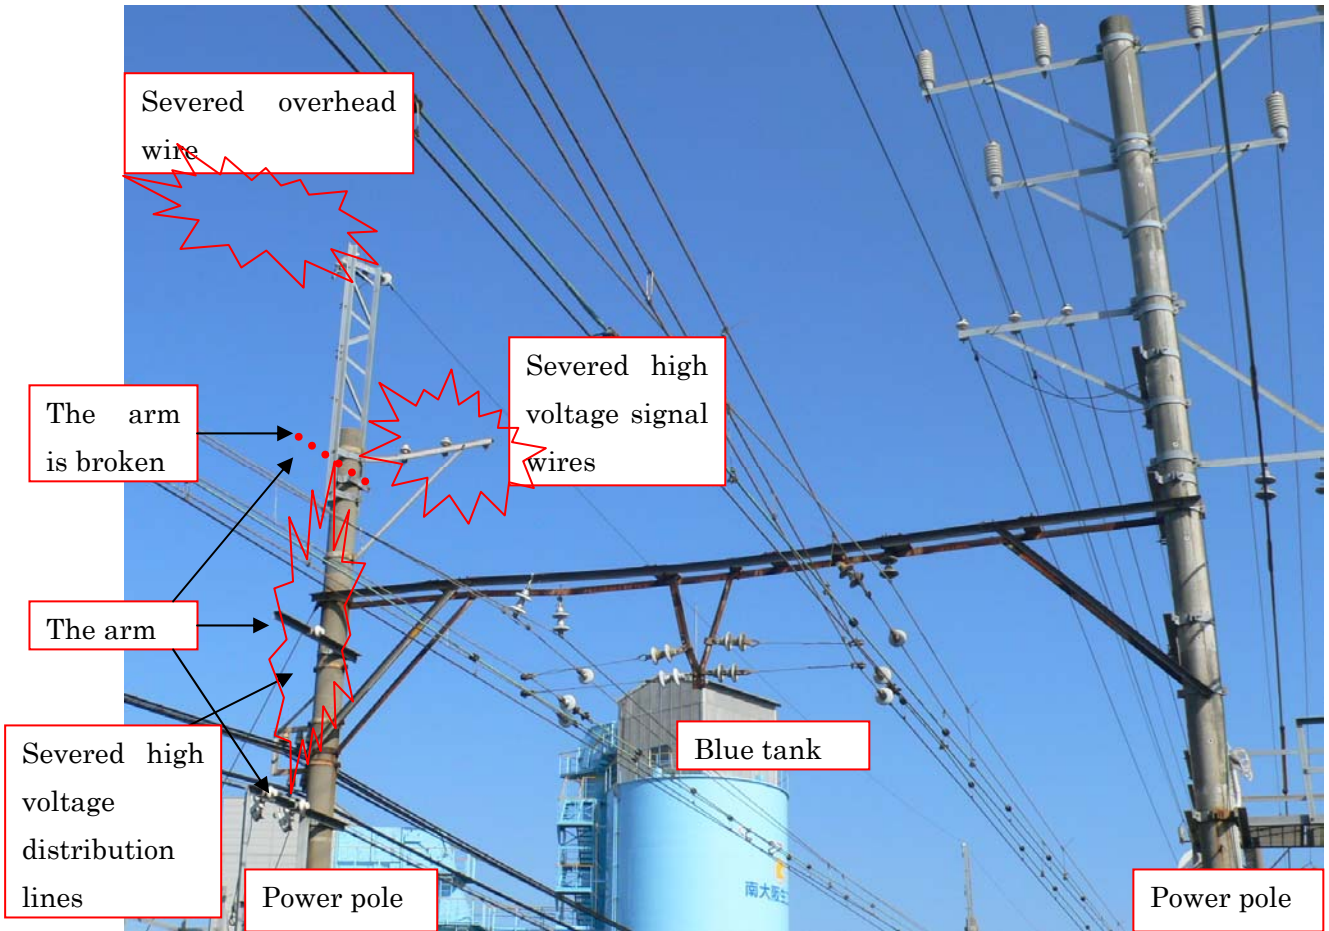
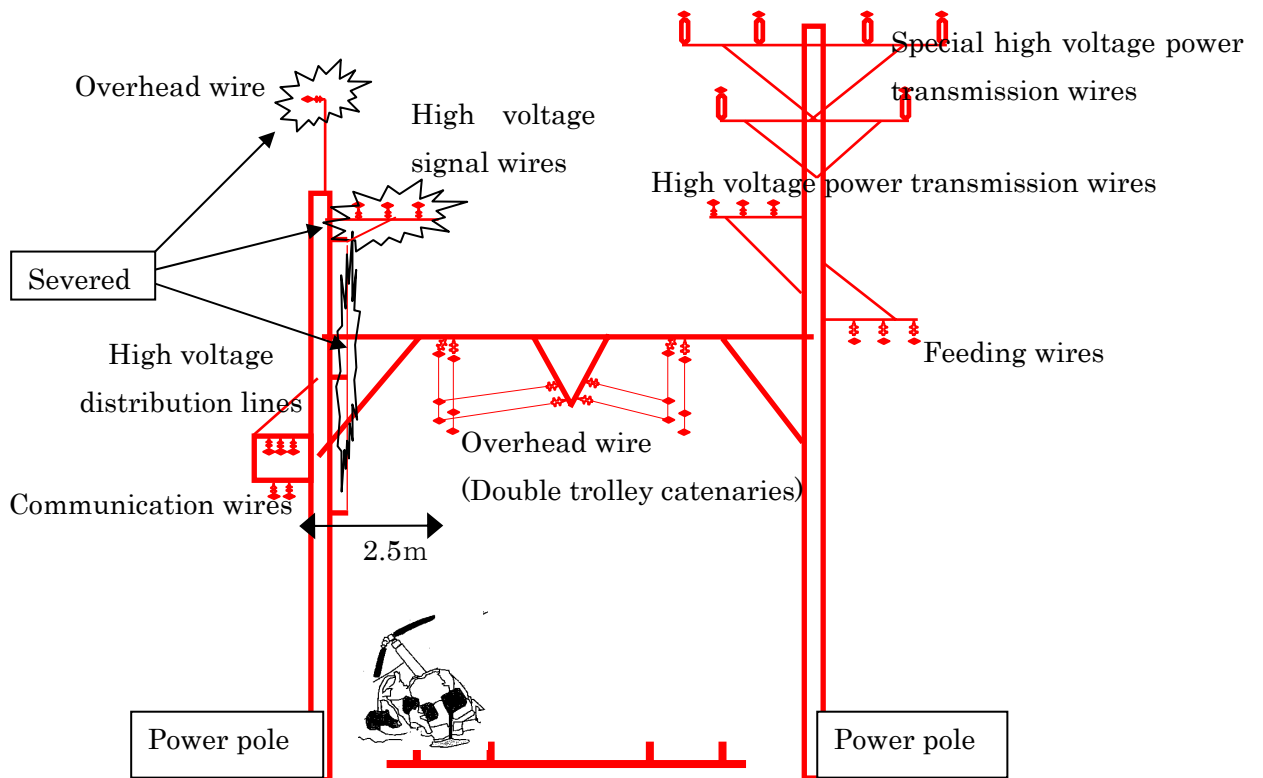
The overhead wires above the inbound train tracks had been snapped by the falling Aircraft and were hanging down. The arm for supporting the high-voltage distribution lines on the power pole about 5 m rearward and to the right of the airframe was found detached from the pole.

Photo 4 High tension signal wires are severed

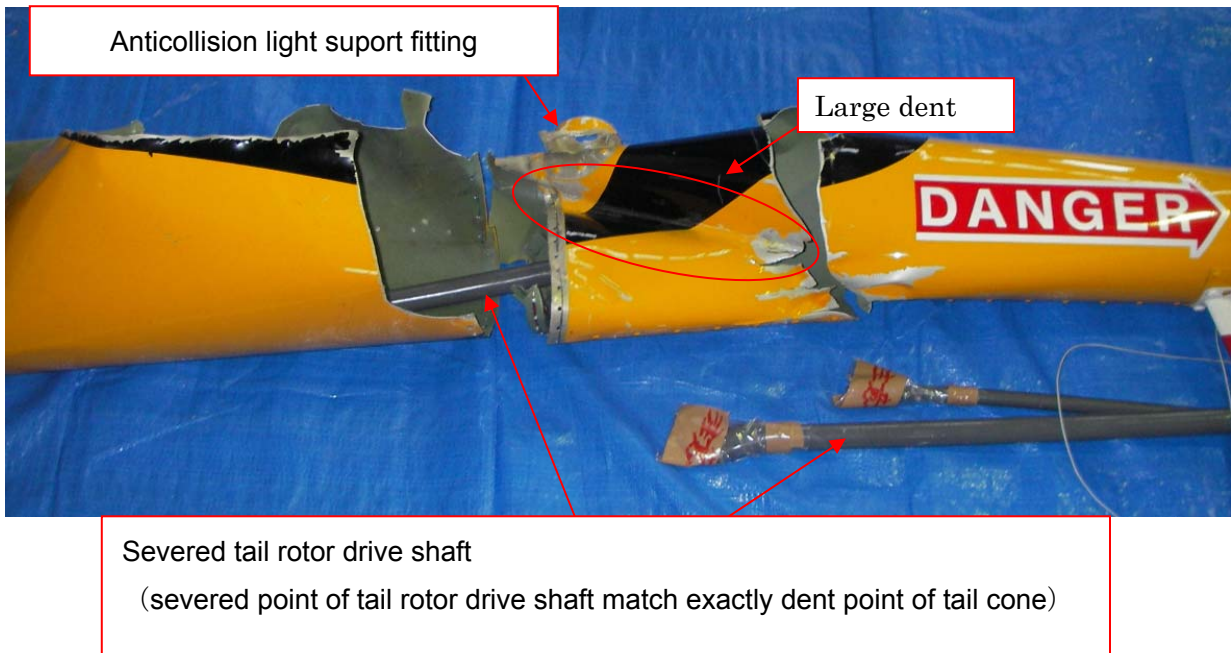
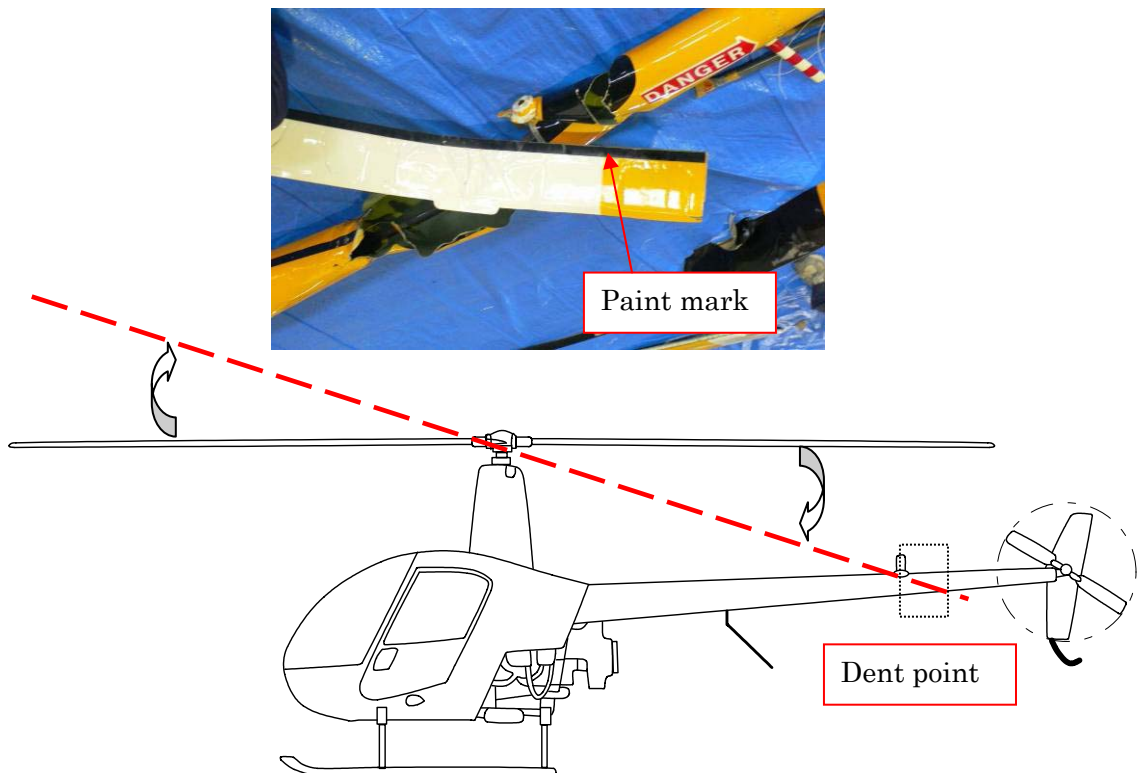
- The tail rotor drive shaft had been hit by the main rotor blade (black) and broken off in the tail cone piece ending at about 2.7 m from the joint.
- The intermediate flex plate was found twisted and broken off.
- One of the two power transmission clutch belts was burnt and the other was detached from the upper and lower sheaves.

- (2) As described in 2.8.2 (3), a large dent made by the black main rotor blade was found on the tail cone at about 2.7 m from its joint to the fuselage.

Photo 5 Large dent of main rotor blade in tail cone

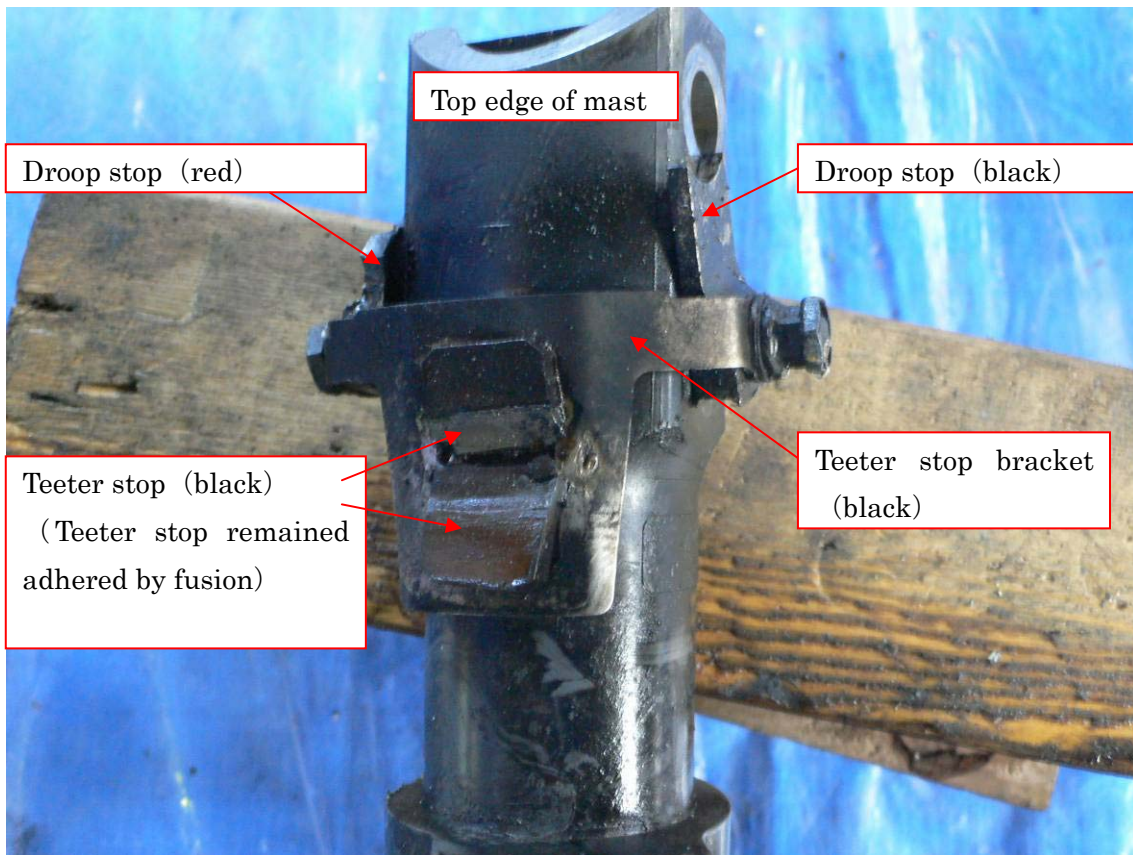
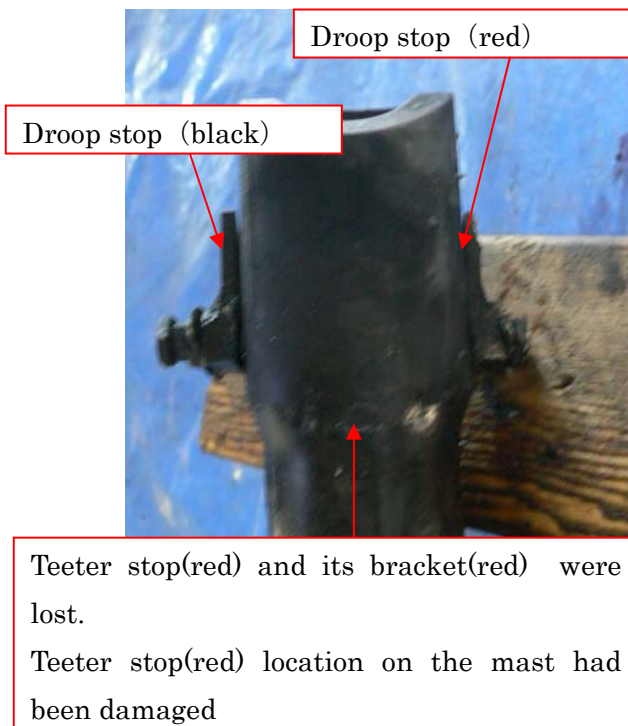
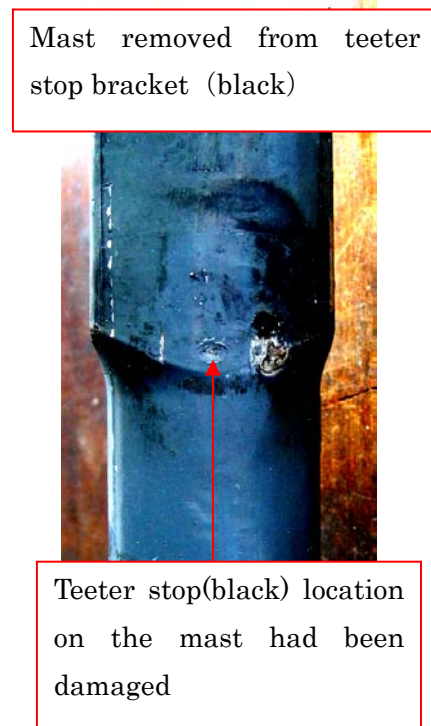
Photo 6 Top edge of mast

- The teeter stop and its bracket for the red blade were lost. The mast had a mark indicative of contact with the hub.
- The bolt of the teeter stop on the red blade side had broken off.

- The teeter stop for the black blade had been crushed and broken into top and bottom halves; they remained adhered by fusion. The teeter stop location on the mast had been heavily damaged. The droop stop had broken off.

- (3) As described in 2.8.2 (2), the teeter stop for the black blade had been crushed and broken into top and bottom halves, which remained adhered by fusion, and the teeter stop location on the mast had been heavily damaged. Considering this, it is recognized that, when the black blade hit the tail cone, the main rotor hub hit the mast with a large force.

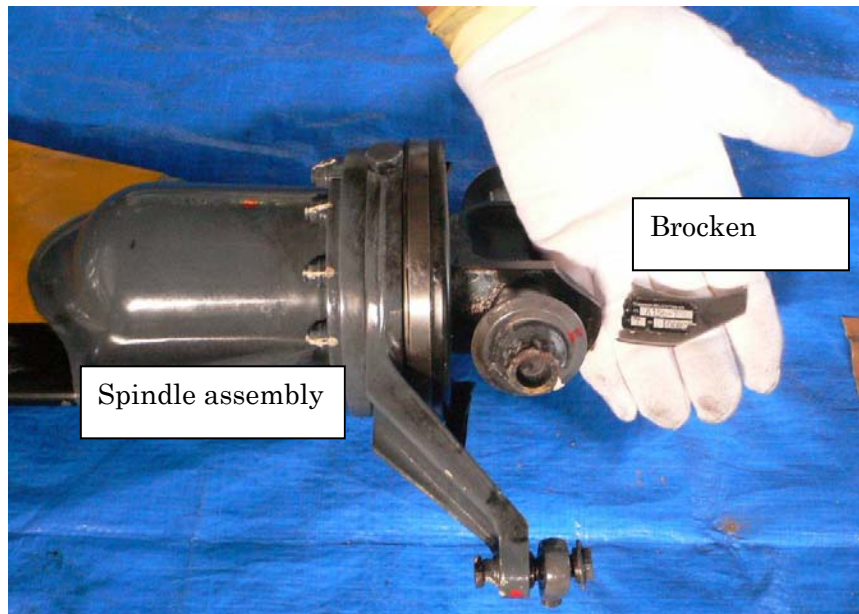
Photo 7 Spindle end on the red blade side

- (5) As described in 2.8.2 (2), the spindle end on the red blade side had broken off.

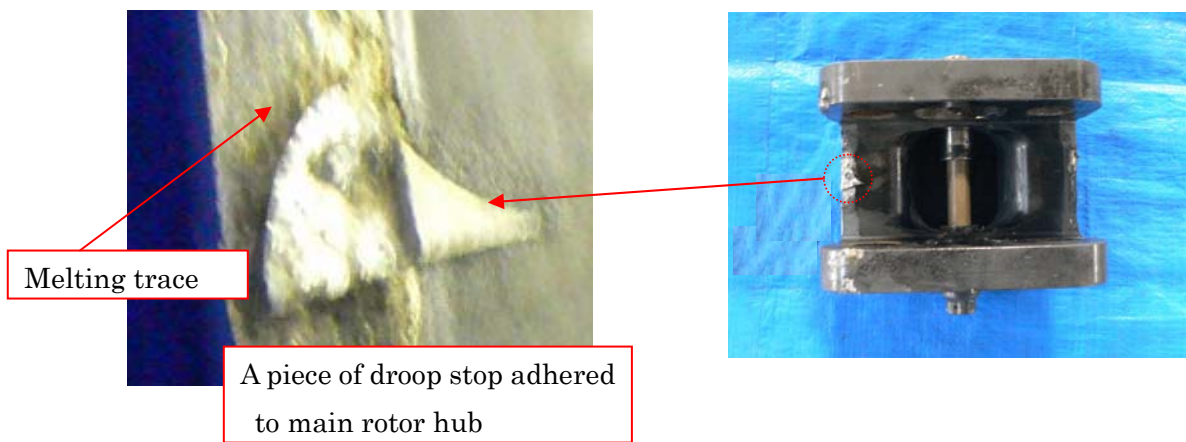
Photo 8 Main rotor hub

A detailed examination of the main rotor hub found that it was partly stripped of paint and discolored and partly melted. A broken piece of a droop stop was found wedged between the spindle and hub and adhered by fusion onto the main rotor hub.
