AIRCRAFT SERIOUS INCIDENT INVESTIGATION REPORT

THE ENGINE IS STOPPED CONTINUOUSLY IN FLIGHT

CESSNA 172R, JA10AZ

NEAR KOHNAN AIRFIELD,

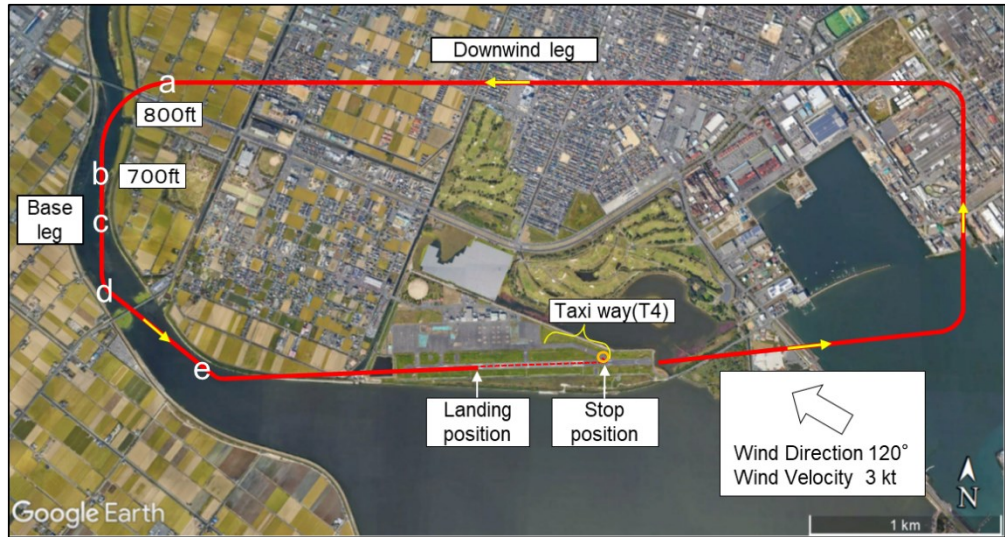
Figure 1: Estimated Flight Route

This serious incident occurred at about 15:06 on July 14, 2023, at about 700 ft about 2.5 km west-northwest of Kohnan Airfield (34° 36' 01" N, 133° 54' 24" E).

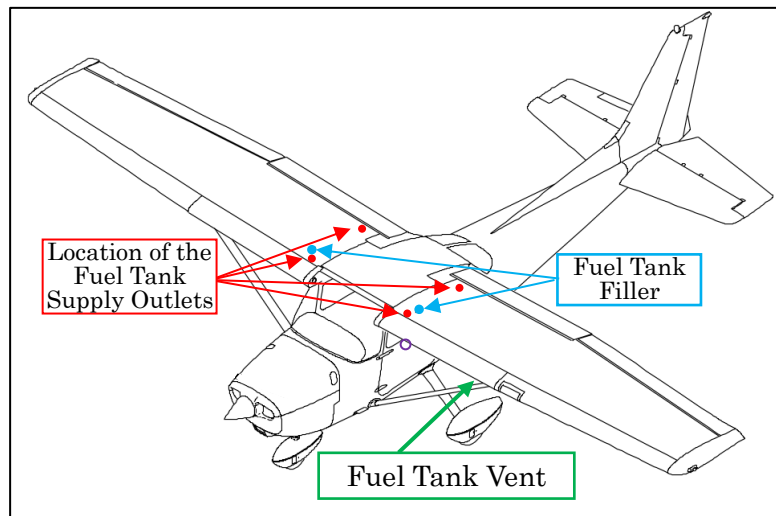
Figure 4: Location of the Fuel Tank Supply Outlets (Added the excerpt from the Aircraft Maintenance Manual)

a) Regarding the interruption of fuel flow to the aircraft's engine, as in the aircraft flight manual, Pilot's Operating Handbook and others that mention the possibility that uncoordinated flight with low remaining fuel flow can uncover the fuel tank outlets, it is possible that a similar case occurred in this serious incident, and the fuel tank outlet was uncovered, resulting in decrease in fuel supply to the engine.

b) As to the fuel tank outlets being uncovered, they were uncovered possibly because the aircraft prolonged uncoordinated flight while conducting the continuous touch-and-go on the south side traffic pattern. There are four fuel tank outlets, and even if one outlet is uncovered and interrupts the fuel flow, it is unlikely to directly affect the engine. However, the aircraft prolonged uncoordinated flight with low remaining fuel flow in the left tank during the continuous touch-and-go training, which likely caused several fuel tank outlets to be exposed. Due to the fuel tank outlets being uncovered, the fuel supply flow to the engine decreased, the fuel in the fuel reservoir tank was consumed, which allowed air to enter the fuel system that delivers the fuel from the tank to the engine, resulting in the engine possibly shutdown.

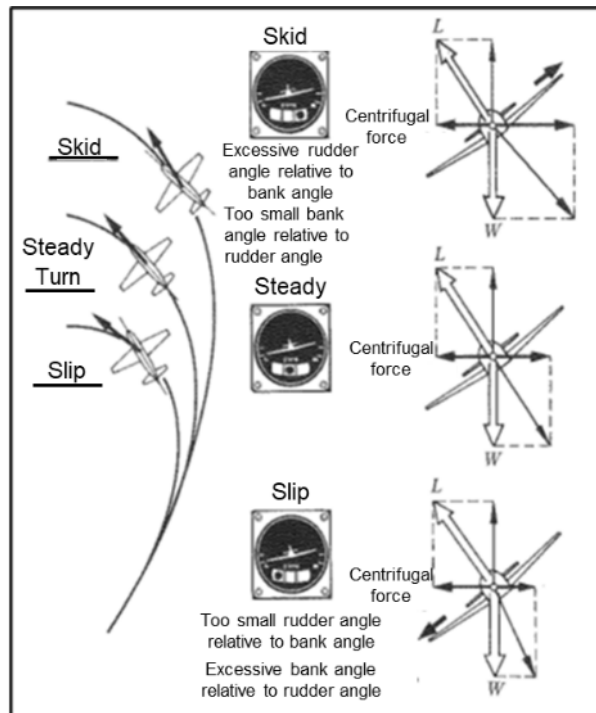
Figure 9: Slip and Skid

The “Uncoordinated Flight” includes slip or skid, as well as flight in an imbalance state due to changes in attitude for ascending, descending and others.
