**AIRCRAFT ACCIDENT
INVESTIGATION REPORT**

AIRCRAFT DAMAGE CAUSED BY BIRD STRIKE NEAR KOHNAN AERODROME, OKAYAMA CITY, OKAYAMA PREFECTURE, JAPAN AT AROUND 11:33 JST, JULY 25, 2018

OKAYAMA AIR SERVICE CO., LTD.
CESSNA 172R, JA10AZ

February 22, 2019

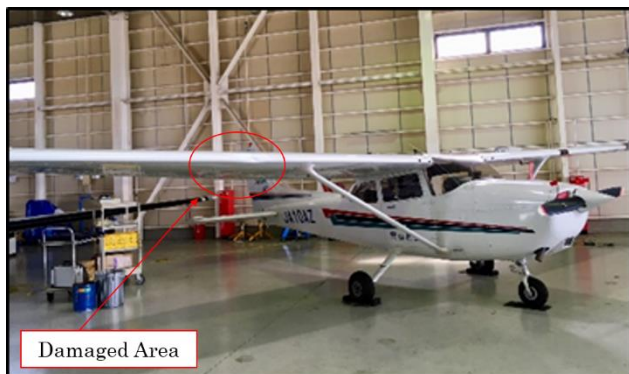
Figure 1: Accident Aircraft and Damaged Area

- Deformation on leading edge of the right wing
(Deformation of about 20 cm in longitudinal direction and about 35 cm in width about 1.3 cm in depth)

It is certain that because the aircraft collided with a bird that had emerged from the left below in the travel direction of the aircraft, while making a right turn to the Aerodrome during the power-off accuracy approach training, it suffered damage to the leading edge of the right wing.

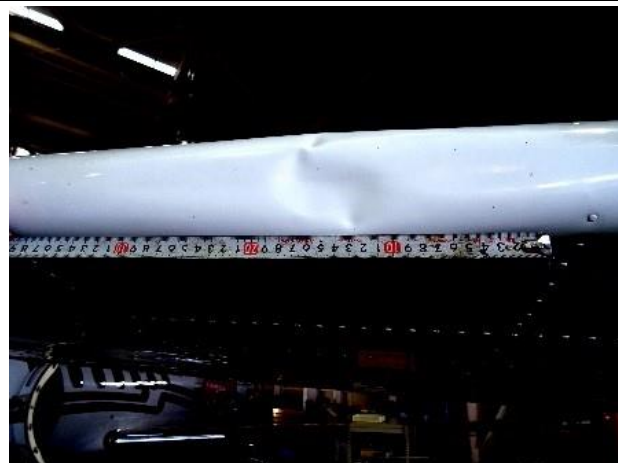
Figure 2: Damaged Area (Enlarged photo)

The bird colliding with the aircraft remained stuck on the leading edge of the right wing even after the collision and fell off onto the runway after the aircraft landed. Upon receipt of the report, the Aerodrome administrator recovered the body of the brown Milvus migrans (length about 30 cm).

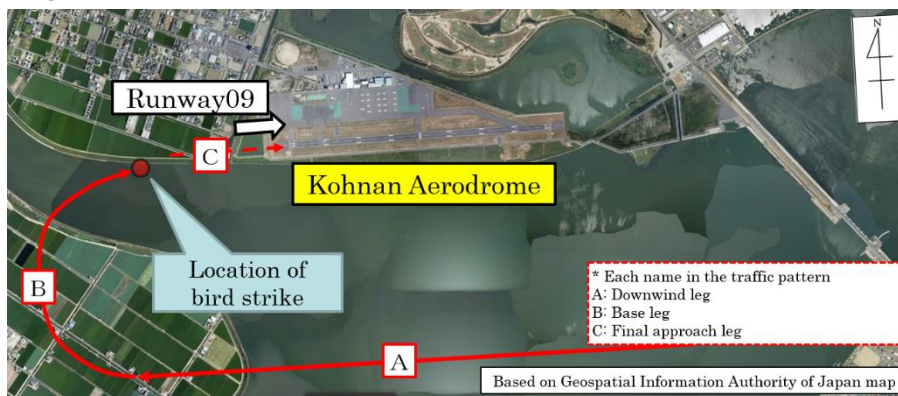
Figure 3: Estimated Flight Route (according to the statement of the PIC)

The aircraft took off from the Aerodrome to conduct training with the PIC as a flight instructor in the right pilot seat and the student pilot A, who was flying the aircraft, in the left pilot seat. In the traffic pattern at the Aerodrome, reducing power to conduct power-off accuracy approach*¹ training, the aircraft was making a right turn from the downwind leg to final approach to Runway 09, when suddenly a bird emerged from the left below in the travel direction of the aircraft and collided with the leading edge of the right wing. At that time, the aircraft was flying at an airspeed of 60 to 65 kt and at an altitude of about 450 ft.
