AIRCRAFT ACCIDENT INVESTIGATION REPORT

**Iwate Prefectural Disaster Prevention Aviation Corps
J A 1 0 T E**

FIREFIGHTER INJURY DUE TO WATER SPRINKLED FROM AIRCRAFT DURING FIREFIGHTING OPERATIONS IWATE PREFECTURAL DISASTER PREVENTION AVIATION CORPS (ENTRUSTED OPERATION TO TOHO AIR SERVICE CO., LTD.) AGUSTA MODEL AW139 (ROTORCRAFT), JA10TE IWAIZUMI TOWN, SHIMOHEI DISTRICT, IWATE PREFECTURE, AT ABOUT 15:31, APRIL 3, 2022

January 13, 2023

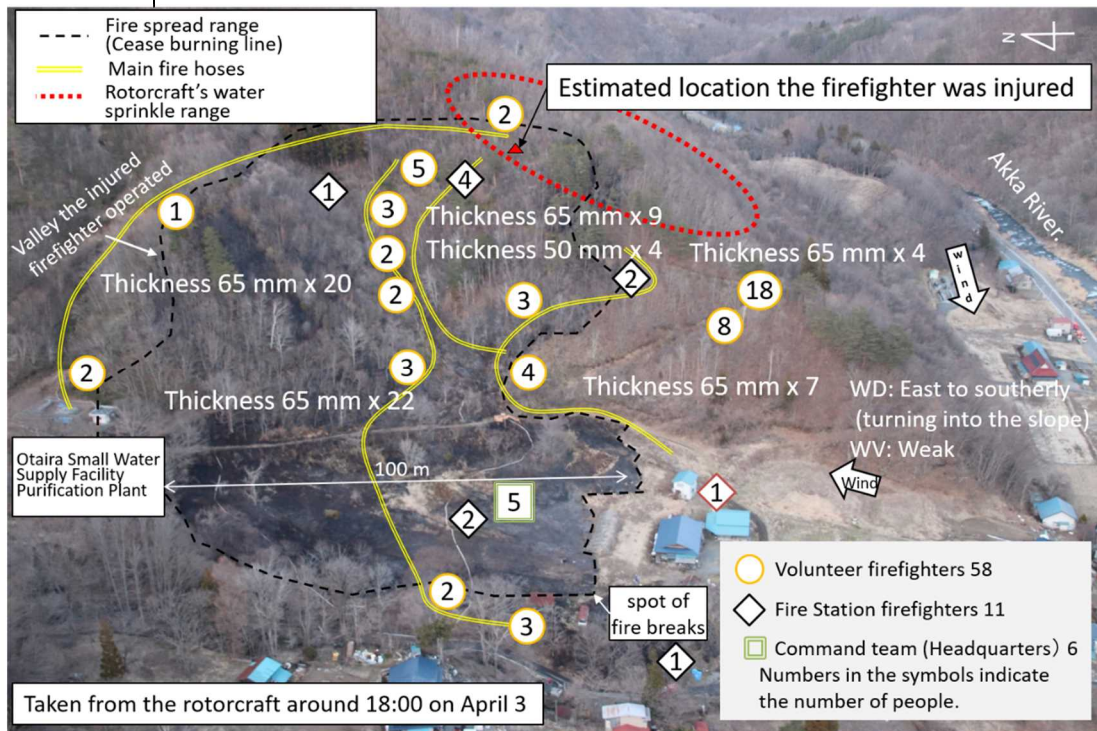
Figure 2: Fire spread range, deployment of the Ground Firefighting Operations Party and the rotorcraft's water sprinkle range

2.7 Accident Site	<p>(1) Fire occurrence location and firefighting operations status near the accident site</p> <p>Figure 2 shows the approximate range covered by the helicopter's water sprinkle operations, the estimated location where the volunteer firefighter was injured, and the locations where the Ground Firefighting Operations Party deployed the main fire hoses for the area where the fire spread. The fire started from about 200 m south-west of the location where the volunteer firefighter was injured, and spread northeastward on the mountain slope. The Ground Firefighting Operations Party extended the hoses from three major locations and performed firefighting operations while deploying firefighters in order to prevent the fire from spreading. On the other hand, the helicopter performed water sprinkling 11 times in the vicinity of the location where the volunteer firefighter was injured.</p>

As the deployment of the Ground Firefighting Operations Unit and the range of the helicopter's water sprinkle operations were overlapped as shown in Figure 2, regarding the helicopter's flight history and the scene of the accident, we made a comparison between the travel direction of the injured volunteer firefighter and the helicopter's water sprinkle location as shown in Figure 7. During the first half of the firefighting operations, the injured volunteer firefighter was extinguishing the fire in the valley located on the upper side of Otaira Small Water Supply Facility Purification Plant on the west side. Besides, the helicopter was sprinkling water along the ridge of the location where the volunteer firefighter was injured. The JTSB concludes that as the helicopter was away from the vicinity of the accident site to refuel from 14:07 to 15:23, it is probable that the volunteer firefighter moved along the yellow route shown in Figure 7 and was extinguishing the smoldering fallen tree while the helicopter was not flying over the site. As the Co-pilot stated that the fire was almost brought under control and no fire was visible at 15:23 when the helicopter was flying over the fire area, the fire was more likely close to being extinguished and the fire spread range became narrower. After that, the helicopter supplied the bucket

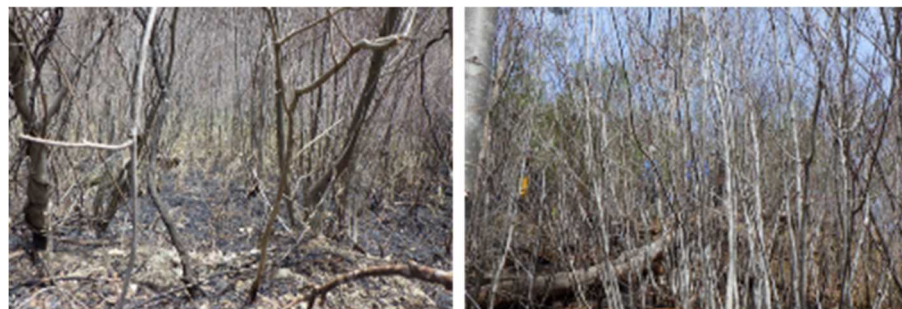
Figure 3: Trees around the accident site

As shown in Figure 3, the area around the accident site was a slope covered with shrubby, young trees, and with thick trees here and there, and there were traces of burnt leaves and fallen trees on the ground. Besides, in a heavily wooded area in the forest, it was difficult to spot someone from the side.

The JTSB concludes that as described in 2.7 (2), due to the heavily wooded area around the accident site, it was more likely difficult to spot someone from the side, therefore, when the helicopter was guided to the fire area at the time of the accident, the helicopter crews would have to visually confirm the injured volunteer firefighter on the ground diagonally from above, and it was difficult for the helicopter crews to find the volunteer firefighter in an early stage. In addition, as the injured volunteer firefighter found the helicopter in the midst of being in a heavily wooded area just before the accident, it was more likely difficult for him to evacuate to a safe place after visually confirming the helicopter.

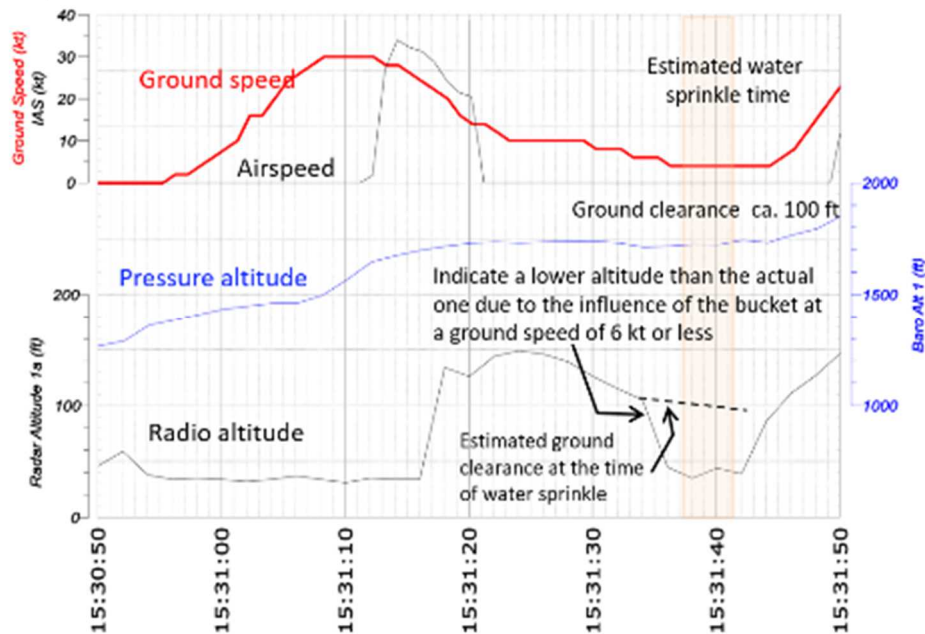
Figure 4: Flight records at the time of the accident

The flight specifications at the time of the accident (about 15:31:40) are as follows:

Pressure altitude: 1,725 ft, Radio altitude: 35 ft

Estimated ground clearance about 100 ft

At the time of the accident (at about 15:31:40), the helicopter was flying at a ground speed of 4 kt and an estimated ground altitude of about 100 ft. During the water sprinkle operations, the helicopter was sprinkling water at a lower speed than that which was recommended, because a flight altitude of 100 to 200 ft and a flight speed of 20 to 40 kt were recommended as described in 2.8 (3).

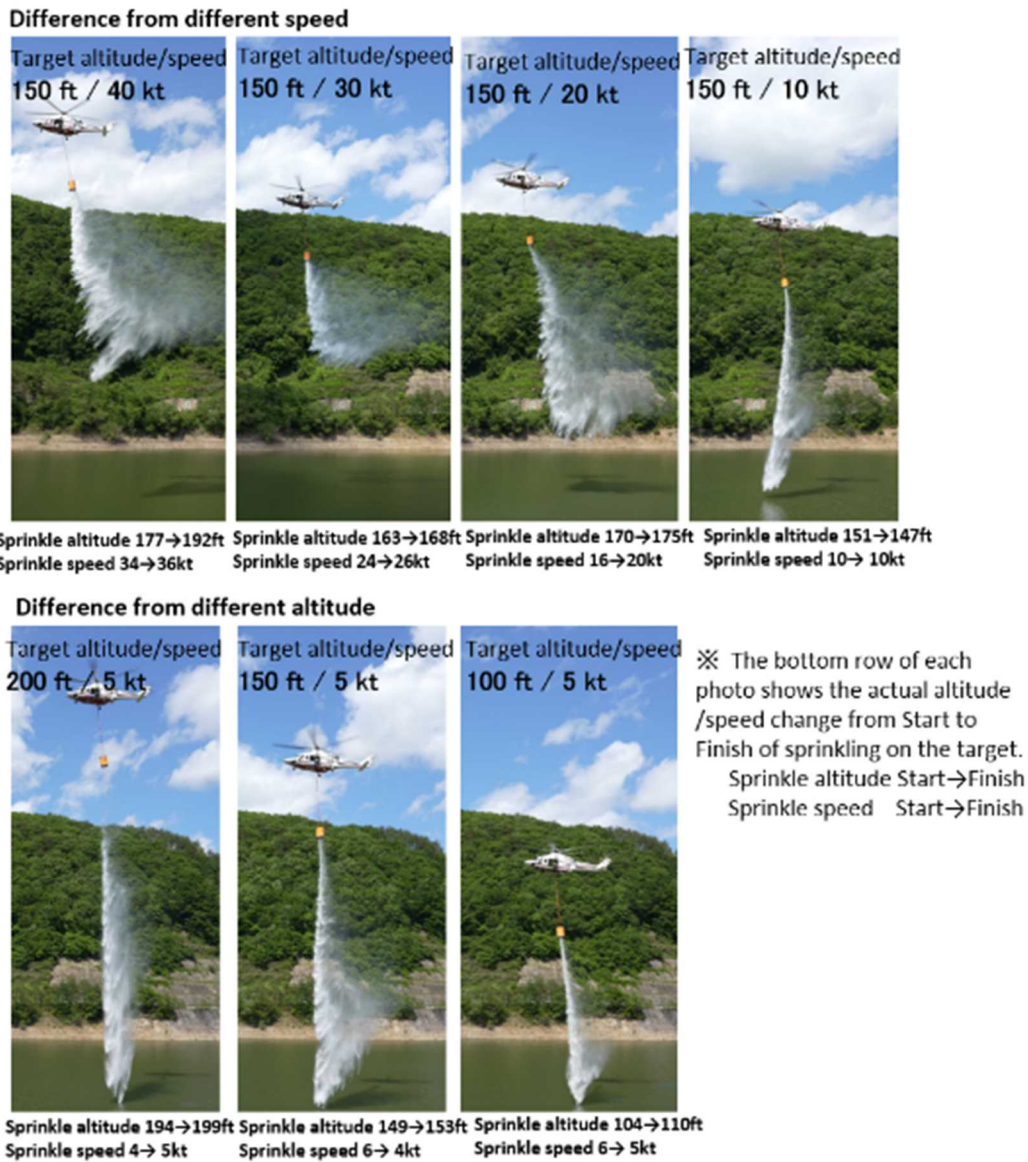
Figure 6: The spread of water sprinkle under different flight conditions

The faster the flight speed was, the wider the sprinkled water spread. At a ground speed of 10 kt or less, the spread range became narrower, particularly, at a ground speed of about 5 kt. The influence from the flight altitude to the spread range was small, and water was sprinkled within an extremely narrow range.

As described in 2.8 (4), when water is sprinkled at a low ground speed of 5 kt, the influence from the flight altitude is small, and water is sprinkled within an extremely narrow range. The JTSB concludes that at the time of the accident, as the fire was almost under control, the range of the fire area became narrower, therefore, the Captain more likely performed water sprinkle operations at a low speed so that the Hoist Operator could easily guide the helicopter and efficient firefighting operations could be conducted. It is possible that as the helicopter sprinkled water at a low speed of 4 kt, a large volume of water was sprinkled without spreading, which might increase the impact on the volunteer firefighter who was hit directly by the sprinkled water.

The JTSB concludes that as in 2.8 (4), the spread of water sprinkle is greatly affected by flight speed, therefore, when extremely low-speed flight is required, it is necessary to sprinkle water after fully grasping the firefighting locations, taking into consideration the impact on the Ground Firefighting Operations Unit.

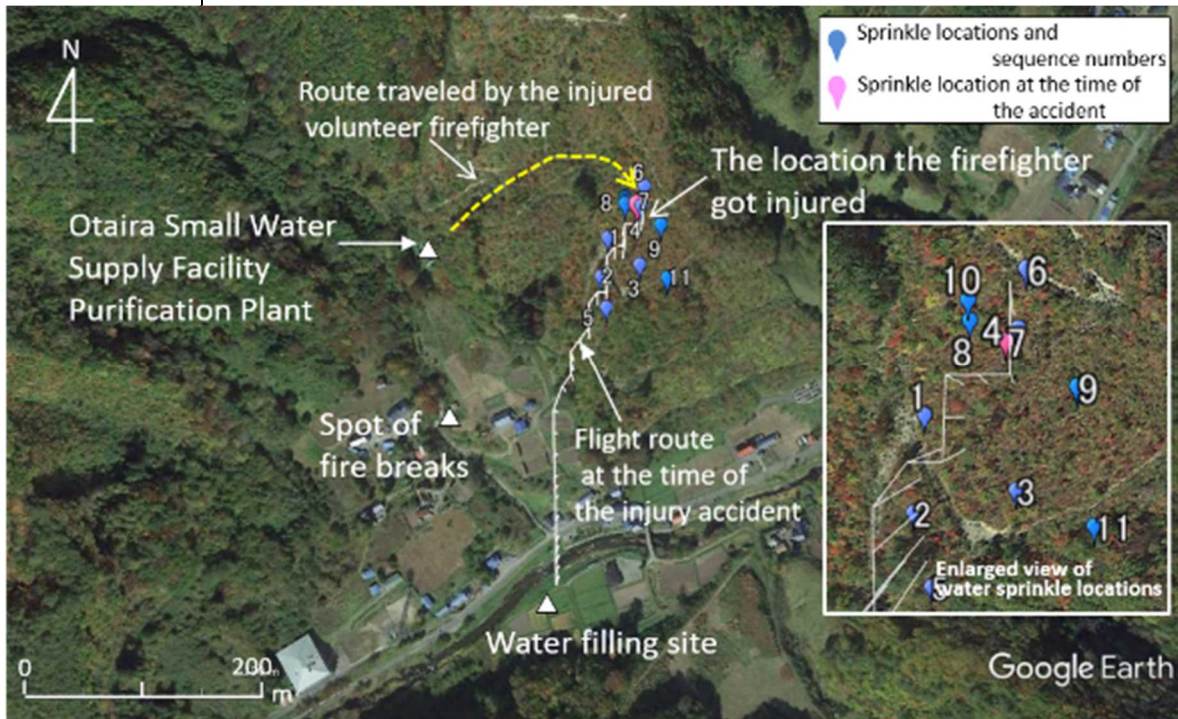
Figure 7: Route traveled by the injured person and the rotorcraft's water sprinkle locations

with 700 liters of water and sprinkled water in the guided location where the smoke was coming from at about 15:31:40. However, it was probable that the insufficient coordination between the helicopter and the Ground Firefighting Operations Party resulted in the target location overlap between the helicopter and the injured volunteer firefighter, and they were extinguishing the same location where fallen trees were smoldering.

The JTSB concludes that as in the Research Expert Committee Report on Helicopter Firefighting for Forest Fires described in 2.8 (6), helicopters and the Ground Firefighting Operations Party more likely need to act in close coordination with each other. And especially, in a situation where the fire is almost extinguished, the fire spread range becomes narrower, which increases the probability of the firefighting locational overlap between helicopters and the Ground Firefighting Operations Party. It is difficult for the Ground Asset to evacuate quickly from the water sprinkle location as a helicopter flies in. Therefore, it is desirable to further consider how to closely exchange information about the helicopters' action plan and the water spray locations and ensure to

convey the obtained information in order to avoid firefighting locational overlap.
