AIRCRAFT ACCIDENT INVESTIGATION REPORT

CRASH

SCHEMPP-HIRTH ARCUS M

(MOTOR GLIDER, TWO-SEATER), JA11AM

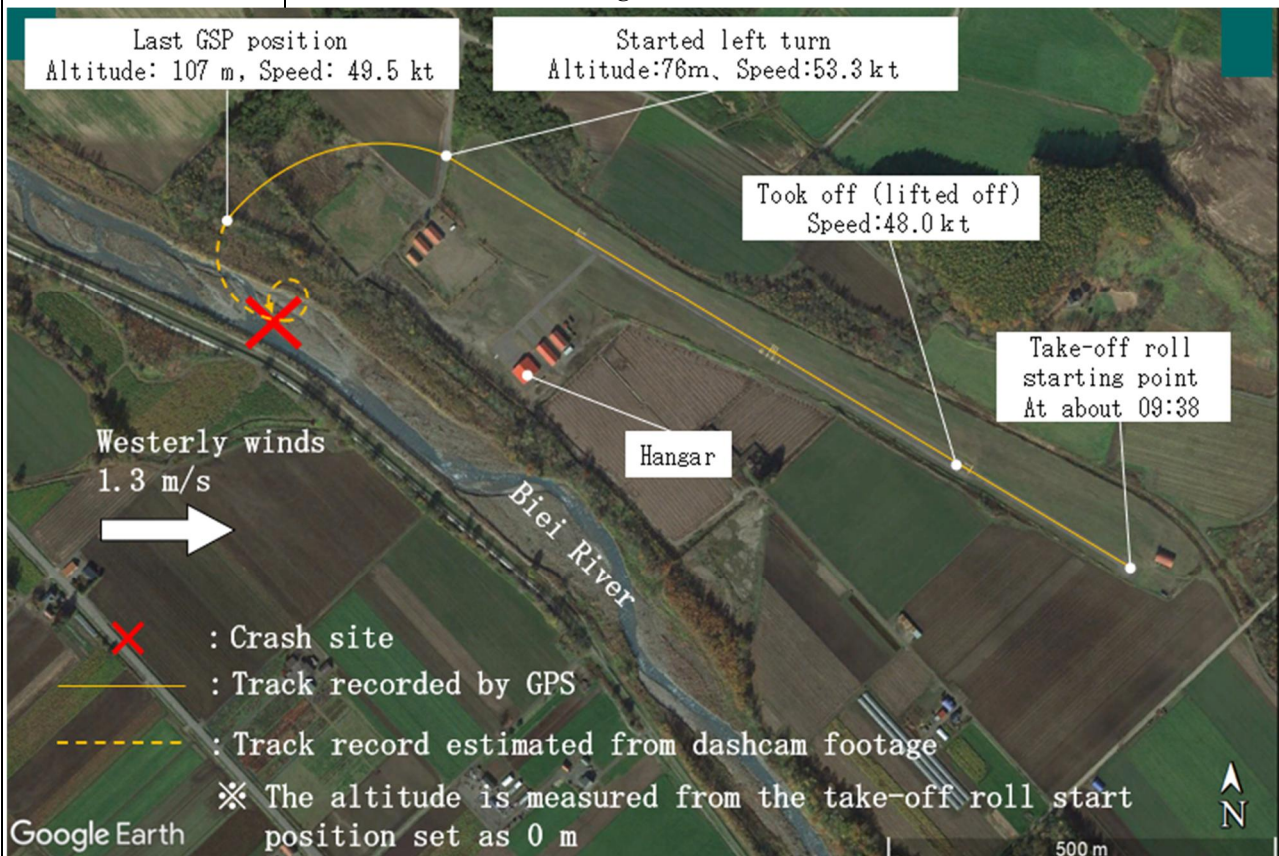
Figure 3: Estimated Flight Route

At about 09:38, the glider took off from the southeast end of the Glider Field toward north-west by self-launching*¹ for a leisure flight. The glider passed near the northwest end of the runway and began to turn left as it climbed, but the engine sound suddenly stopped as the glider made a turn to about 90°. Normally, in case of engine shut down in flight, the aircraft must descend to maintain the flying airspeed, however, the glider continued the left turn with no sign of descending even after the engine sound stopped. The glider then entered a left spin at about 100 m AGL, nosediving. The spin stopped after one turn, and when the nose started to be slightly raised, the glider crashed into the Biei River (see Figure 3).

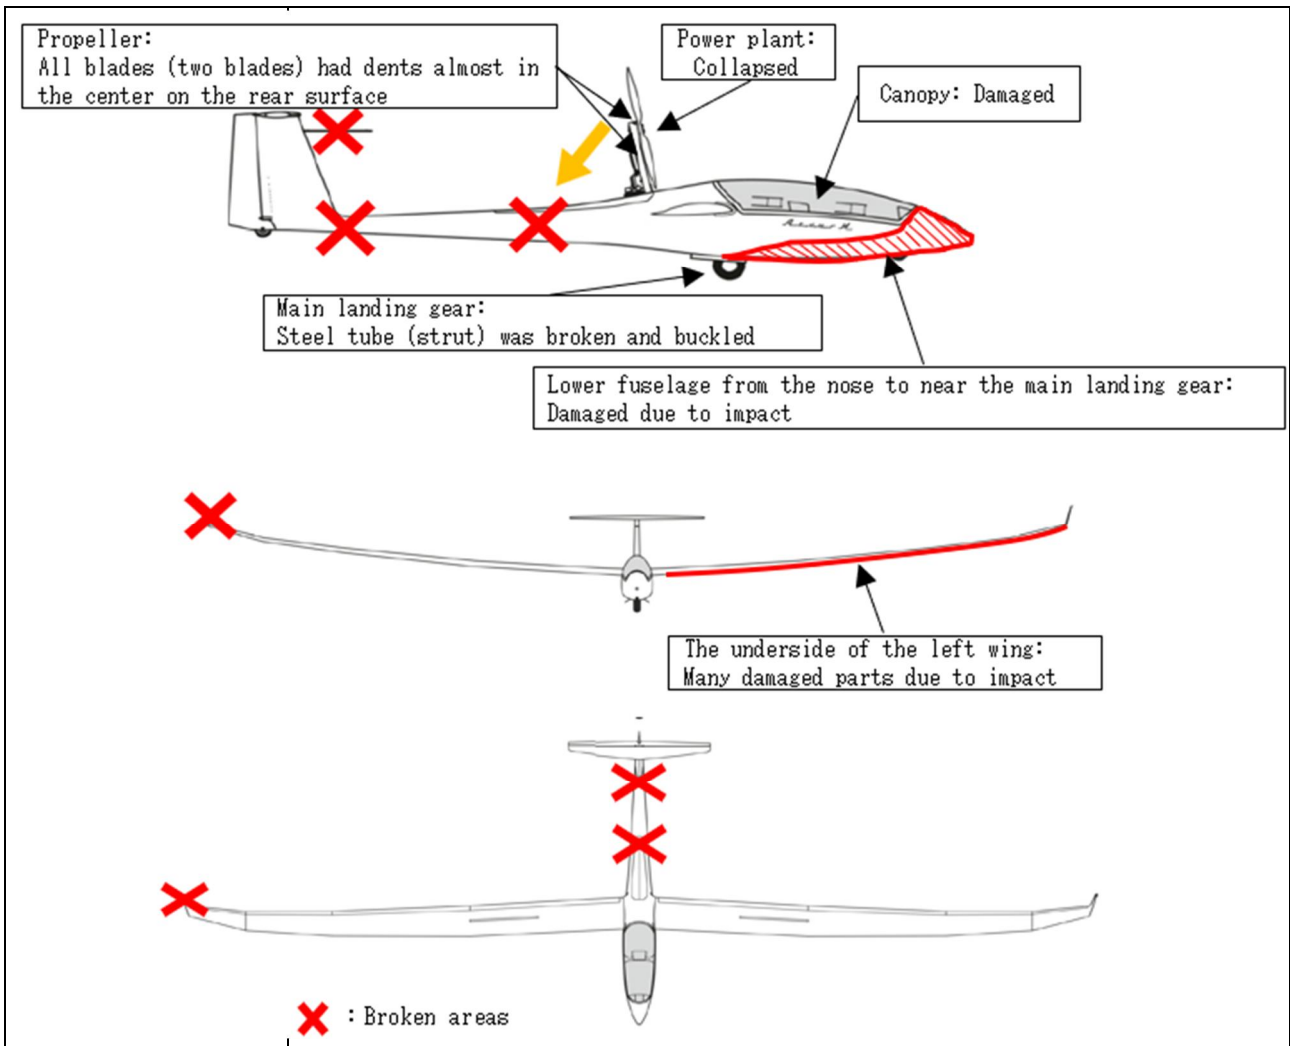
Figure 4: Damage to the Glider

| <p>2.3 Damage to the Glider</p> | <p>(1) Extent of damage: Destroyed (2) Damage to parts of the Glider (see Figure 4)</p> <ul style="list-style-type: none"> • Cockpit: The canopy was damaged, front and rear seat buckets were damaged, and the front seat flap lever was bent and stuck. • Fuselage: Broken in the center, and its lower surface was broken from the nose to near the main landing gear. • Wings: The underside of the left wing was damaged and the tip of the right wing was broken. (No damage was found at the wing-fuselage joint.) • Power plant: Collapsed toward the tail <ul style="list-style-type: none"> ※ The actuator that extends and retracts the power plant was in the fully extended position (engine operating position) • Propeller: All blades (two blades) had dents almost in the center on the rear surface. • Main landing gear: Steel tube (strut) was broken and buckled. <p>No failure was found in the control system. And there were no abnormal combustion and internal destruction in the engine, but the continuity checks on the airframe side of the engine ignition system (between the wiring connectors and the engine control unit) revealed a disconnection.</p> |

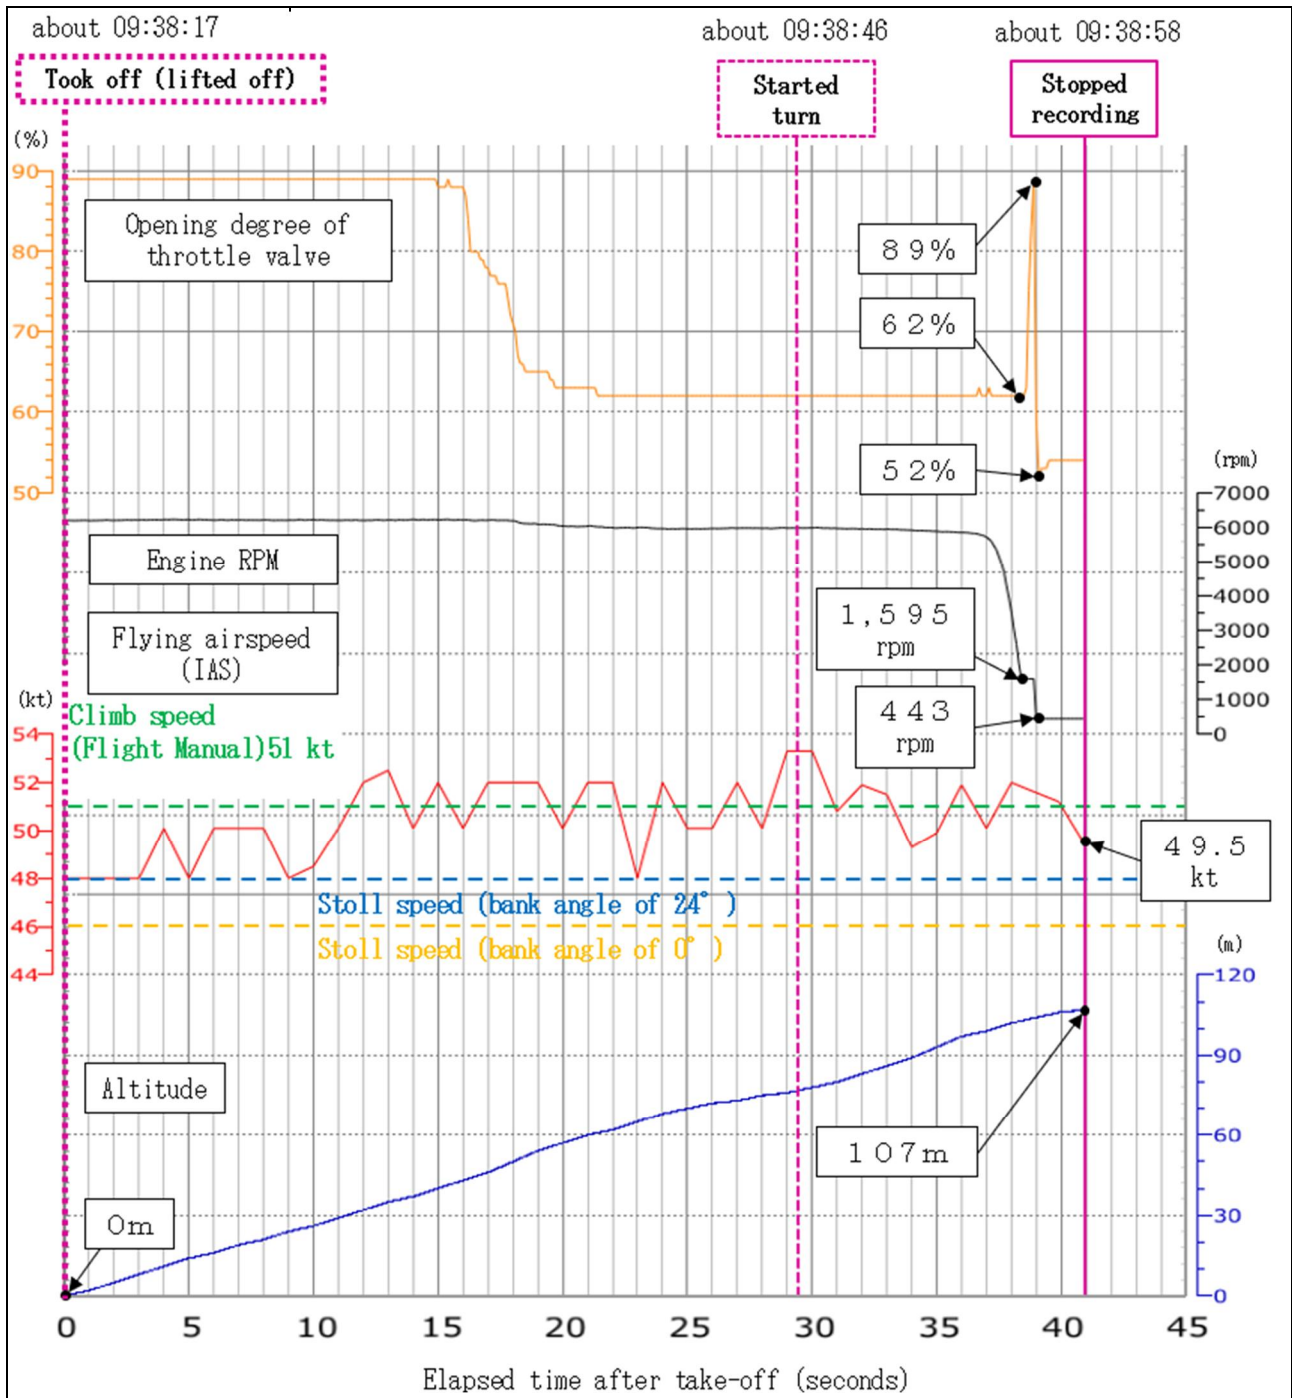
Figure 5: Changes in Flight Altitude, Flying Airspeed, Engine RPM, and Throttle Valve (for 41 seconds from take-off to the stop of recording)

As shown in Figure 5, the unit recorded the engine RPM, the opening degree of the throttle valve and others. According to the data analysis results, after the glider started the take-off, the engine had been normally operating (engine RPM: about 6,200 rpm). However, after the engine RPM suddenly dropped from 4,949 rpm (3.4 seconds before data recording stopped) to 1,595 rpm (2.6 seconds before data recording stopped), the opening degree of the throttle valve rapidly increased (increased from 62% to 89% 2.1 seconds before data recording stopped). Besides it was recorded that the engine RPM dropped to 443 rpm (1.9 seconds before data recording stopped).

Based on the results of the analysis of the engine data recorded prior to the accident, the engine manufacturer and the engine control unit manufacturer presented the viewpoint that the drop in engine RPM was caused by an engine stalling*4. According to this viewpoint, when the engine RPM dropped to 1,595 rpm, it is possible that the pilot's operation of the throttle lever caused the throttle valve to operate abruptly (the opening degree increased from 62% to 89%), resulting in an engine stalling and a further drop in engine RPM to 443 rpm (in general, in a two-cycle engine, abrupt throttle operation instantaneously increases the airflow rate, making it difficult to secure an appropriate fuel-air mixture in the combustion chamber and ultimately leading to a stall) (see Figure 5).

In addition, prior to the drop in engine RPM due to the engine stalling, the engine RPM rapidly decreased from approximately 6,200 rpm to 1,595 rpm 2.6 seconds before the data recording stopped. However, as no damage was found inside the engine of the aircraft after the accident, it is considered that this decrease was not attributable to the engine's internal mechanisms. Nevertheless, since the engine installed in the aircraft had been in use for only 2 hours and 44 minutes after manufacture, the possibility of an initial failure cannot be ruled out. The cause of the rapid drop in engine RPM to 1,595 rpm could not be determined.

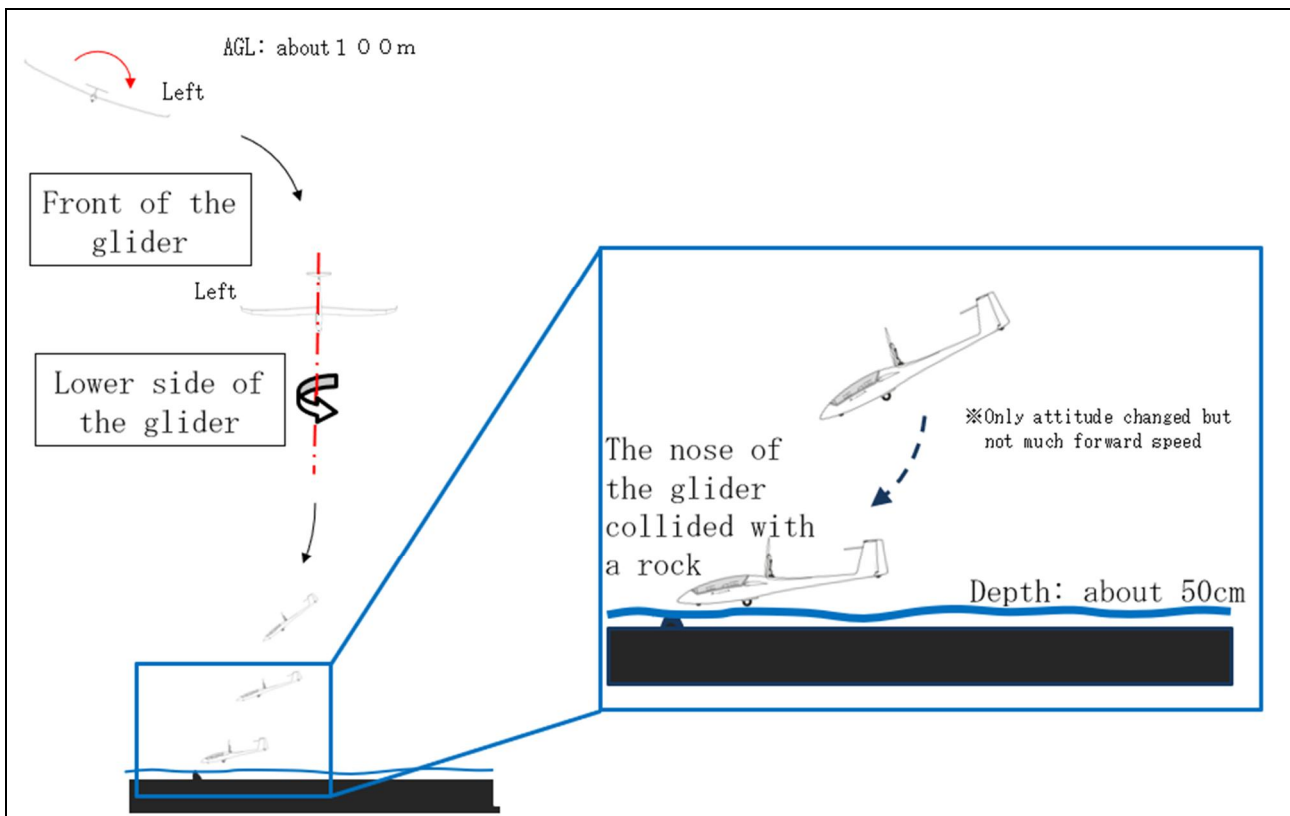
Figure 6: The Glider Movement after Entering a Spin

For the reasons given above, it is more likely that the engine output was decreased in line with a drop in engine RPM when the glider made a left turn of about 90° while climbing after the self-launch, and that the glider then continued to turn without lowering the nose, causing a rapid loss of speed, and the glider stalled and entered a spin. And the spin stopped about one second before the glider crashed into the ground, but the glider most likely hit the ground surface with its nose slightly down and its wings in an almost horizontal position as unable to reduce its rate of descent (see Figure 6). At this point it is more likely that the nose section collided with the rock in the river, causing significant damage to the glider.

The reason that the spin stopped is probably because the pilot had applied a spin recovery method, since the Flight Manual describes that with the standard recovery, the glider will stop rotating after about ½ to ¾ turn, and even in the footage, the glider's spin generally stopped after one turn. As the spin of the glider immediately before the accident was a left turn, the right rudder should be applied for the spin recovery method. Therefore, the fracture of Pilot A's right lower tibia likely occurred when the glider hit the ground and the nose section was damaged while Pilot A was applying the right rudder during the recovery procedures. However, the details of the spin recovery procedures could not be determined, as both pilots sustained fatal injuries.
