**AIRCRAFT ACCIDENT
INVESTIGATION REPORT**

**Fukushima Prefectural Police Aviation Unit
J A 1 3 9 F**

INJURIES TO PERSONS ON BOARD AND ROTORCRAFT DAMAGE CAUSED BY HARD LANDING FUKUSHIMA PREFECTURAL POLICE AVIATION UNIT AGUSTA AW139 (ROTORCRAFT), JA139F AT MIHOTA TOWN, KORIYAMA CITY FUKUSHIMA PREFECTURE, JAPAN AT ABOUT 08:08 JST, February 1, 2020

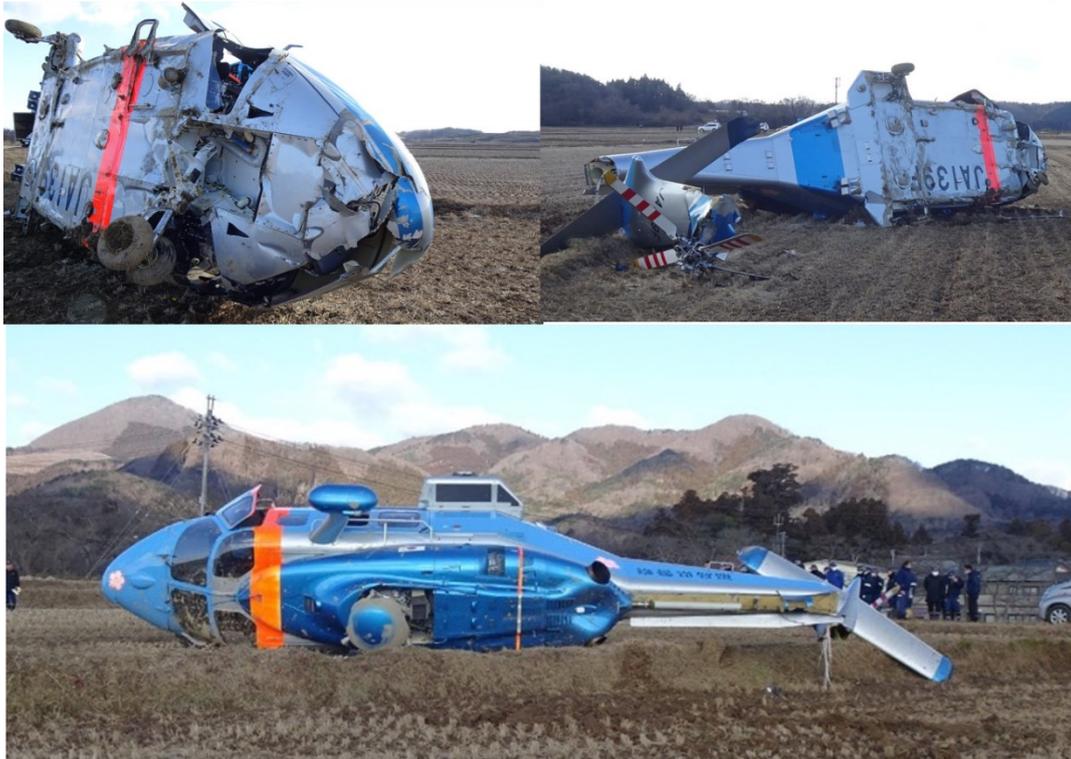
Figure 4: Rollover of the Accident Helicopter

- Fuselage : Deformed from the nose to the bottom surface of the main landing gears
- Tail section : Separated, damaged
- Engines : Damaged (Partially deformed)
- Rotor system : Main rotor system: Damaged, blades scattered
Tail drive shaft: Damaged, scattered
- Landing gears : Damaged

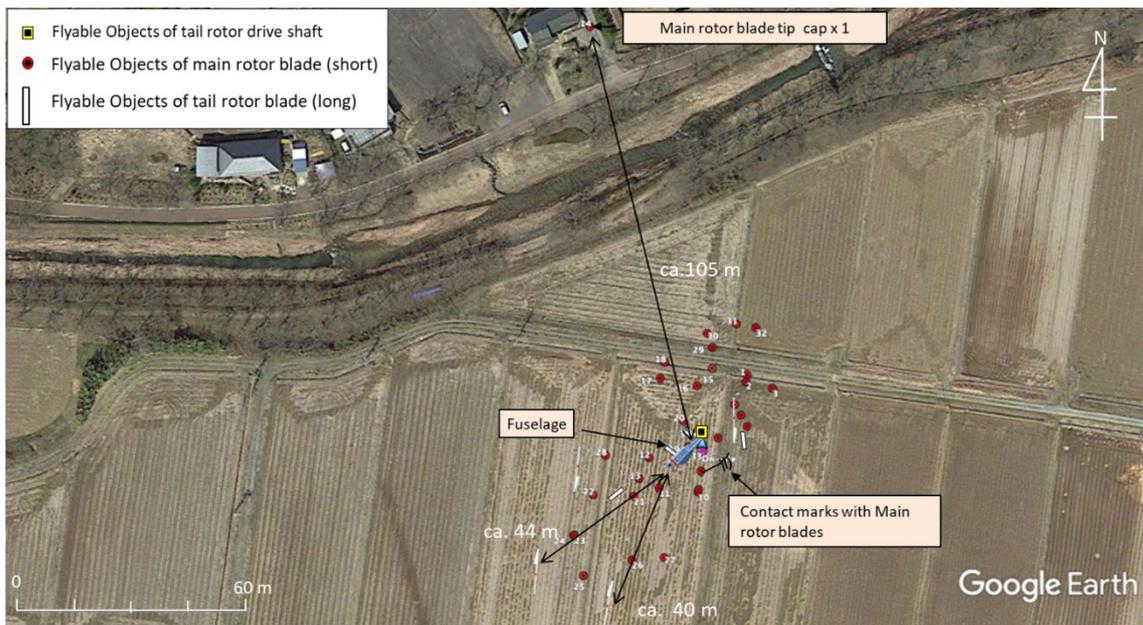
Figure 7: Wreckage scattered near the accident site

As shown in Figure 7, the accident site is located in a rural area extending toward the west side in Koriyama City, and there is a village about 100 m to the north of the accident site.

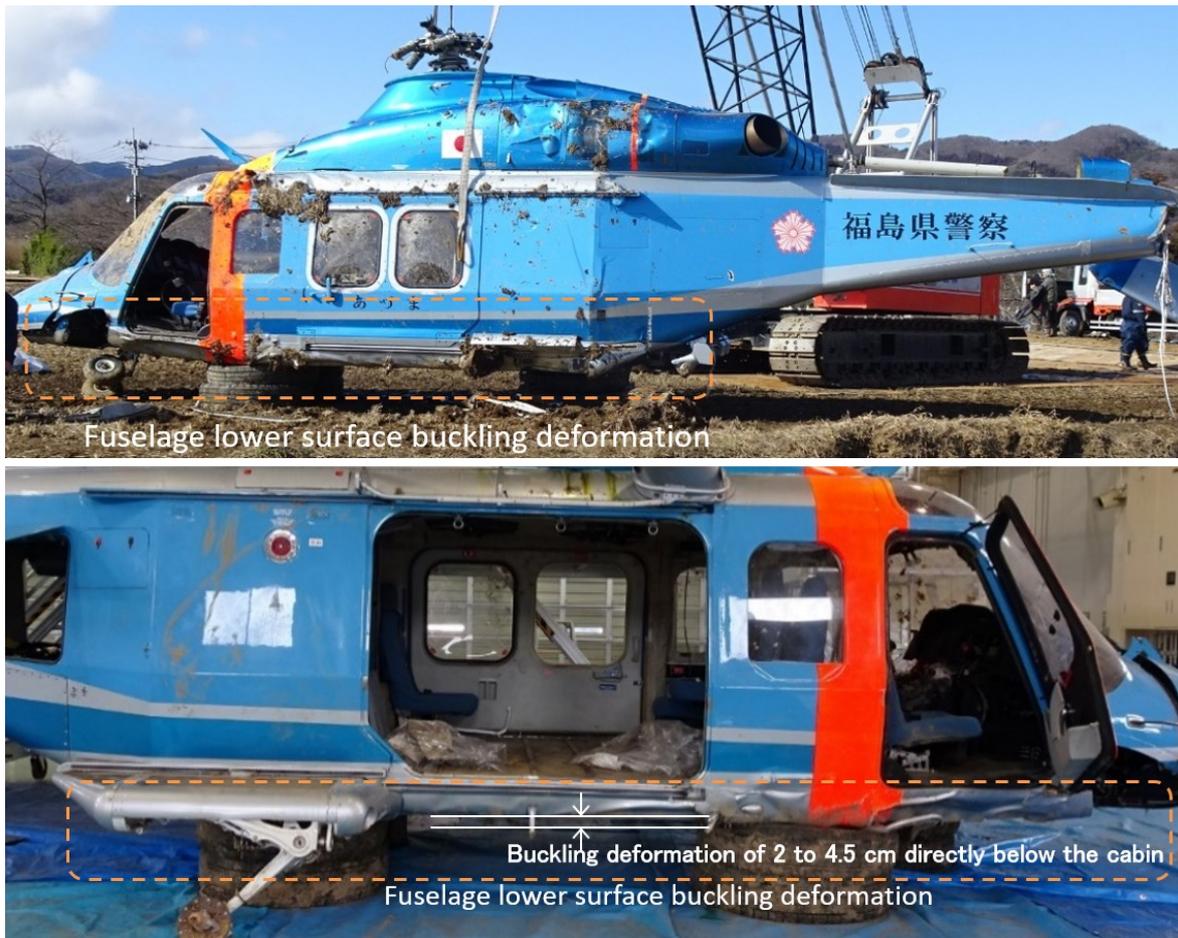
Figure 8: Damage to fuselage and landing gears

- Almost all over the lower part structure of the fuselage from the nose section to the main landing gear attachment position was deformed by buckling upward.

- The three wheels of retractable landing gears were broken (See Figure 4 and 8) near their mounting portion. Particularly the left main landing gear was broken from the mounting portion and was separated.

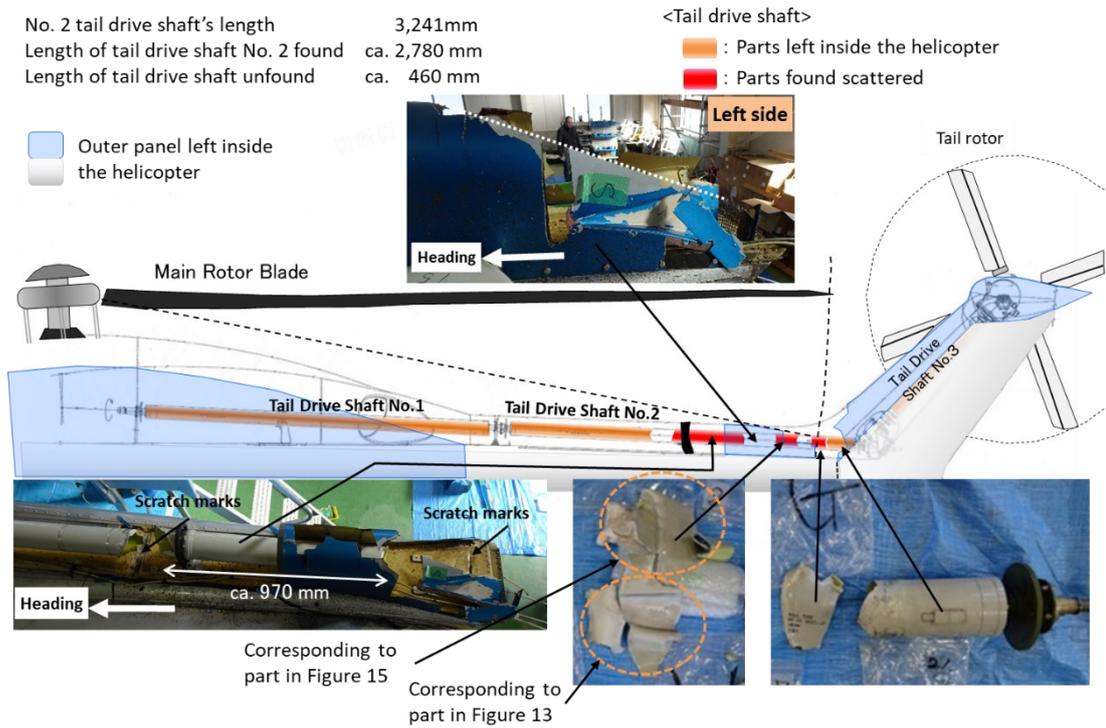
Figure 9: Damage to Tail Drive Shaft

- The tail section separated in front of the vertical stabilizer, and there was no significant damage to the tail rotor blades.
- The red colored part of tail drive shaft No.2 at the front upper portions of the tail section was found together with other upper tail drive shaft cover including the No.2 GPS antenna in the mountains about 1,300 m north of the accident site. (See Figure 9 and 10.)
- The fracture surface seen from the side of the tail drive shaft cover at the aft fuselage coincided with the position and shape when the main rotor blade lowered, and the left cover had more damage than the right cover. In addition, the lower fuselage where the tail drive shaft was damaged had scratch marks.
- A part of the tail drive shaft (corresponding part in Figure 15) had contact marks with jagged shaped dents.

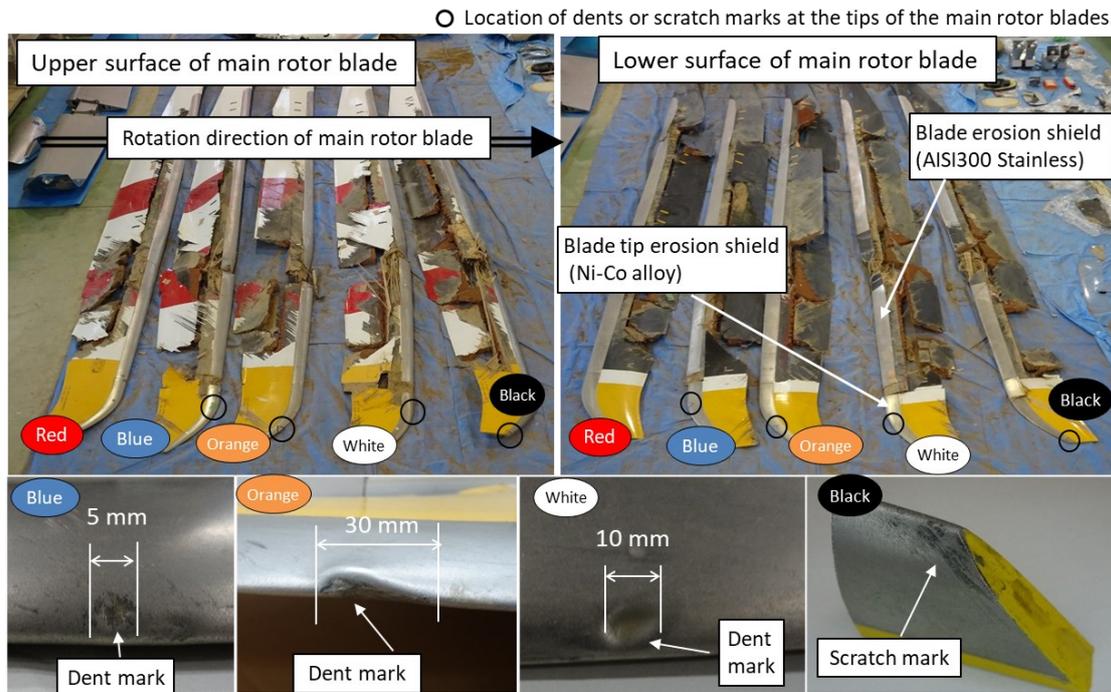
Figure 11: Wreckage of main rotor blades and the locations of the dent or scratch marks on the main rotor blades

- All five main rotor blades identified in 5 colors (red, blue, orange, white, black) were broken from the attachment part and were scattered around the accident site. The tip erosion shields (Made of Ni-Co alloy) of three main rotor blades (blue, orange and white) had dent marks, and on the tip erosion shield of the black there were scratch marks not seen in the other main rotor blades.

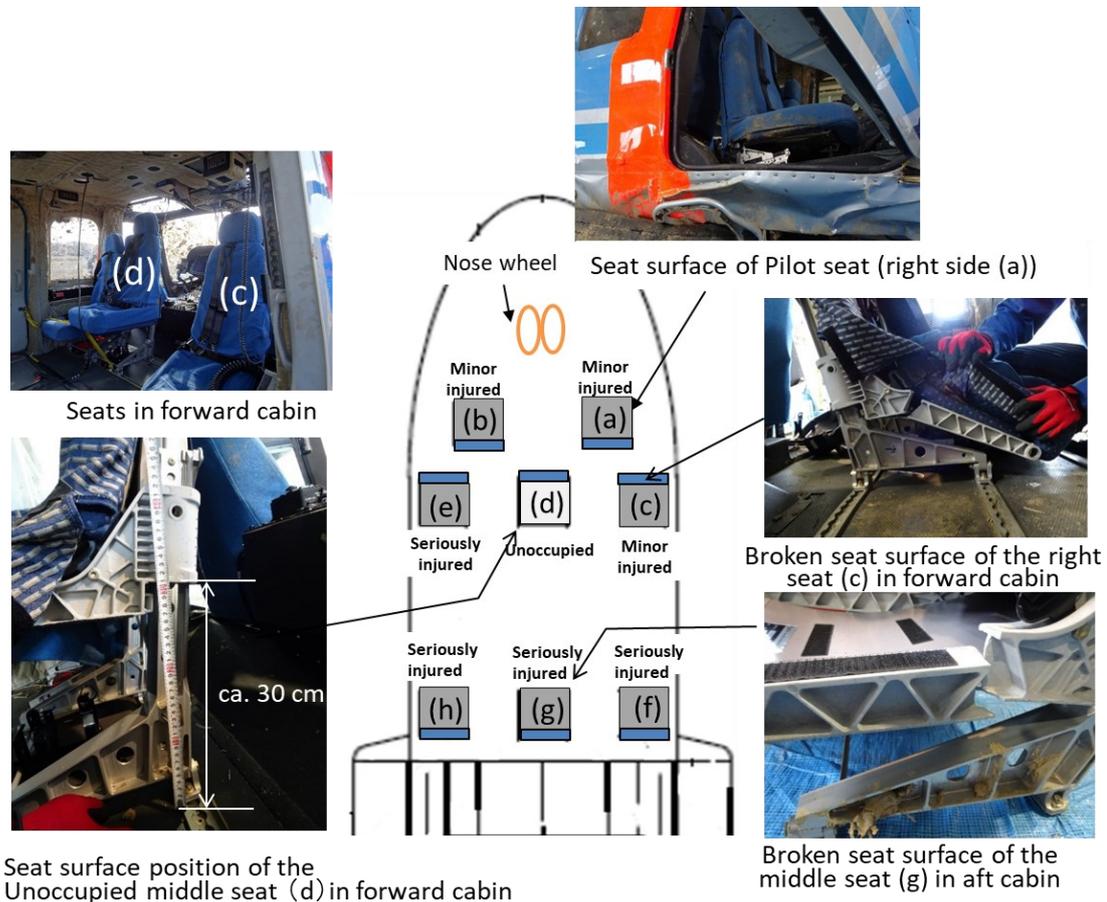
Figure 12: Occupant positions of all persons on board, and damage to the seats

persons were seriously injured, and one sustained a minor injury. There was no abnormality in the operation of the seatbelts for all the seats on board, and the seating surface was moved to the lowermost position as the load limiter*²¹ operated. In addition, the bases of the seating surface for the right seat in forward cabin (c) and the middle seat in after cabin (g) were broken.

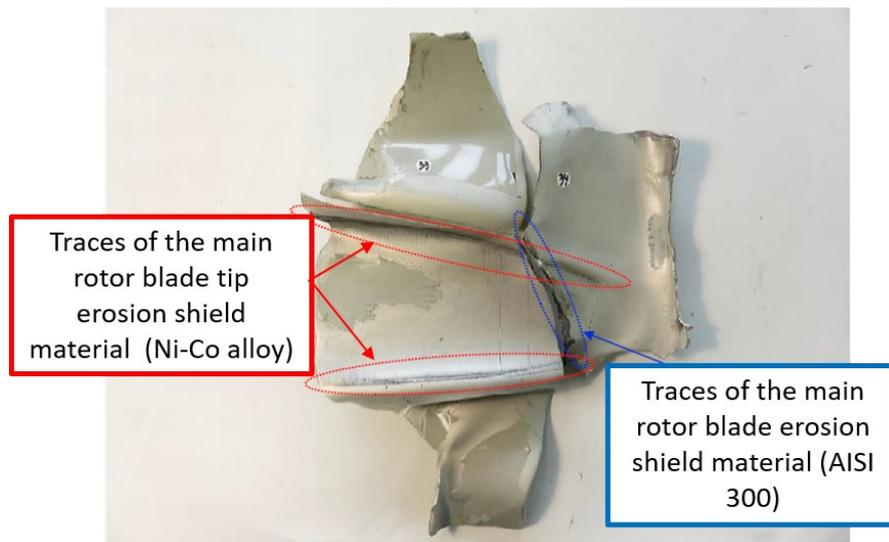
Figure 13: Investigation results of the contact marks between main rotor blades and tail drive shaft

that there was a trace (part within blue dotted line) of friction with the material (AISI 300 stainless) that was compatible with the main rotor blade erosion shield. From a point of view of each shape of those two contact marks, it was indicated that the tail drive shaft initially had contacted the main rotor blade tip, and next had been separated into two by the main rotor blade.

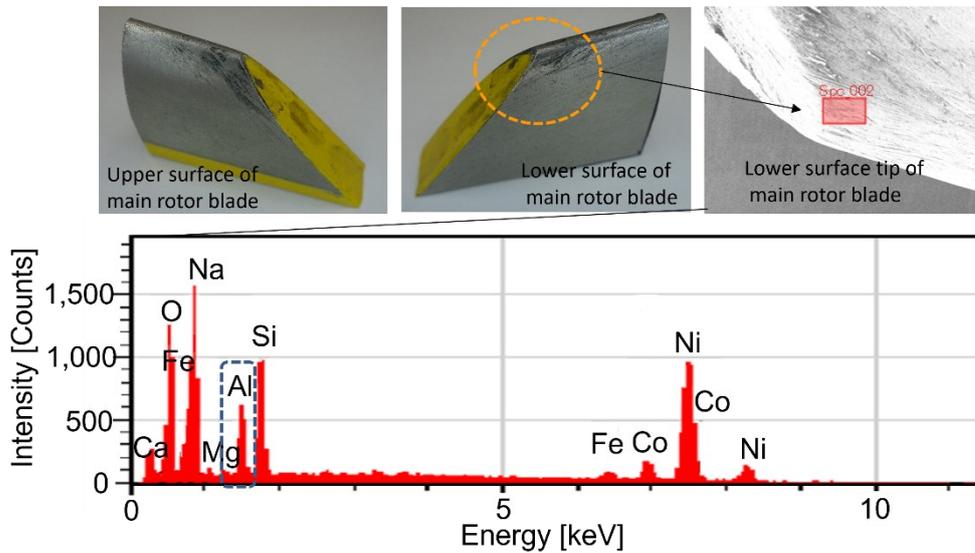
Figure 14: Contact marks on the black main rotor blade tip (above) and component material analysis (below)

On both sides of the tip of the black main rotor blade shown in Figure 14, there were contact marks. Besides, there were many of adhered component materials indicating that the helicopter made contact with the ground when rolling over at the time of the forced landing. And among the component materials, there was the one that was compatible with that of the tail drive shaft (aluminum alloy). Furthermore, it was confirmed that the four contact marks on the fragment (see Figure 15) of tail drive shaft found in the mountains matched well with the shape of the main rotor blade tip.

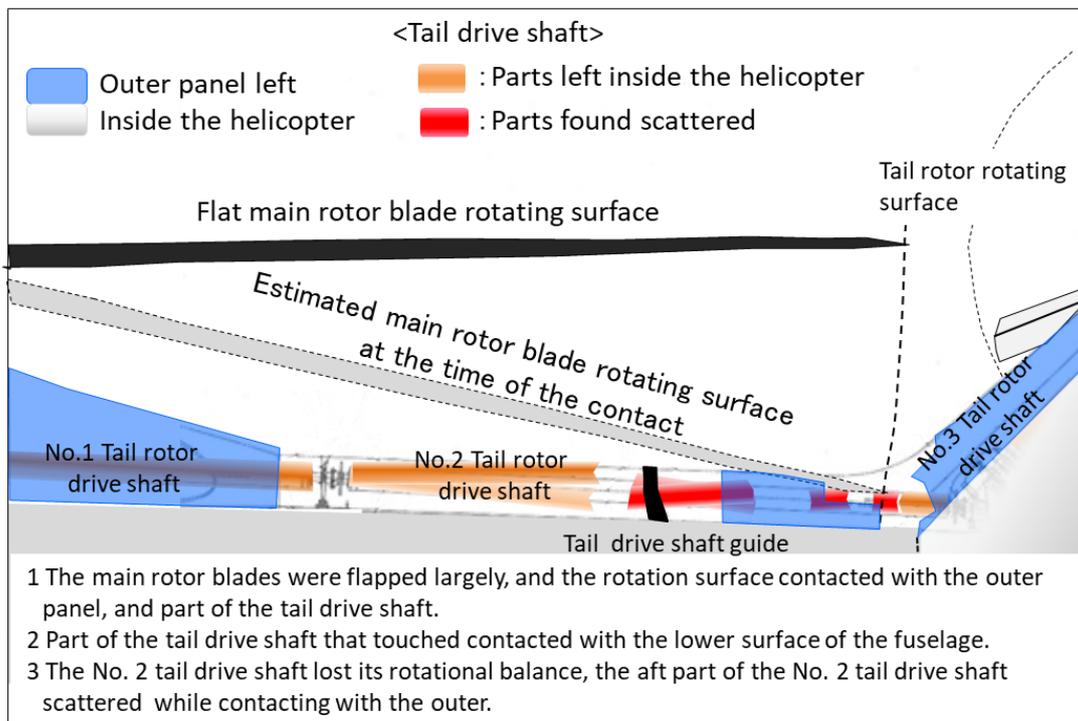
Figure 29: Estimated movement plane of rotation of main rotor blades at contact, and scattering of No. 2 tail drive shaft rear part

The main rotor blades of the AW139 are structured to limit the vertical flapping^{*36} movements by upper and lower limiters that make it difficult to contact with the fuselage. As described in 2.13.1, in case of the weight of the helicopter at the time of the accident, the first sign of the stall of the retreating main rotor blade is expected to be shown in the range of TAS 190 to 200 kt. Because while the helicopter was in level flight, the airspeed rapidly increased to IAS 188 kt (TAS 195 kt), in which the sign of the stall should be shown, but low-frequency vibrations of the main rotor blades, including torque oscillations (see Figure 16), did not occur, and because a right rolling motion started in response to the control by auto-pilot and the operation of cyclic stick during acceleration, it is unlikely that the retreating main rotor blades stall caused the main rotor blades to contact with the tail drive shaft.
