# AIRCRAFT ACCIDENT INVESTIGATION REPORT

## PASSENGER INJURY DURING DISEMBARKATION

AIRBUS A320-232, JA14JJ

CHUBU CENTRAIR INTERNATIONAL AIRPORT

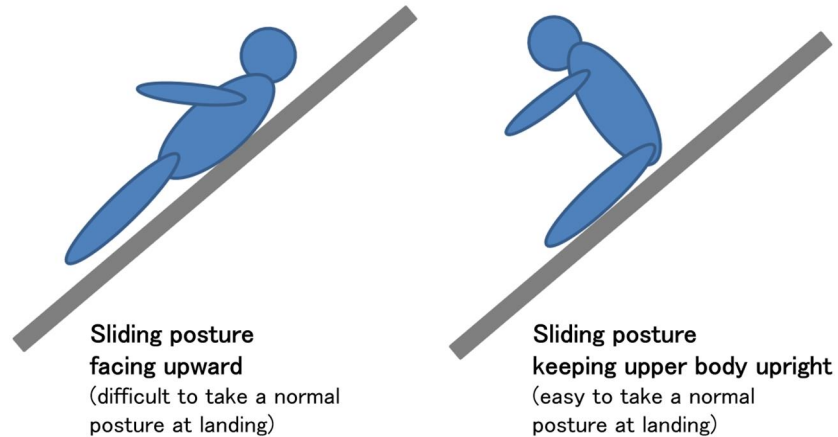
Figure 2: Posture in Descending the Slides

comparison to sitting straight when sliding down the Slide (Page 124 of the report) (see Figure 2). Furthermore, it is analyzed that the Slide is designed for a prompt escape in the event of an emergency, therefore, in case of involving such factors as worsening the sliding conditions, injuries may occur (on page 132 of the report).

To prevent injuries during the disembarkation using the Slides, it is important to descend the Slide by keeping upper body upright that makes it easy to take an appropriate landing posture, as recommended in the past similar Event c. Therefore, it is vital to surely inform passengers that they should put their hands on the laps, extend their hands forward, and keep their body upright when sliding the Slides by having the visual of landing point.
