**AIRCRAFT ACCIDENT
INVESTIGATION REPORT**

**PRIVATELY OWNED
J A 2 0 T D**

June 30, 2016

CRASH DURING ATTEMPTING TO OFF-FIELD LANDING
PRIVATELY OWNED, SCHEMPP-HIRTH DISCUS bT
(SINGLE-SEAT MOTOR GLIDER), JA20TD
URASU TOWN, KABATO DISTRICT, HOKKAIDO, JAPAN
AT 12:36 JST, MAY 30, 2015

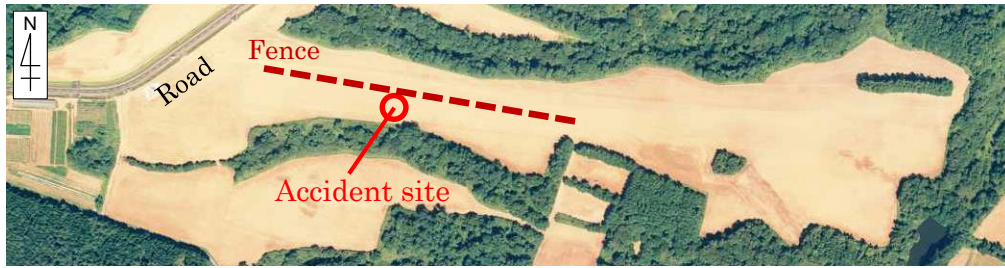
Photo 1: Topography of Grassland of the Accident Site

(electric current flows through bare metal wires in the fence) was installed near the center of the landing place, along which wheel tracks were left.

There are several grasslands and places like that allowing for the landing of the Glider in the vicinity of the grassland.

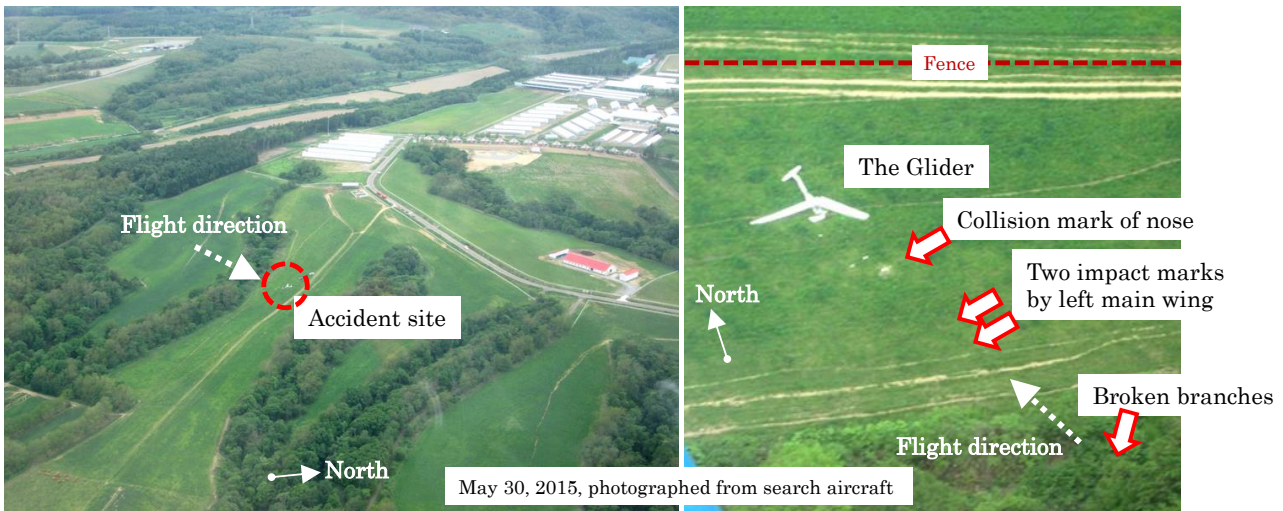
Photo 2: Aerial View of the Accident Site

According to GPS unit records, the Glider approached from the south side of the accident site while turning to the left. First, there was the impact mark by the left wingtip, and the impact mark when the left wingtip was ruptured was left around its north. From that point on, there was the collision mark of the nose, and many pieces of the canopy and other things were scattered near the mark. Further from that point on, the Glider of which the nose was severely damaged and the left main wing and the fuselage were broken halted with the nose roughly headed the south.

In the south of the impact mark by the left wingtip, a tree with broken branches was found. The positions of the broken branches were not the top of the tree, and there were taller trees in the surroundings.

The distance from the tree with broken branches to the halt position of the fuselage was about 50 m in the north-northwest.

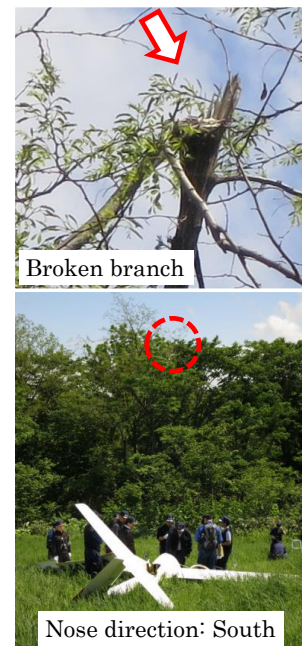
Photo 3: Situation of Tree

It is probable that, around 12:35:40, the Glider turned to the left at low altitude and attempted to land without ensuring the straight final approach course. As described in 2.9.1, there were taller trees surrounding the tree with broken branches. Based on the thickness of broken branches, the distance between the tree and the impact marks, and other facts, it is probable that the Glider greatly lost the height during the left turning, which made the left main wing collide with the tree.

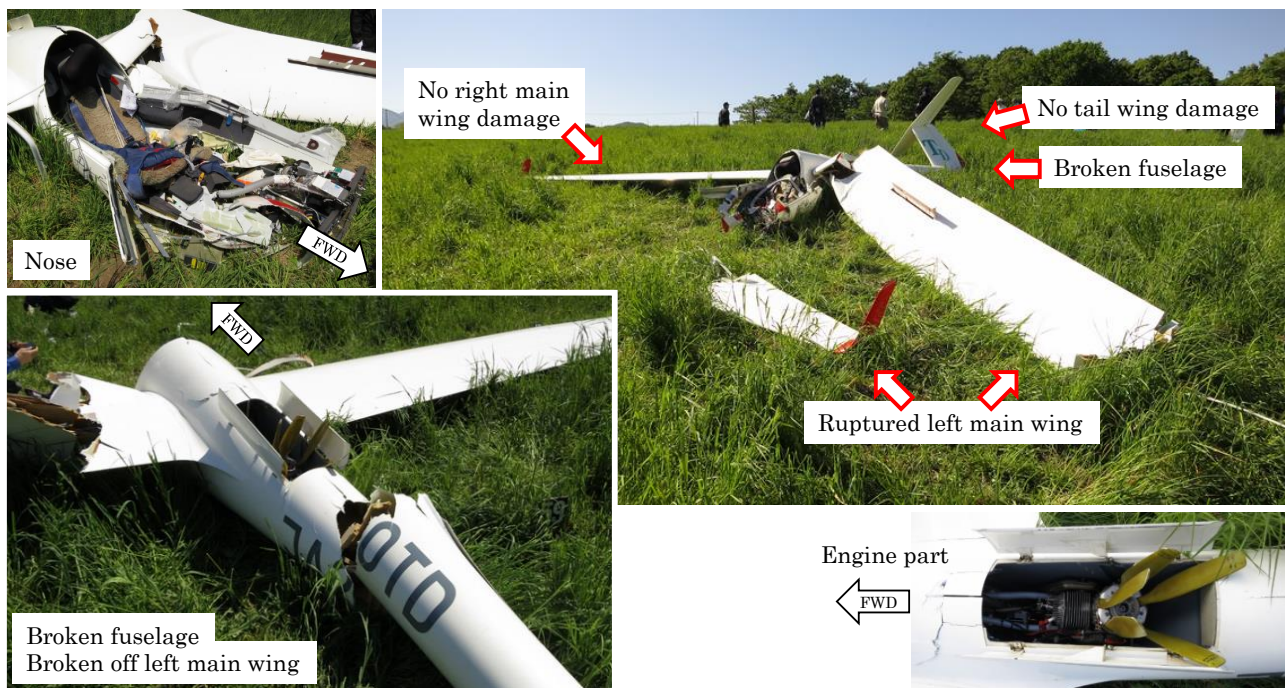
Photo 4: Detailed Damage Description

The left wingtip of the Glider was ruptured, and around the connection part between the wing and the fuselage was also broken and twisted. The fuselage was broken in the rear of the engine. No damages were found in the right main wing, the vertical stabilizer, and the horizontal stabilizer. While the airbrake of the damaged left main wing was fully extended, the airbrake of the undamaged right main wing was completely retracted.

The cockpit was severely damaged, and the airspeed indicator, variometer, and altimeter on the instrument panel were fallen off. The airbrake lever was in the forward-leaning position (Closed), and was damaged to be bent. The operation of three controls (ailerons, elevator, and rudder) by control stick and rudder pedals were uncontrollable due to the severe damage of the cockpit. The retractable main landing gears were damaged in the retracted position.

The engine and propeller of the Glider were not completely retracted and the propeller blade tips stood out with the engine door opened. The propeller blades were not damaged. The rod of electrical spindle drive for extending/retracting the engine was extended (extending position), and the upper end of the installation part was ruptured. The two arresting cables (wires) for supporting the engine in order not to fall forward were ruptured. The front side of the engine retraction opening was damaged due to the hit of steel-tube pylon supporting the engine. (See Appendix 5: Engine Extended/Retracted)

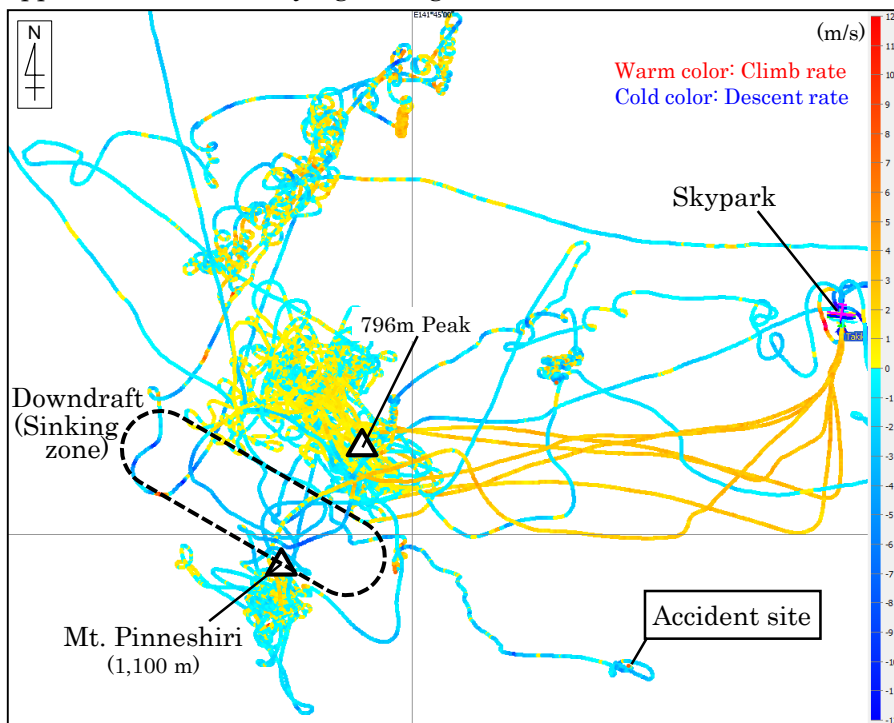
Figure 5: Climb/descent Rates of Gliders Flying near Mt. Pinneshiri

On the day when the accident occurred, six gliders (including motor glider) other than the Glider launched from Skypark for flight, five of which flew above mountainous regions, in the same period as well as the Glider. According to GPS records of these five gliders and the records of GPS unit of the Glider, any of the six gliders approaching the north of Mt. Pinneshiri (lee side) descended at high descent rate.

As described in 2.1.1, the Glider went south towards Mt. Pinneshiri from around 12:15 and turned to the left on the way to get away from it, during which it largely descended to an altitude of about 3,200 ft. As described in 2.12.1 (2), other gliders which flew above the same mountainous regions in the same time period as well as the Glider also lost the height at high descent rate near the almost same place; therefore, it is highly probable that the large descent was caused by entry into the downdraft zone (sinking zone) which occurred in the north of Mt. Pinneshiri.

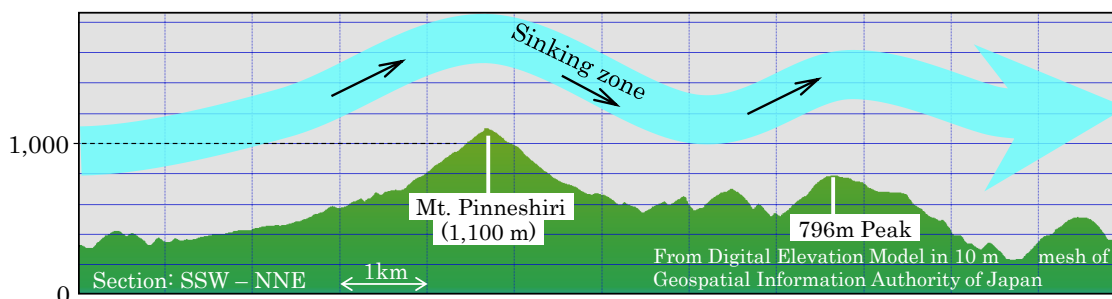
Figure 7: Air Current of Mountainous Regions (Conceptual figure)

Based on the description of 2.7, it is probable that the south wind with slight westward drift blew in the surroundings of Skypark where the Glider launched and the plains in its south. As described in 2.9.1, the accident site is a place at an elevation of less than 100 m, which is located in the foot of mountainous regions. Based on the fact and the surrounding geographical features, it is probable that the south wind mainly blew there as well. Based on the description of 2.12.1 (2), it is highly probable that the south wind caused a downdraft zone (sinking zone) in the north of Mt. Pinneshiri.

In addition, based on the statement of 2.1.2 (1) and the description of 2.7, though mountainous regions where the Glider flied were covered with clouds, some places got sunshine through the rifts in the clouds; therefore, it is probable that the updraft existed.

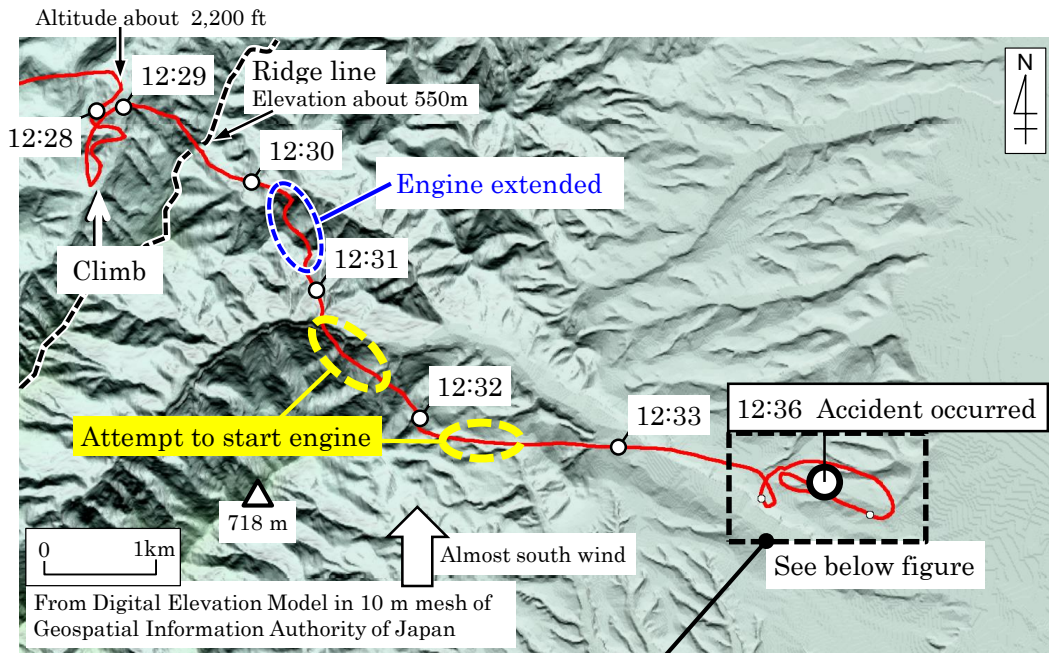
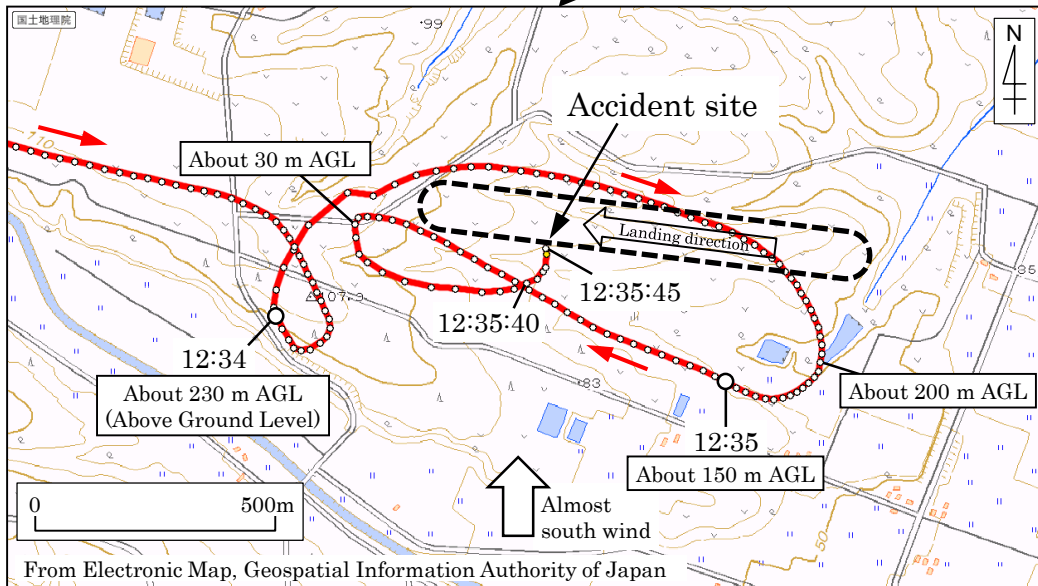
Appendix 1: Estimated Flight Route

somewhat likely that the captain tried the engine start again. As shown in Appendix 1, it is probable that the change of directions to the east is because the Glider lost the height; therefore, the captain tried to head eastern valleys, and it is also somewhat likely that the captain visually confirmed several grasslands and other places surrounding the accident site and considered them as places which allow for landing even if the second engine start failed.
