# AIRCRAFT ACCIDENT INVESTIGATION REPORT

## AIRCRAFT DAMAGE FROM BELLY LANDING ACADEMIC CORPORATE BODY HIRATA GAKUEN TEXTRON AVIATION G58, JA212H KOBE AIRPORT AT ABOUT 14:27 JST, MAY 31, 2024

August 8, 2025

Adopted by the Japan Transport Safety Board

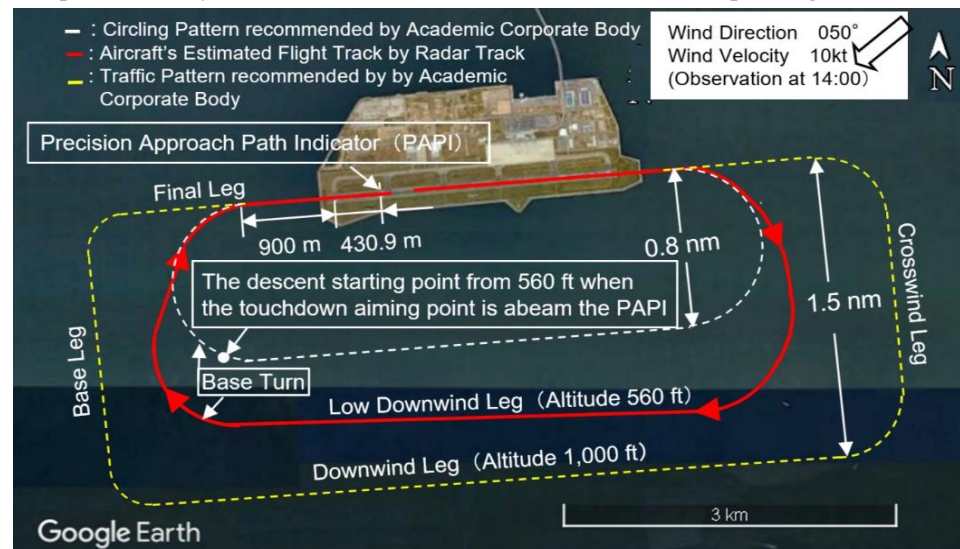
Figure1: Estimated Flight Route

When the aircraft performed a second touch-and-go while flying the circling pattern, the captain instructed Trainee A to make a go-around just before landing. Trainee A raised the landing gear and also fully retracted the flaps following the normal go-around procedure. After flying straight up to an altitude of 560 ft, the normal altitude for flying the circling pattern, Trainee A put the flaps into the approach position when making a right turn toward the downwind leg of the circling pattern (hereinafter referred to as the "low downwind leg") in preparation for landing.

The captain confirmed that Trainee A was performing a go-around and advised the Academic Corporate Body by radio that they would land while the aircraft was still heading straight ahead. When a trainee performs a go-around during a touch-and-goes and continues to fly a circling pattern, the captain would advise the trainee to extend the landing gears when the go-around is complete, but the captain forgot to give this advice on this occasion.

When the aircraft completed the turn towards the low downwind leg, the captain instructed Trainee A to make corrections as the captain recognized that the aircraft's airspeed was high and that the distance between the aircraft and the runway was long.

Trainee A started the base turn while correcting the distance between the runway and the low downwind leg. As the aircraft's speed at the time, it started the base turn faster than the target speed of 110 knots, therefore, Trainee A had to start the descent when the aircraft's flight altitude and the descent path 3° from the touchdown aiming point intersected while correcting the aircraft's speed and also had to operate putting the flaps fully down. The captain provided Trainee A with instructions about the airspeed and the descent path. While Trainee B was also looking at the runway to determine the descent path, Trainee B was concerned that the aircraft was approaching the maximum speed of 122 kt at which the flaps could be fully down.

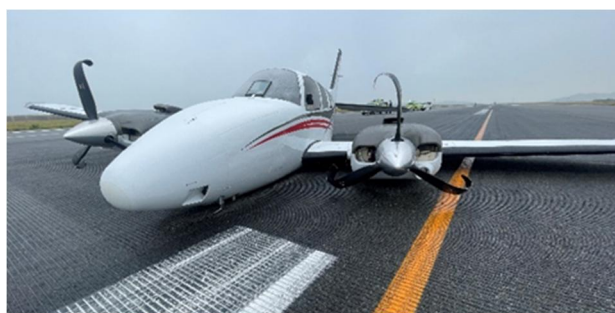
Figure 2: The aircraft

| <b>2.3 Damage to Aircraft</b> | <p>Extent of Damage: Substantially damaged</p> <ul style="list-style-type: none"> <li>• Lower fuselage structure: Scratch marks (see Figure 3)</li> </ul> |

| | <p>(Damage equivalent to major repairs)</p> <ul style="list-style-type: none"><li>• Lower fuselage : Scratch marks,<br/>Detachment of panels,<br/>Antenna<br/>(Radio communication:<br/>Detached and damaged,<br/>ATC transponder: Damaged)</li><li>• Both propeller blades: Bent, Scratch<br/>marks (see Figure 2)</li></ul> <p>Figure 3: Lower Fuselage</p> <p>Figure 4: Left Flap</p> | | | | | | | | | | | | | | | | | | | | | | | | | | | | | | | | | | | | | | |

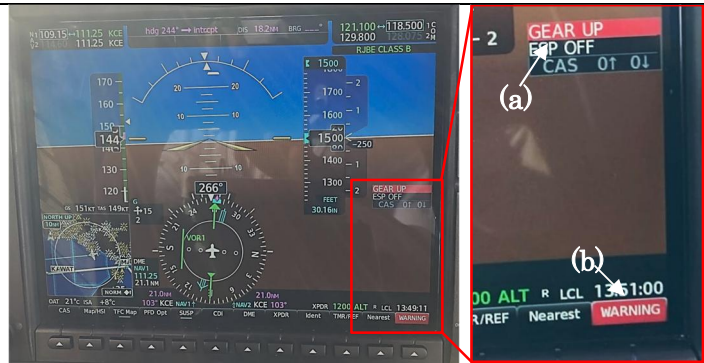
Figure 5: PFD with developing the warning

According to the aircraft's Flight Manual, the warning sound will sound intermittently when the landing gears are retracted and one

of the throttle levers is retarded until the manifold pressure goes down to about 13 inHg or less, or the flaps are moved to the full down position. The ALERT soft key at the bottom right on the PFD\*2 will also change to the red flashing warning (see Figure 5 (b)) with the text warning of GEAR UP (see Figure 5 (a)) in red in the annunciation window of the PFD. In the case of an audible warning, the procedure in the Academic Corporate Body is for the pilot to voice the situation and identify the cause of the warning.

During the onsite investigation, it was confirmed that the warning sound, the text displays on the PFD and the red flashing warning of the ALERT soft key was operating normally.

Furthermore, the landing gear warning was not issued because Trainee A did not operate the throttle lever to a position that would reduce the engine intake pressure to approximately 13 inHg or less while flying on the low downwind leg after performing the go-around, and it is more likely that the captain and the trainees did not have the opportunity to notice that the landing gears
