# AIRCRAFT ACCIDENT INVESTIGATION REPORT

## SCHEIBE SF28A TANDEM FALKE

## (MOTOR GLIDER, TWO-SEATER), JA2177

## TAKAYAMA CITY, GIFU PREFECTURE

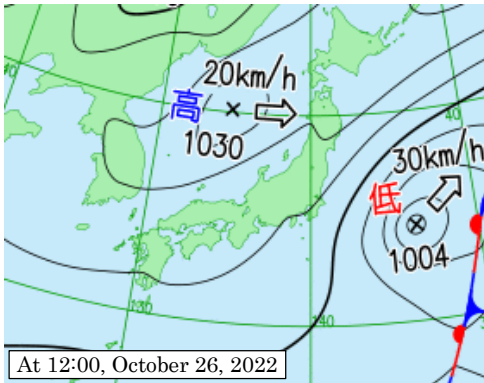
<p>Figure 4: Surface Analysis Chart</p> </div> <div style="text-align: center;">

<b>2.6 Meteorological Information</b>	(1) On the day of the accident, the whole of Gifu Prefecture was cloudless and covered by the migratory high-pressure system. <div style="display: flex; justify-content: space-around; align-items: flex-end;"> <div style="text-align: center;">

The JTSB concludes that on the day of the accident, there were most likely no meteorological problems that would have hindered the flight, and that in the mountainous areas, the flight was not affected by airflow disturbances and downdrafts.

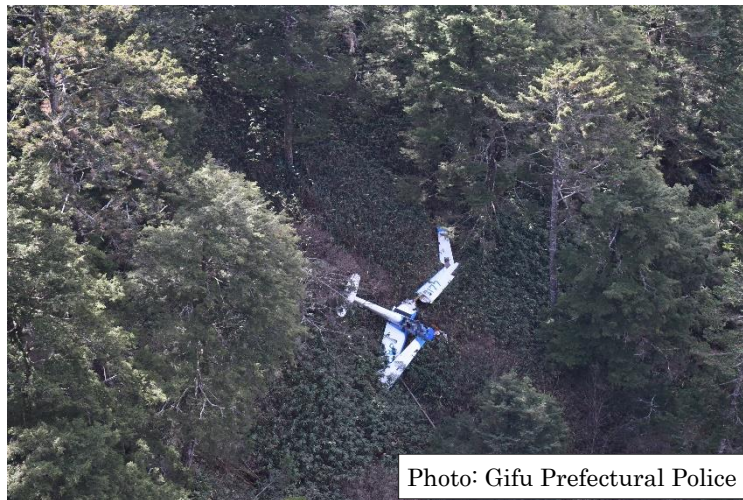
Figure 7: Accident Site and Glider Damage

The right and left wings were broken off and the nose section of the fuselage, where the engine was mounted, was broken, bent and deformed.

In addition, there was deformation and damage to all parts of the glider, the canopy was cracked and scattered all over the place, but there was no evidence of fire in the engine, fuel system and others, and fuel remained in the tank.

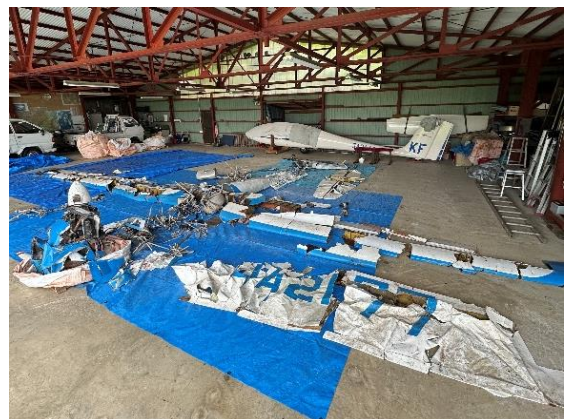
Figure 8: The Glider after Recovery

The recovered glider was cut into small sections for transport, but there was no stiffening or damage to the control system connections and hinges, and no defects were found in the fuel system hoses and piping. In addition, there was no evidence in any of the cockpit switches that engine shutdown procedures were performed during the flight.

The engine, including accessories and other items, was disassembled and examined in detail, and from use, no defects were identified that would cause engine failure, such as sudden loss of power during flight, engine shutdown or others, except for carbon build-up from use.

About two weeks before the accident, the glider had undergone a periodical check, and there had been no malfunctions in the period between the periodical check and the accident. The glider crashed with fuel remaining in the tank, and during the examination of the glider after recovery there was no evidence of the occurrence of any malfunction in the glider, control system and others, which would have prevented continuation of the flight during the flight, and no malfunction was observed which would have caused the engine to fail. In addition, the glider is a motor glider capable of gliding flight with the engine deliberately shut down, and is the type of glider where engine failure is unlikely to be a direct cause of the crash. From the above, it is highly probable that the damage to the glider was caused by the impact of the crash, and it is more likely that there was no failure in the glider or engine which led to the glider crashing.

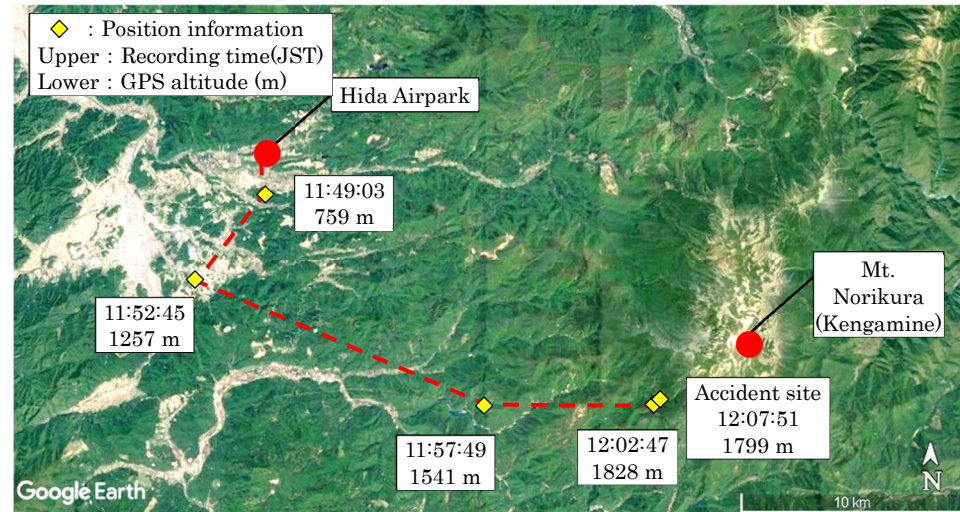
Figure 9: Changes in Position Information  
(The straight lines do not indicate the flight track.)

The position information after 12:07:51 was almost unchanged from the same position, and was consistent with the accident site where the glider was found.

The JTSB concludes that at 12:02:47, the glider had not yet reached the crash site (the accident site), and at 12:07:51, the glider's position information was consistent with the crash site, therefore the glider most likely crashed between these times.
