AIRCRAFT ACCIDENT INVESTIGATION REPORT

Adopted by the Japan Transport Safety Board

Company	Kyushu Institute of Technology
Type, Registration Mark	Alexander Schleicher ASK13 (Glider, Two-Seater), JA2189
Accident Class	Crash
Date and Time of the Occurrence	At About 16:22 Japan Standard Time (JST: UTC+9 hours), May 25, 2024
Site of the Accident	Ubuyama Village, Aso County, Kumamoto Prefecture (33° 03' 38" N, 131° 12' 17" E)

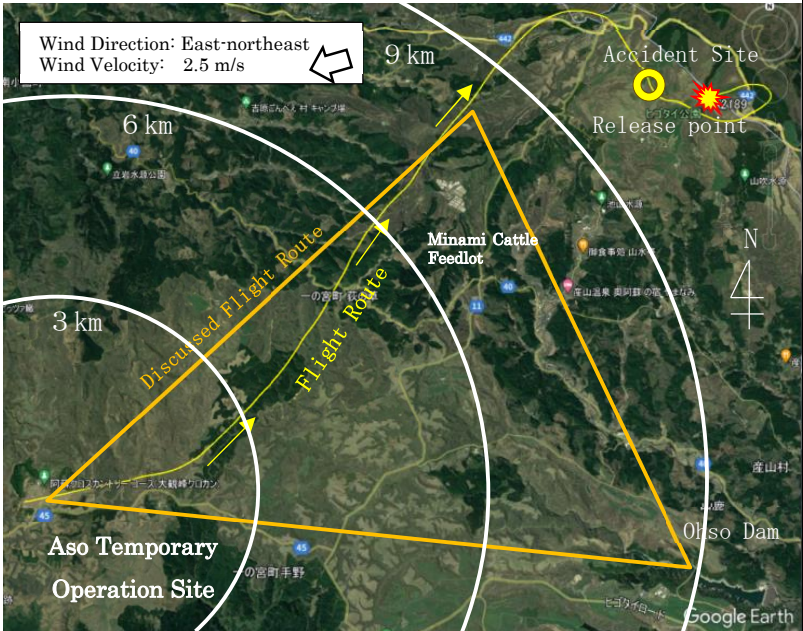
Figure 1: Estimated Flight Route
(based on mobile phone GPS records)

around 11km from the departure site, the speed had reached 150 km/h and the towplane made a 90° turn to the right, the glider pilot was scared and tried to reduce the speed by opening dive brakes. But climb rate reduced, and the speed has further increased, glider pilot contacted the tow pilot using radio “The speed is too high, please slow down.” Upon receipt of this radio, the tow pilot acknowledged that the towplane speed was about 150 km/h, so the tow pilot pulled the control stick to increase the pitch to reduce the speed. However, the glider further accelerated and reached 170 km/h and the towline slacked severely, which was about to entangle the left wing of the glider, so the glider pilot released the towline.

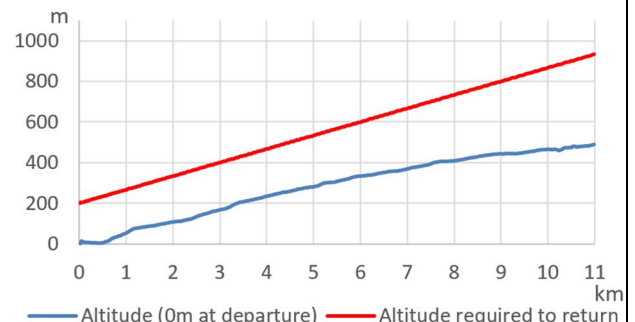
Figure 2: Altitude Required to Return

Figure 2 shows the flight altitude according to the distance from the departure site recorded by the glider pilot mobile phone GPS and the glide ratio 15, which can be used as a reference to be able to fly back to the departure site (200m for the altitude for the traffic pattern).

Based on GPS records, the distance from the departure site where the glider released the towline was 11 km, and the altitude difference was 320 m, therefore, as a glide ratio of 15, the glider did not have required altitude to return ($11 \text{ km}/15 + \text{pattern height } 200 \text{ m} = 933 \text{ m}$). As shown in Figure 2, after take-off, the glider had been flying below required altitude to fly back to Operation Site until it was 11 km away. The tow pilot was conscious to reach 1,000m AGL over Ohso Dam where was the planned as release point, and climbed slowly, and the tow pilot most likely did not consider required altitude for the glider to return to the Operation Site in an emergency such as a towline break.

As being concerned too much about the altitude reached at the planned release point, the tow pilot had most likely towed the glider at an altitude well below the glider to return safely to the departure site. Upon aerotow, it is necessary for tow pilot to fly considering the altitude required for glider to return, so that glider can land safely even if any emergency occur and glider pilot is forced to release. In addition, if glider is significantly below the altitude required to return, it is impossible to correct this from glider side, so glider pilot needs to contact tow pilot by radio early enough to make corrections.

At the time of aerotow, the tow pilot must consider emergency such as a towline break and always maintain sufficient altitude for the glider to return to the gliding field. The glider and tow pilots should confirm the aerotow speed limit of the glider during its pre-flight briefing and must not exceed this limit.

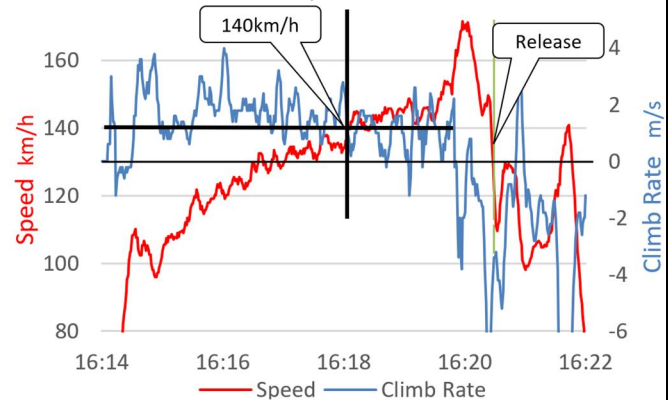
Figure 3: Speed and Climb Rate

From the GPS record, the speed of the glider gradually increased from 100 km/s from the start of the aerotow and continued to accelerate beyond 140 km/h, glider operation limitation for aerotow. On the other hand, the

climb rate was positive and climbing until the speed of the glider reached 140 km/h, and then the climb rate was negative, and the glider gradually descended (see Figure 3).

When the glider was towed, the speed gradually increased, and exceeded glider operation

limitation speed for aerotow, 140 km/h (see Figure 3). On the other hand, the climb rate started to be negative when the speed got 140km/h. It is more likely that the tow pilot has reduced pitch unconsciously and increased speed and reduced climb rate. As the towplane made a tight right turn, which glider was difficult to follow, causing the glider pitch down and exceeded the tow speed, most likely resulting in significant slack in the towline. The tow pilot should have paid close attention to the tow speed to ensure a constant speed and rate of climb throughout the aerotow.

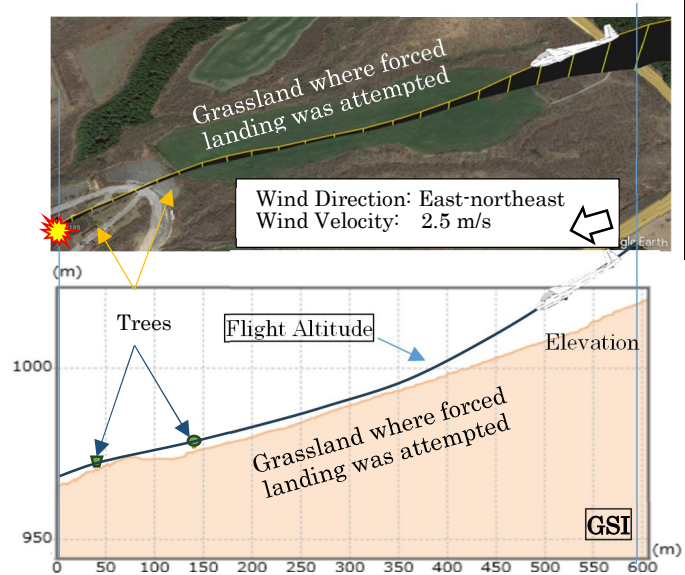
Figure 4: Cross Section of where Forced Landing was Attempted and Flight Altitude

Based on GPS records and elevation data from the Geospatial Information Authority of Japan, the cross section of the grassland where the glider pilot attempted the forced landing was approximately 6° downslope, as shown in Figure 4. When the glider reached the grassland, the flight altitude was about 60 m AGL, but it dropped to a few meters AGL in the middle of the field. Then after flying almost parallel with the ground, the glider contacted trees at the end of the field.

Upon release from the towplane, the glider pilot thought that it would be impossible to fly back to the departure site for the flight altitude was too low and looked for a place to make a forced landing. The glider pilot found a grassland nearby where it would be possible to land, and the glider pilot made an approach toward this field. However, as shown in Figure 4, field the glider approached was 6° downslope, which is close to landing approach angle of the glider, despite of the efforts of the glider pilot, the glider more likely was unable to touch down and overshot the field, and the glider contacted a tree.

For the glider pilot was on his first aerotow solo, had chosen a field with a slope unsuitable for a forced landing was probably due to lack of experience of the glider pilot.

- (c) When performing aerotow, glider pilot and tow pilot shall discuss flight course, emergency procedures, and aerotow speed limits at pre-briefing.
- (d) As the areas such as Aso and Kuju are mountainous areas, where the members of the Kyushu Institute of Technology normally fly, most of the out-landing sites would be slope, therefore on the importance of landing on an upslope shall be educated. A map of emergency landing sites confirmed on-site, and the approach procedures shall be provided.
