**AIRCRAFT ACCIDENT
INVESTIGATION REPORT**

CRASH DUE TO MID-AIR BREAKUP

PRIVATELY OWNED, GLASFLÜGEL 304CZ-17

(GLIDER, SINGLE-SEATER), JA21BB

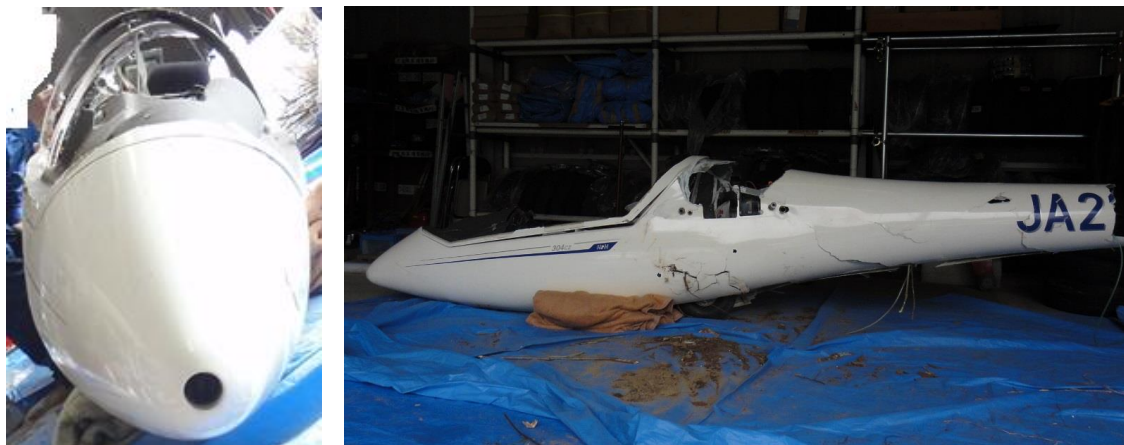
Photo D Nose section and forward fuselage

Nose section: Virtually undamaged

Windshield: Broken, fragments scattered around the accident site

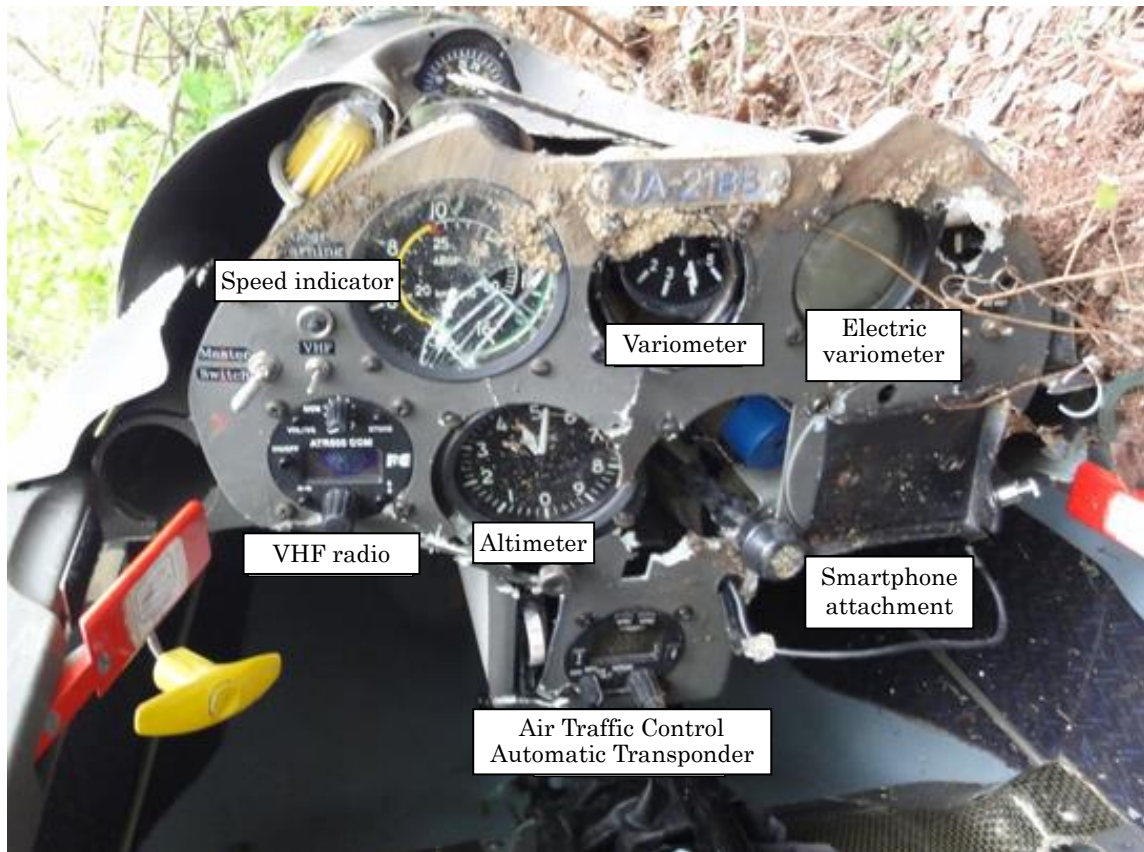
Photo E Instrument panel

Speed indicator: 0km/h indicated, Altimeter: 4,500m indicated, Variometer: rate of descent 4m/sec indicated, Electric variometer (with altimeter function displaying altitude in ft): No display, Instrument panel: Deformation damage

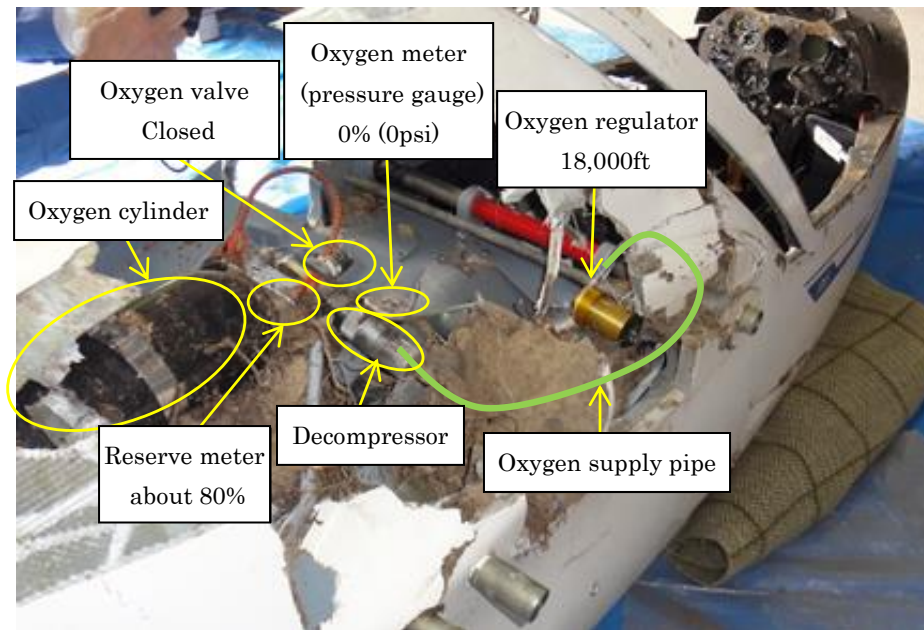
Photo F Oxygen supply equipment

Oxygen valve: Closed position, Oxygen cylinder reserve meter: about 80% (a state in which oxygen is ejected when the valve is opened), In-system oxygen meter (pressure gauge): 0% (0 psi), Oxygen regulator: 5th position^{*1}, Oxygen supply pipe: Oxygen supply pipe missing between decompressor and oxygen regulator, intranasal supply pipe worn by the pilot, portable oxygen device: Unused state

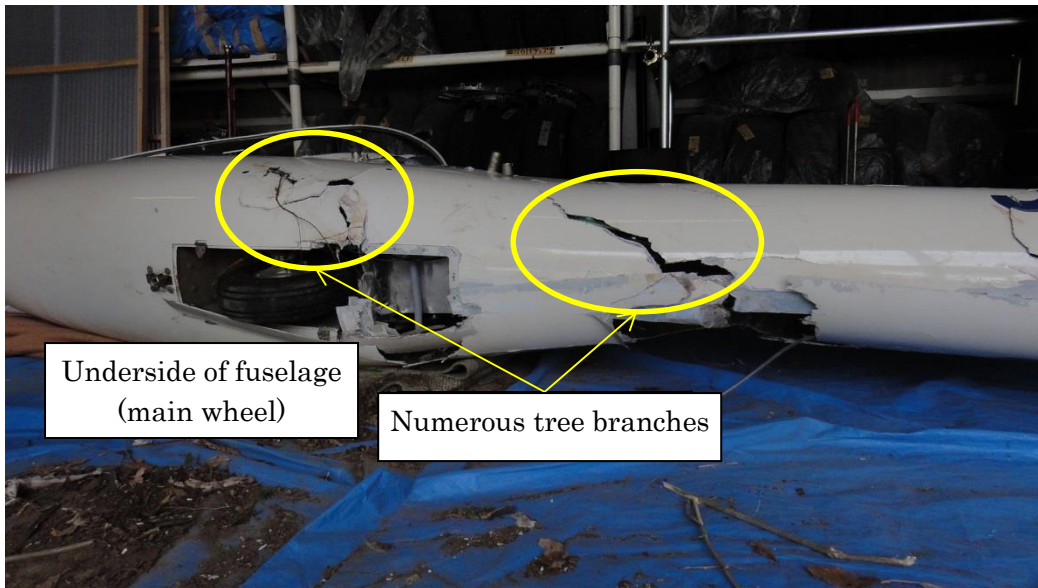
Photo H Underside of forward fuselage

- 4) Parachute
 - Worn but unused by the pilot
- (3) Underside of forward fuselage
 - Outer skin: Cracked, torn, twigs remaining
 - Inside landing gear wells: Pine branch and numerous twigs remaining

As described in 2.8.2 (3) above, there were cracks and breakage on the outer skin of the fuselage underside, and twigs were still remaining there. There was also a pine branch lodged inside the landing gear well.

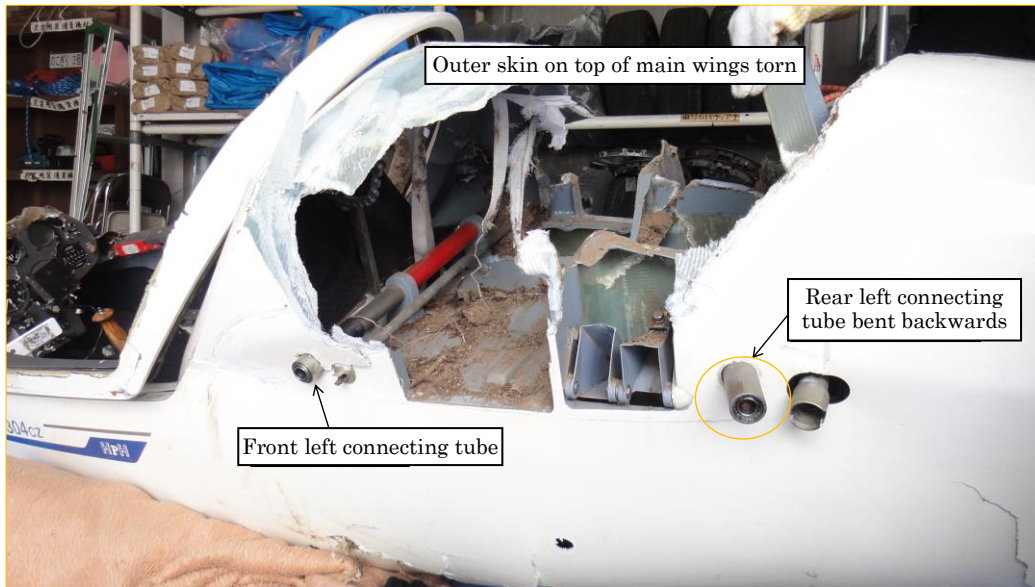
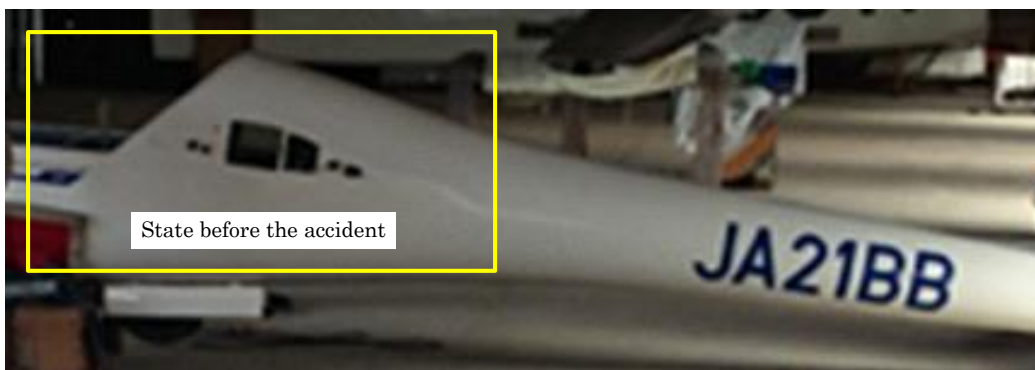
Photo J Joint between forward fuselage and main wings

Outer skin on top of forward fuselage at main wing joint torn off, whereabouts unknown; both main wings separated from joints, whereabouts unknown; one main wing connecting tube at rear left bent backwards.

Tail flight control system disconnected at break between forward and after fuselage.

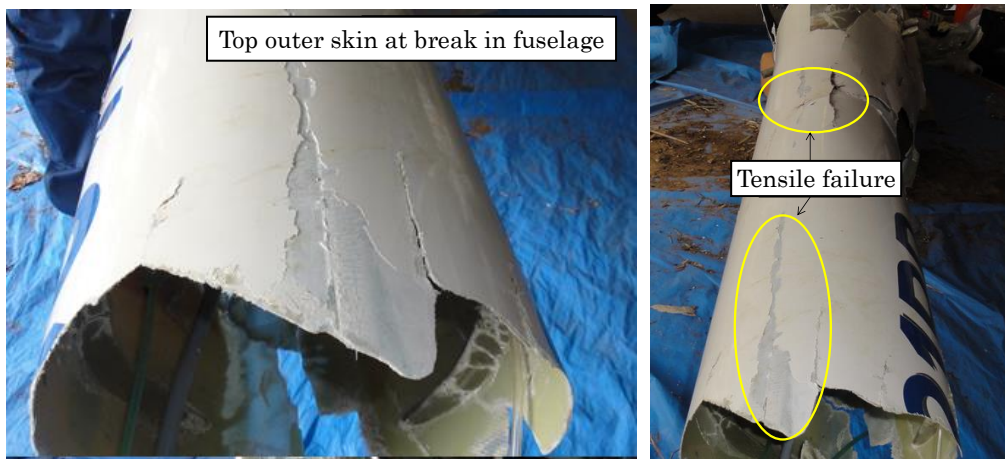
Photo M State of the upper forward fuselage

Although there was little damage to the top outer skin where the forward fuselage was broken, traces of damage caused by tensile load can be seen.

As described in 2.10.2.2 above, the top outer skin of the fuselage appears to have ruptured as a result of tensile load. In addition, parts that were whitened and damaged as a result of compression when the fuselage itself was crushed into an elliptical shape can be seen in the center of the reinforcing frame at the sides of the fuselage interior. The fuselage outer skin is badly damaged in a clockwise direction, accompanied by peeling in the surrounding area, and there are traces showing that the damage progressed from the outside to the inside.

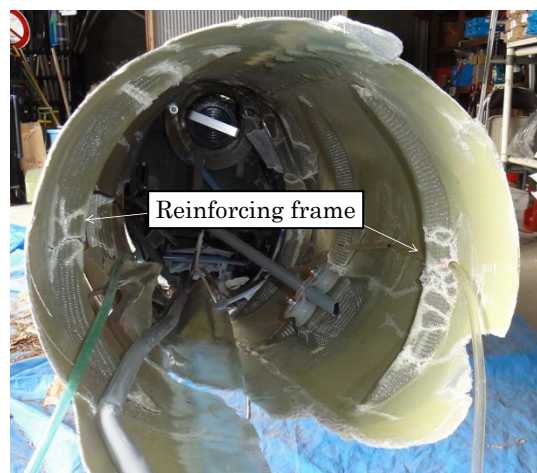
Photo N State of the outer skin at the break in the forward fuselage

Parts that were whitened and damaged as a result of compression when the fuselage itself was crushed into an elliptical shape can be seen in the center of the reinforcing frame at the sides of the forward fuselage interior.

The surface of the outer skin on the right side of the fuselage is badly damaged clockwise from around 3:00 to around 6:00 on the underside, accompanied by peeling in the surrounding area, and there are traces showing that the damage progressed from the outside to the inside.

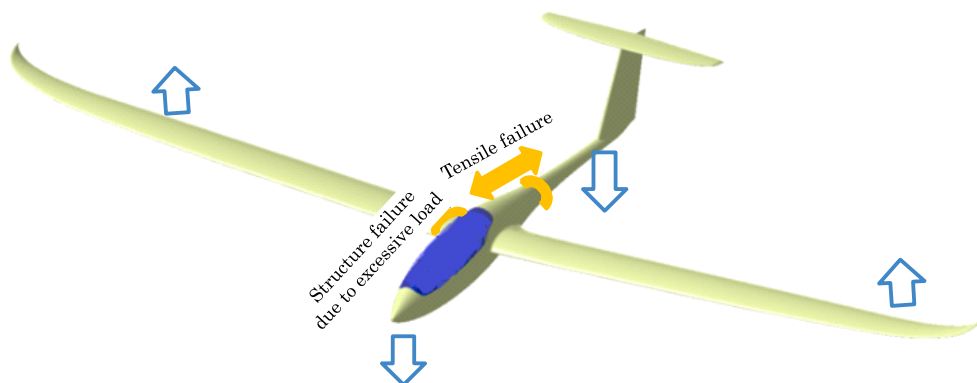
Diag. 6 State of damage

- (1) Excessive upward bending occurred in the main wings due to aerodynamic force, downward bending between the forward fuselage and the after fuselage including the tail (tension above, compression below) then occurred due to the resultant inertial force, a load exceeding the ultimate maneuvering load described in 2.11.2 (1) 3) was applied, the right wing stump (tongue) broke, and the right wing became separated from the Glider. Meanwhile, at the point when a large downward bending occurred in the Glider, the fuselage was subjected to bending compression, the center of the reinforcing frame inside the fuselage broke, and next the outer skin was torn from the top of the mid fuselage.

- (2) The loss of the right wing caused the Glider to roll in a clockwise direction, while the left wing slid out of the connecting tubes on the fuselage and became separated from the fuselage. At more or less the same time, the after fuselage including the tail became severed from the forward fuselage, accompanied by rupturing of the outer skin.
