AIRCRAFT ACCIDENT INVESTIGATION REPORT

January 15, 2026

Company	Nagano Gliding Association
Type, Registration Mark	Alexander Schleicher ASK21 (Glider, Two-Seater), JA21YP
Accident Class	Damage to the aircraft during landing
Date and Time of the Occurrence	At About 13:50 Japan Standard Time (JST: UTC+9 hours), October 26, 2024
Site of the Accident	Near Naganoshi Glider Site, Nagano City, Nagano Prefecture (36° 38' 20" N, 138° 15' 34" E)

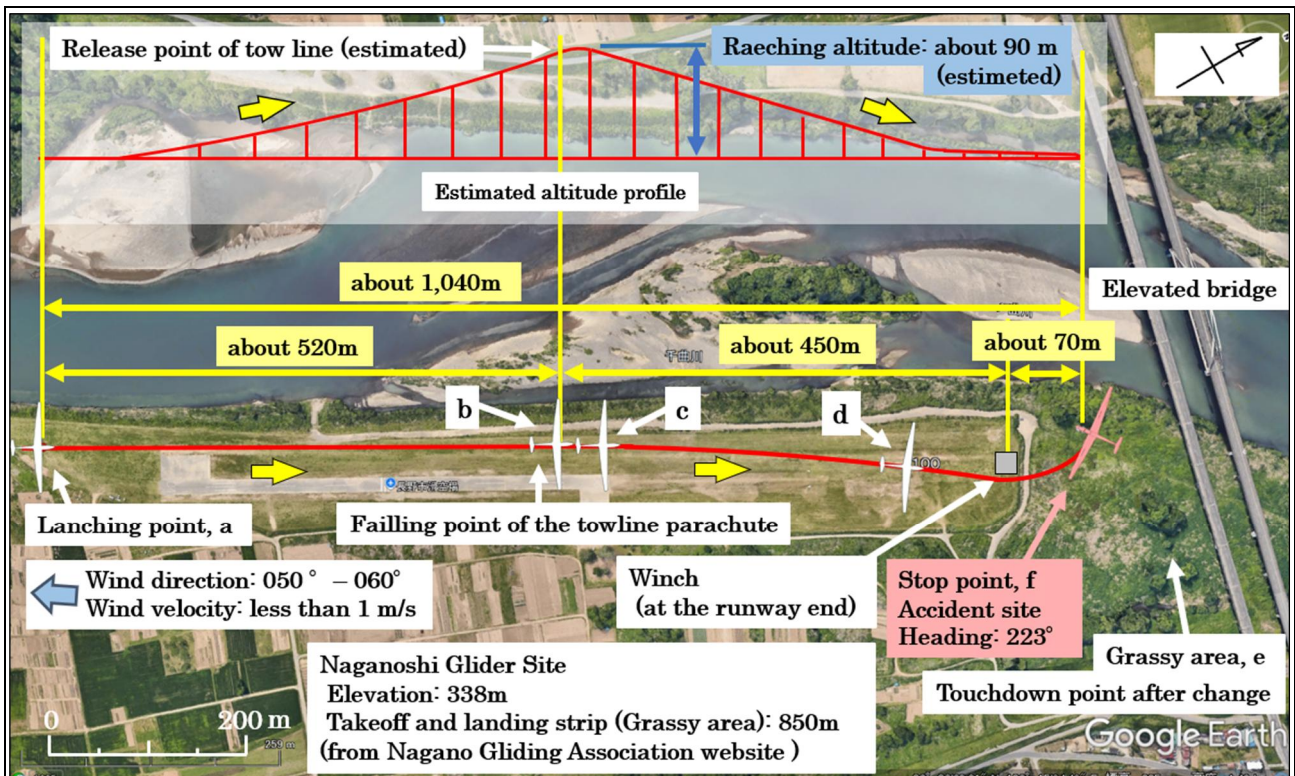
Figure 1: Estimated Flight Route

At 13:50, the glider was launched from Runway 04L at the Glider Site, with the instructor pilot seated in the rear seat and the trainee in the front seat, to conduct emergency operations training in preparation for losing the towing force of the winch (hereinafter refer to as “the winch power off”) at a low altitude (assumed during transition*¹) during winch launches (Figure 1, a.).

Shortly after the glider became airborne and established the climb attitude, the trainee realized that the winch had lost its towing force. The trainee therefore promptly restored the glider to a horizontal position and released the tow line (Figure 1, b.). At this time, the speed indicator showed about 90 km/h, and the altimeter showed about 430 m (about an altitude of 90 m the above ground level (AGL)).

After confirming the position of the runway end, the trainee extended the dive brakes and attempted to land on the runway. However, the instructor judged that using only the dive brakes would not enable the glider to decrease its altitude sufficiently to land within the runway, immediately took over control of the glider (Figure 1, c.).

Concluding that neither scenario would ensure the safety of the occupants, the instructor aborted the landing on the runway (Figure 1, d.) and changed the landing point to the grassy area (Figure 1, e.) located about 70 m northeast ahead of the runway.

When the glider glided over the runway and passed the runway end, the instructor made it turn left to avoid colliding with trees and plants in the grassy area (Figure 1, e.) and the elevated bridge ahead. However, as the left main wing was lowered during the left turn, it touched the trees and plants, causing the glider to touch down while rotating to the left. After skidding to the right, the right side of the nose collided with the trees and plants and the glider came to a stop (Figure 1, f.). Neither of the instructor nor the trainee sustained injuries.

The JTSB concludes that the glider was more likely to have released the tow line approximately over the parachute's falling point because the trainee let the glider release the tow line promptly after the winch winding was stopped and there was a calm wind at the time of the accident. Therefore, the runway remaining distance at the time the glider released the tow line was probably about 450 m, which is the distance from the parachute's falling point to the runway end (see Figure 1).

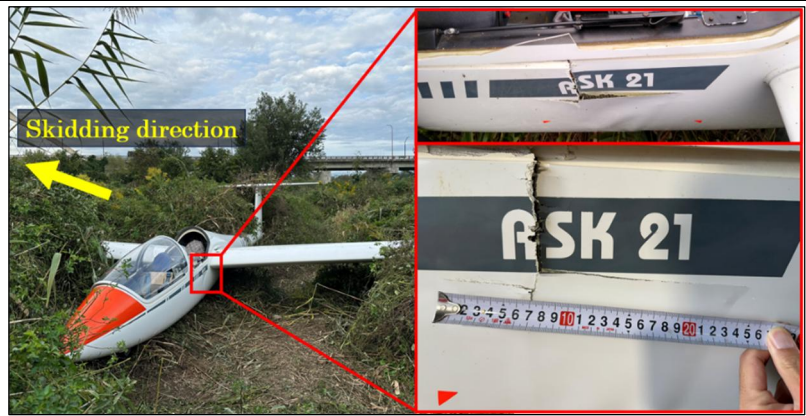
Figure 2: Main Damage to the Glider(left fuselage)

Substantial

- Cracks in the outer skin of the left fuselage (required major repair)
- Cracks in the leading edge of the left wing
- The rear seat canopy was broken.

The JTSB concludes that the glider most likely began to skid to the right after turning left and touching down, which resulted in damage to the glider due to the compression load applied to the outer skin of the left fuselage when the right side of the nose collided with trees and plants.

The JTSA concludes that the probable cause of the accident was that, during the winch power off training exercise, the glider most likely failed to land within the runway and touched down in the grass area ahead of the runway while turning left, which resulted in the glider colliding with trees and plants, causing damage to the outer skin of the left fuselage.

This training related to emergency operations and involved simulating situations in which the winch loses its towing force. Therefore, the training provider must specify the scope of the conditions under which aircraft can safely land on the runway at the Glider Site. In addition to this, the training provider should provide regular education and training to their instructors, enabling them to deliver training within the scope of the specified conditions.

- The association has decided to define the scope of the conditions under which aircraft can safely run straight and land within the current effective valid runway length, and to inform their instructors about these conditions through regular training.
- To standardize the content of the instructions, the association's instructors confirmed the training content with one another.
- The association stipulated that during training exercises simulating emergency situations at low altitudes, the instructors should determine the timing of releasing from the winch.
