**AIRCRAFT ACCIDENT  
INVESTIGATION REPORT**

**J A 2 2 N E**

**Japan Transport Safety Board**

PRIVATELY OWNED  
ROBINSON R22 BETA (ROTORCRAFT), JA22NE  
KAMOTO-MACHI, YAMAGA CITY, KUMAMOTO PREFECTURE, JAPAN  
AROUND 14:01 JST, AUGUST 1, 2010

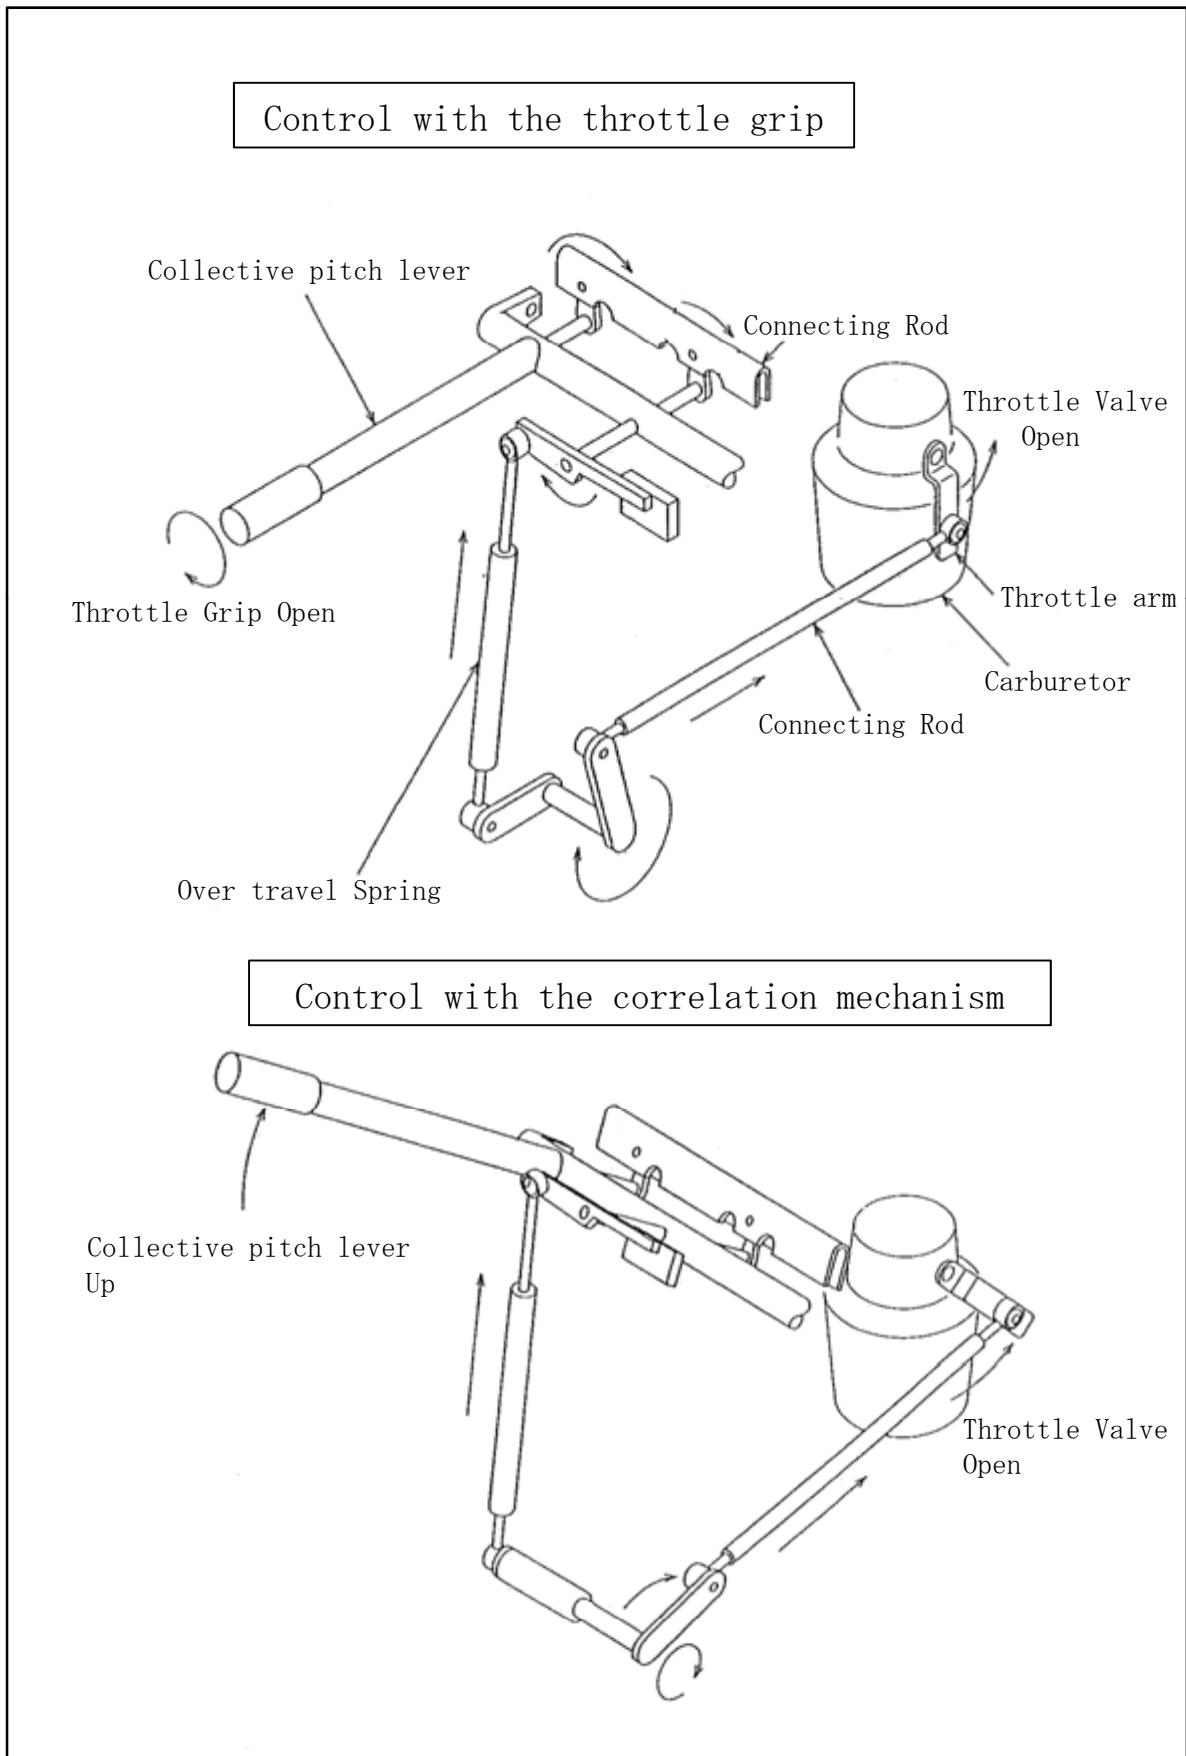
Figure 5 The Throttle Valve Control

- a. There was no major damage in the appearance, but the throttle valve control was stuck at the lower part of the left seat and the throttle arm was jammed.

- a. Under a condition of the engine not running and the C/P set almost in the full down position, cross examined helicopter's throttle grip was opened to a confirmed throttle arm position of the Aircraft. The position proved to be about 50% full open position
- b. Under a condition of engine running and the C/P set almost in the full down position, above mentioned condition was recreated with the throttle grip turning. The engine RPM was about to exceed the limit of 104 %, indicating that the throttle position is beyond the operational range.
- c. Under a condition of engine running and the C/P set almost in the full down position, the C/P was gradually pulled up from the full down position letting the linkage mechanism to open the throttle until the throttle arm position corresponds to that of the Aircraft.

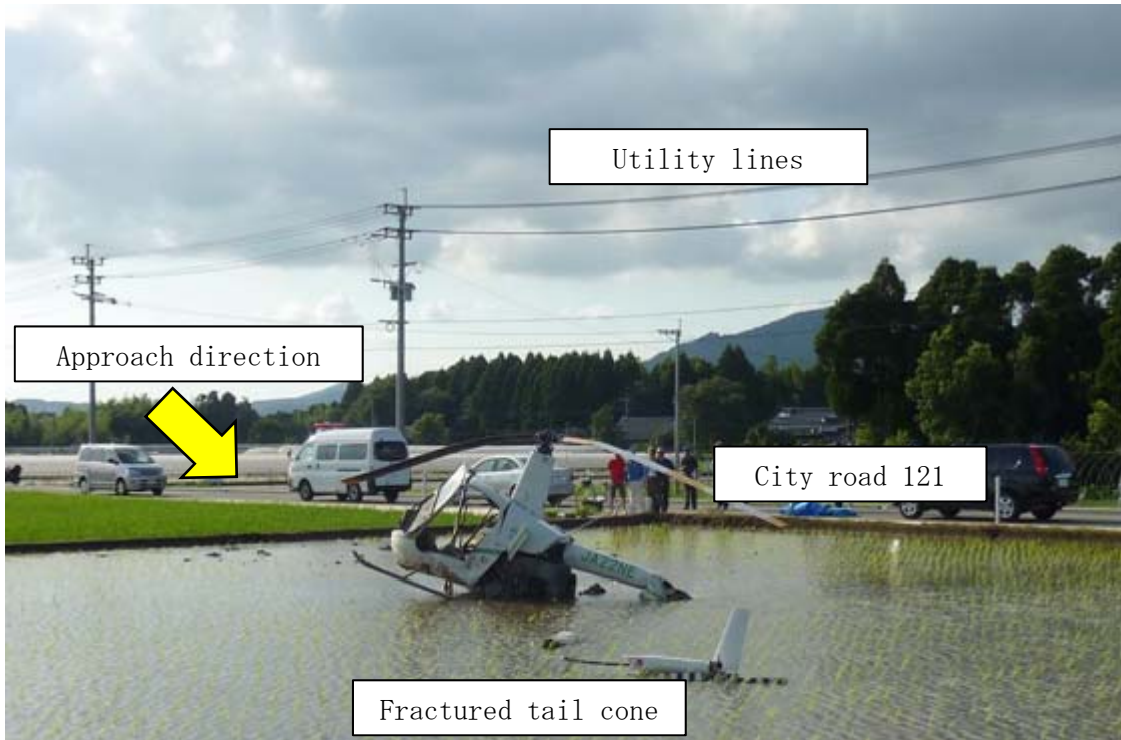
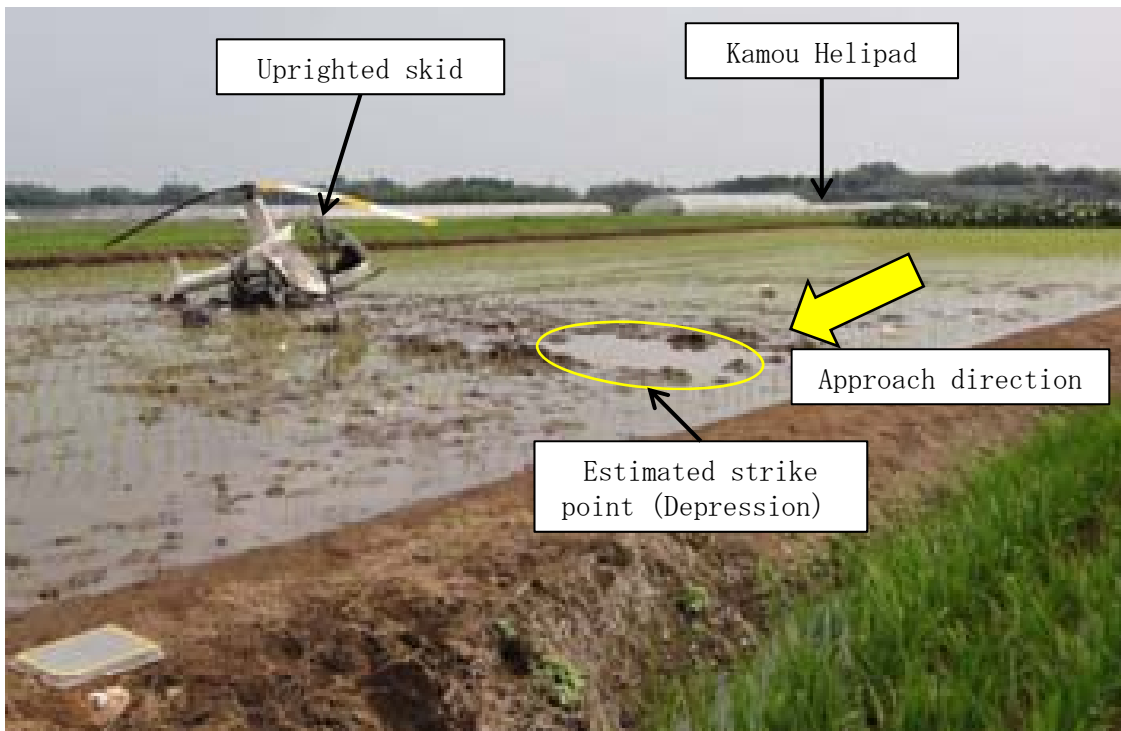
Photo 1 Accident Site

This accident occurred at a paddy field about 160 m north of Kamou Helipad (Latitude 33°00'54" N and Longitude 130°44'03" E) at about 14:01.

The tail cone and the TR, which had been fractured, were found at a place about 6 m from the aircraft on an extended line drawn from the depression, while small pieces of broken components were found around the aircraft. .

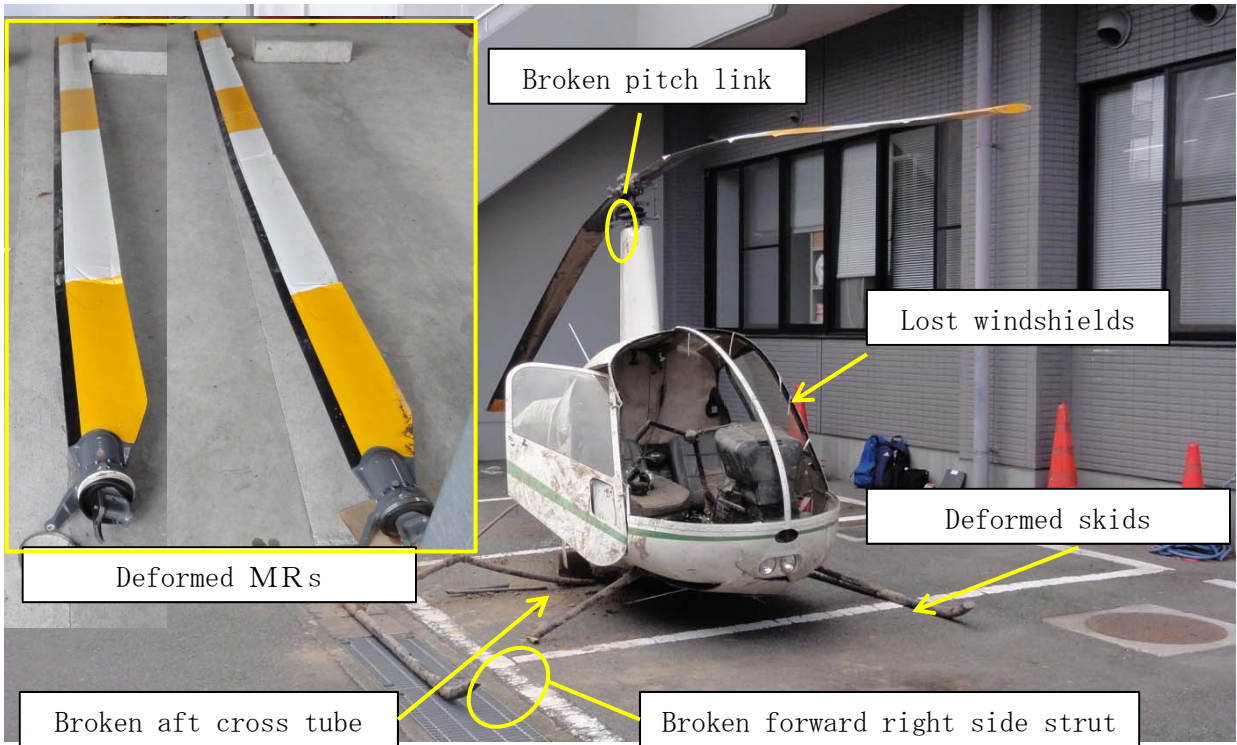
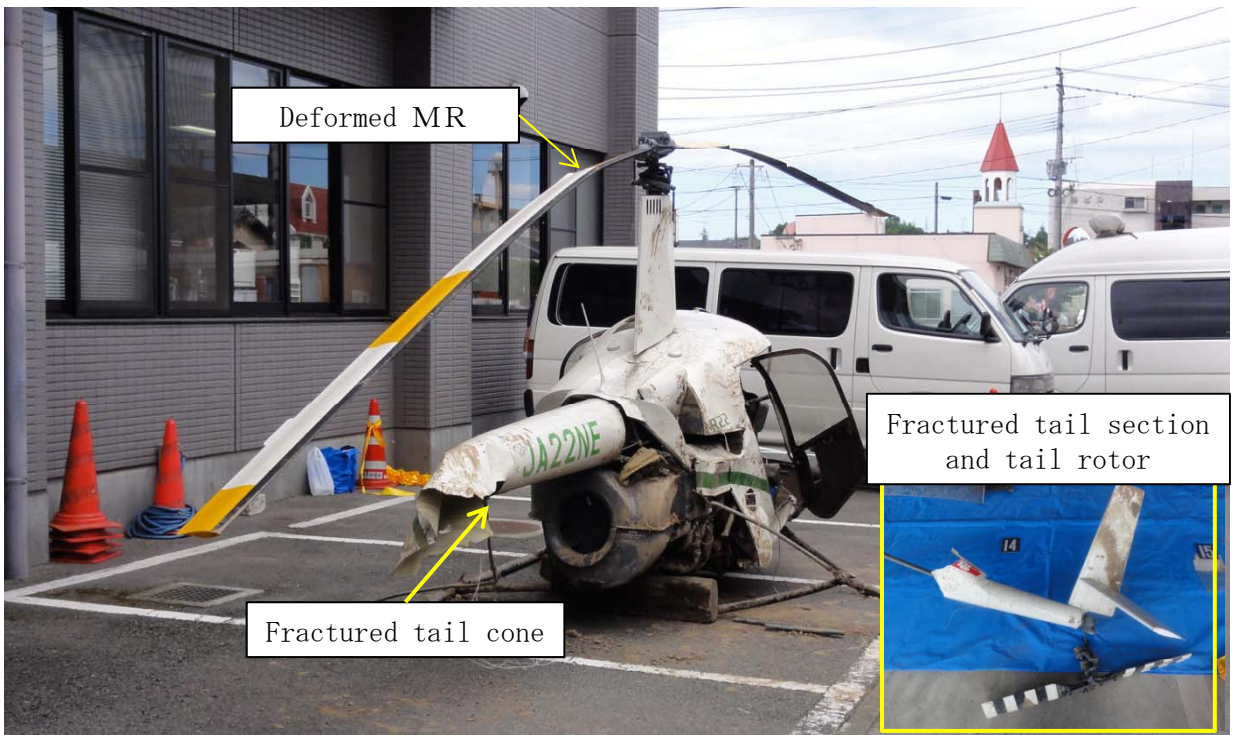
# Photo 2 Accident Aircraft (Overview)

The forward cross tube\*<sup>2</sup> was stuck in the bottom of the fuselage and deformed, while the aft cross tube was found fractured in its middle area. The two skids were widened apart.

The right skid was fractured at the joint with the forward strut and was upright pivoting around the joint with the aft strut.

It is considered highly probable that damage to the Aircraft in all areas affected, as described in 2.3.2 and 2.7.2, had been caused by force applied from the outside under the circumstances mentioned below upon the crash of the Aircraft, because no pre-impact anomalies were seen in the Aircraft.

Judging from the condition of damage to the Aircraft, it is considered highly probable that the Aircraft crashed into the ground from its right side while slightly lowering the nose, with the MR RPM greatly decayed and its fast speed kept horizontally and vertically.

It is considered highly probable that the stuck forward cross tube into the bottom of the fuselage, the fractured aft cross tube and the widened skids were all caused by a load applied vertically to the airframe at the time of the crash.

It is considered highly probable that the fracture of the skid on the right side in the joint with the forward strut and its pivoting around the aft joint with the strut was caused by a load applied horizontally when the Aircraft struck the ground from its right side with the nose slightly lowered.

It is considered highly probable that the tail cone was bent downward slightly to the right with a vertical load applied to the airframe when the Aircraft hit the ground from its right side with the nose slightly lowered, and it was fractured and detached as if torn off forward with a horizontal load applied and as a result, the tail cone was thrown away forward to a place about 13 m from the depression which is believed to be the first strike point with the ground.

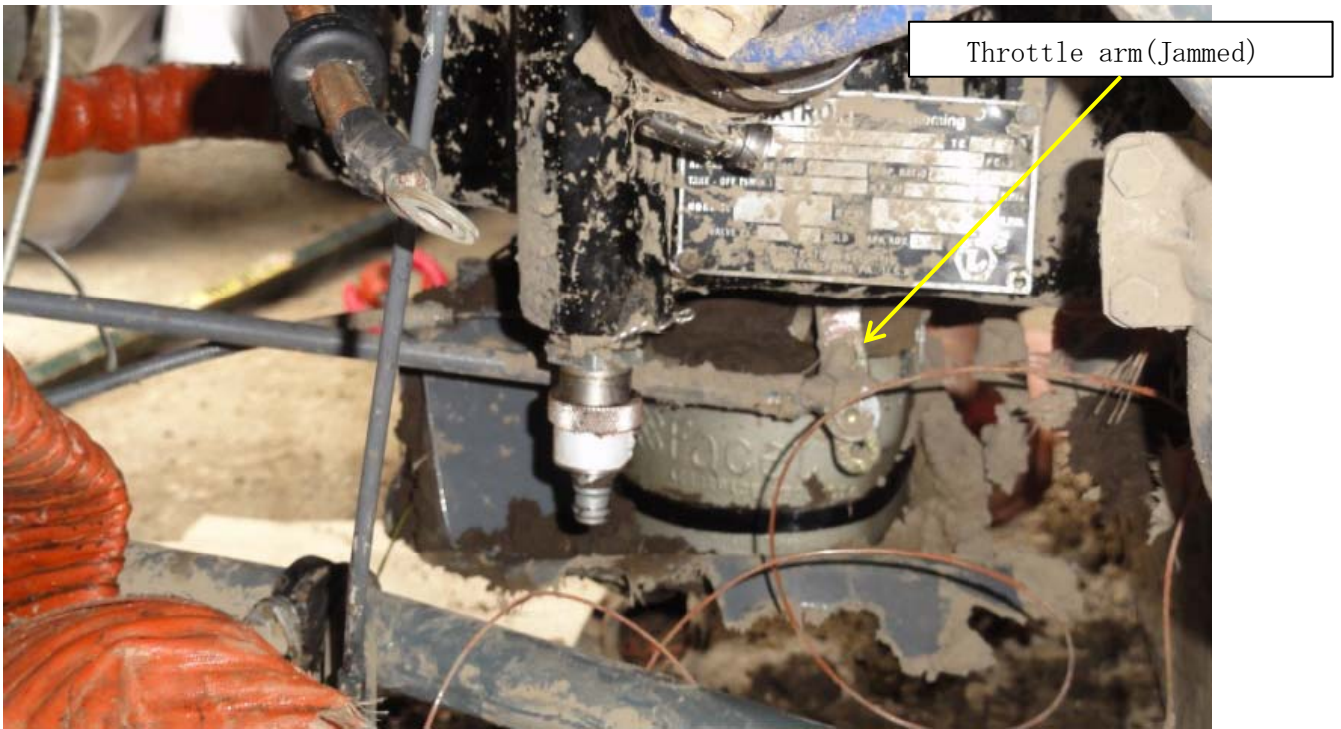
Photo 3 Accident Aircraft  
(Engine)

- d. The lower ignition plugs of four cylinders exhibited healthy electrode condition and they were in dry condition, however, grains of muddy powder were in the plugs.

a. It is considered probable that the driving belts of the Aircraft had been detached from the clutch assembly due to an impact on the crash. It is also considered probable that an engine over speed running had occurred because the engine became free from the MR and TR load. Judging from the condition of the ignition plugs and the intake and exhaust
