**AIRCRAFT ACCIDENT
INVESTIGATION REPORT**

**WASEDA UNIVERSITY
J A 2 2 W P**

CRASH DUE TO STALL
OIZUMI TOWN, OURA-GUN, GUNMA PREFECTURE
AT AROUND 15:14 JST, OCTOBER 10, 2016

WASEDA UNIVERSITY
ROLLADEN-SCHNEIDER LS4-B
(GLIDER, SINGLE SEATER), JA22WP

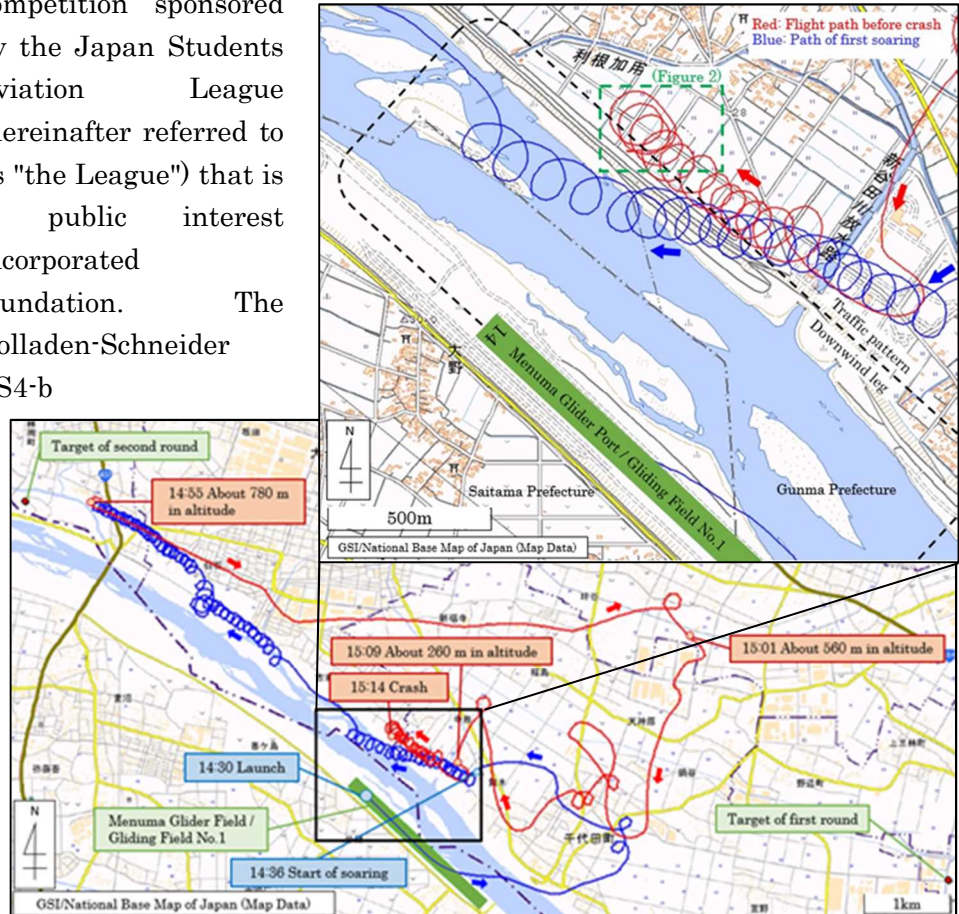
Figure 1: Estimated Flight Route

(hereinafter referred to as "the Glider") controlled by the Pilot released the towline at the pressure altitude of about 500m. In the competition, a pilot had to control his/her glider along the airfield traffic pattern to compete for the flight distance and time. At 14:36, the Glider started soaring at around 1km northeast of the Gliding Field and flying northwestward while climbing by riding the thermal (See blue line in Figure 1).

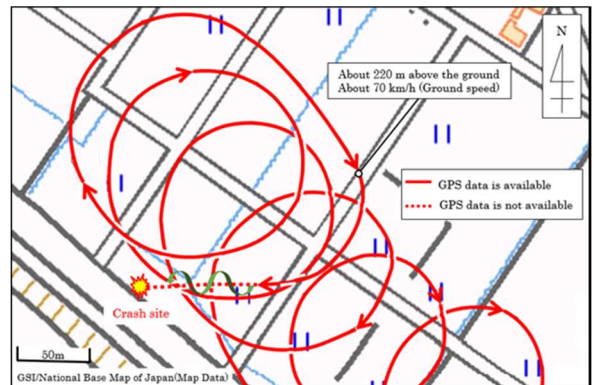
Figure 2: Enlarged View of Figure 1

<p>the weather conditions to turn for the better.</p> <p>Two of the gliders landed earlier than the Glider. The Pilot reported the Field Flight Operations over the radio that he was going to land next to these two gliders and made the right circle at about 220m above the ground and at the ground speed of about 70km/h in order to enter the downwind leg. The bank angle of the right turn was steep; the nose of the Glider dropped; and the Glider went into a nosedive. At the end of the right circling, the Glider nose was lifted up a little and it seemed that the Glider recovered its normal attitude. However the Glider nose dropped heavily, and went into a nosedive again. The Glider went into the left spin and crashed after spinning about 2.5 times.</p> <p>The Accident occurred at Oizumi Town (Latitude 36°13'21"N and Longitude 139°24'57"E), Oura-Gun, Gunma Prefecture at around 15:14 on October 10, 2016.</p>
