**AIRCRAFT SERIOUS INCIDENT
INVESTIGATION REPORT**

**OKAYAMA GLIDER CLUB
J A 2 3 3 0**

CONTINUED HALT OF POWER OF ENGINE DURING FLIGHT

SCHEIBE SF25C FALKE (MOTOR GLIDER, TWO-SEATER)

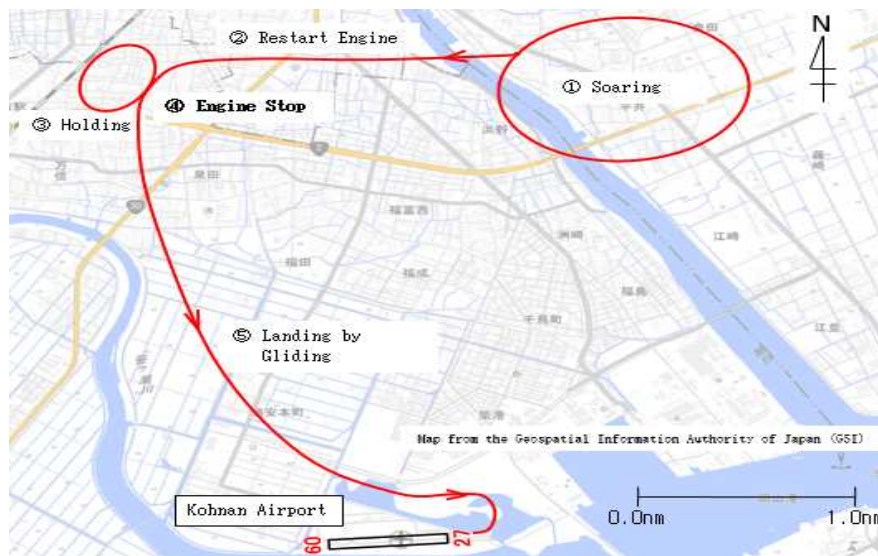
Figure 1 Estimated Flight Route

This serious incident occurred at about 15:10(I) on February 12, 2017, at the point with an altitude of about 2,000ft, about 3nm northwest of Kohnan Aerodrome (34° 38' N, 133° 54' E).

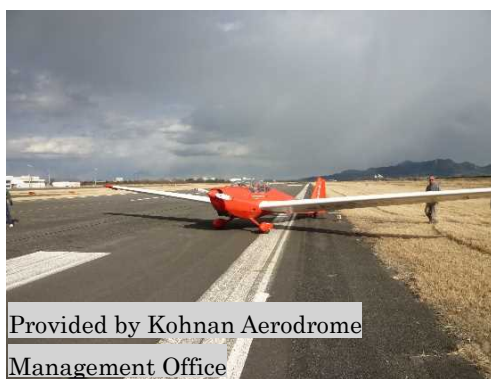
Photo 1 The aircraft after landing

1.1 Summary of the Serious Incident	<p>On Sunday, February 12, 2017, Scheibe SF25C Falke, registered JA2330, operated by Okayama Glider Club, landed on Kohnan Aerodrome by gliding and halted on a runway, because its engine halted while flying over Okayama City and was unable to restart.</p>

In this serious incident, it is highly probable that the engine halted and could not restart due to the carburettor icing occurrences during the flight of the aircraft.

As for the reason of occurrences of the carburettor icing, it is probable that the carburetor heater was not used while the aircraft executed descent by idling at the low oil temperature, was holding at the airspace of serious carburettor icing risk.

- (1) Recheck the club rules and the flight manual relating use of the carb-heat, engine halt and restart.
- (2) Inform all relevant parties about additional instructions concerning the restart of engine.
- (3) Promote to use the check sheet to check items for the confirmation by the captain before departure.
- (4) Revise the checklist.
- (5) Revise the syllabus for training.

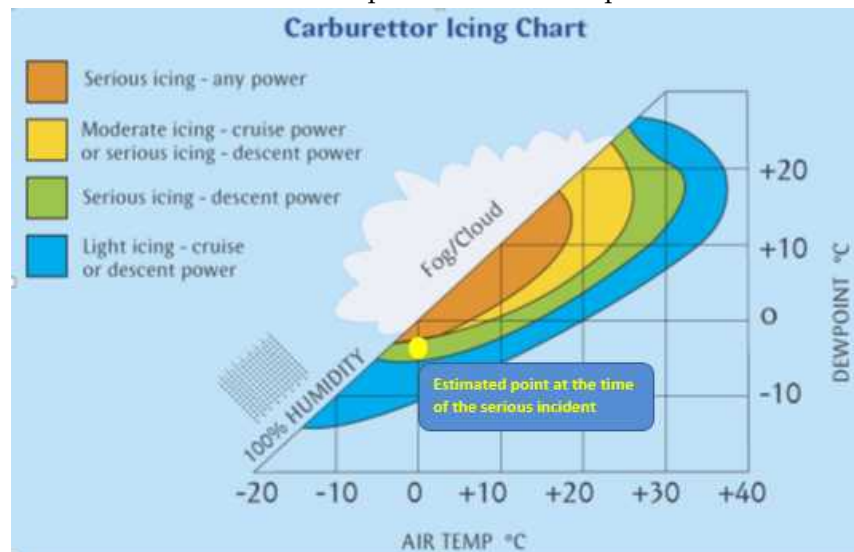
Figure 2; Carburettor Icing Chart (partially revised)

Civil Aviation Authority of New Zealand has introduced “Carburettor Icing Chart” which is able to predict an occurrence of the carb-ice based on outside temperature and dew point.
