AI2022-8

**AIRCRAFT SERIOUS INCIDENT
INVESTIGATION REPORT**

A SITUATION WHERE A PILOT IN COMMAND OF AN AIRCRAFT
DURING FLIGHT RECOGNIZED A RISK OF COLLISION OR
CONTACT WITH ANY OTHER AIRCRAFT

OVER THE WEST TRAFFIC PATTERN OF MENUUMA GLIDING
FIELD, KUMAGAYA CITY, SAITAMA PREFECTURE

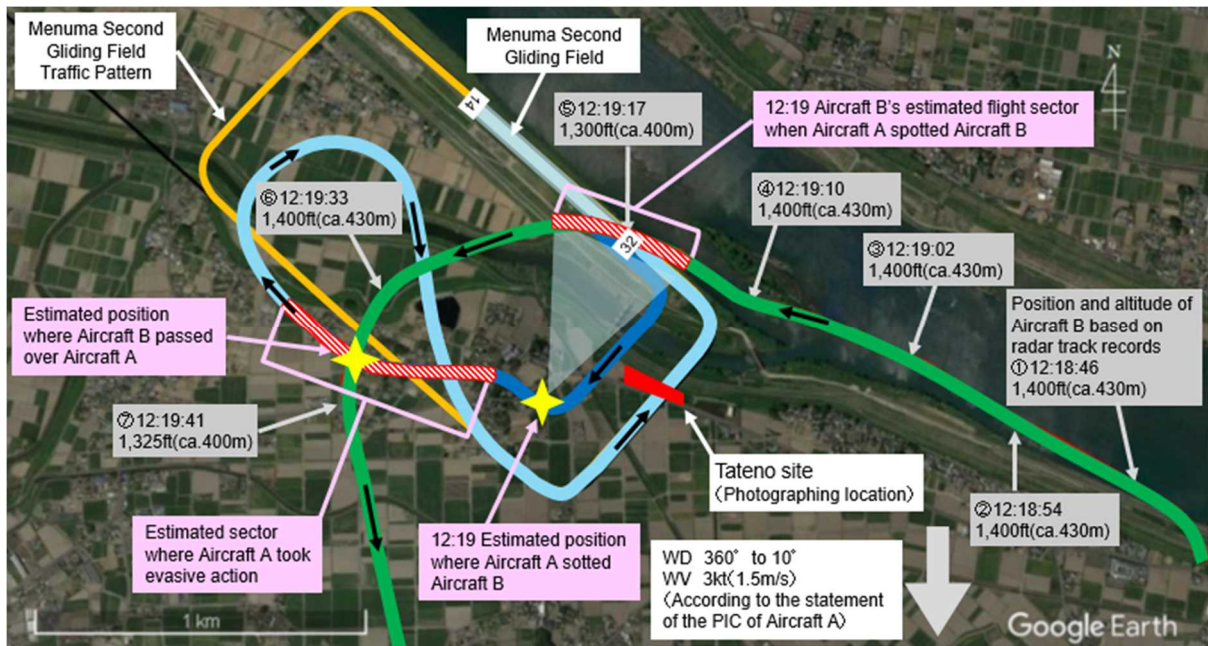
Figure 2: Estimated flight routes and relative positions of both aircraft

The PIC of Aircraft A and the trainee stated that they spotted Aircraft B immediately before finishing to turn from the crosswind to the downwind (the second turn) (see Figure 2). The JSTB concludes that the reason why they were unable to visually confirm Aircraft B until then was because, it was more likely invisible in the horizontal direction due to the large climb angle when Aircraft A was climbing immediately after the launch, and the interval between the time Aircraft A leveled off and the time it made the first turn was too short to find Aircraft B.

The JSTB concludes that based on the estimated positions of both aircraft (see Figure 2) when Aircraft A had finished turning from the crosswind to the downwind, the horizontal distance between the two aircraft at this moment was most likely about 600 m. After that, it is more likely

Besides, the flight altitude of Aircraft A was highly probable about 330 m until Aircraft A took evasive action after it had spotted Aircraft B. On the other hand, the altitude of Aircraft B was most likely about 400 m when the PIC of Aircraft A found Aircraft B, then once after Aircraft B climbed to about 430 m, its flight altitude was most likely about 400 m when it passed over Aircraft A, and during this time, the altitude difference between both aircraft was about 70 m.

After spotting Aircraft A, the PIC of Aircraft B continued to fly toward the photographing location while seeing Aircraft A left below because Aircraft A appeared to be descending and did not seem to climb, he thought. On the other hand, the PIC of Aircraft A took evasive action after finding Aircraft B, however, probably this is not because he intended to avoid imminent danger but it was a preventive evasive action as he felt uneasy about the unpredictable movement of Aircraft B without any traffic information about it.

Besides when PIC of Aircraft A found Aircraft B, it is most likely that the horizontal distance between both aircraft was about 600 m, the vertical distance between them was about 70 m, and when Aircraft B passed over Aircraft A, the altitude difference between them was about 70 m.
