# AIRCRAFT SERIOUS INCIDENT INVESTIGATION REPORT

| <b>Type,<br/>Registration<br/>Mark</b> | Grob G109B (Motor Glider, Two-Seater), JA2416 |
| <b>Incident Class</b> | Dragging during landing of an engine cowl and any other part of the aircraft other than the landing gears<br>Item (iii), Article 166-4 of the Regulation for Enforcement of the Civil Aeronautics Act of Japan |
| <b>Date and Time<br/>of the<br/>Occurrence</b> | At about 14:04 Japan Standard Time (JST: UTC+9 hours), May 5, 2024 |

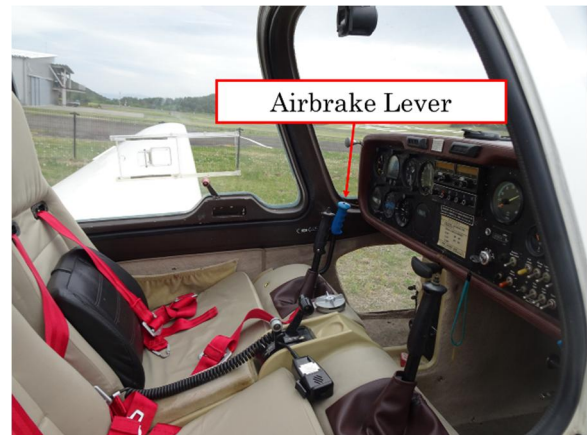
Figure 1: Airbrake Lever

| Once convincing that reaching the runway was possible, the captain set the engine power to idle, initiated the descent and unlocked the lever of airbrakes*2 (see Figure 1) to deploy the airbrakes. Considering sudden speed loss caused by fluctuating winds, the captain made an approach at 70 kt, which was 8 knots faster than usual. | |

However, during the final approach, the glider was blown by the wind and lost altitude. Therefore, the captain retracted the airbrakes, moved the airbrake lever to the locked position, increased the engine power and regained altitude. As the altitude returned to the captain's desired descent path, the captain unlocked the airbrake lever, and deployed the airbrakes to continue the approach.

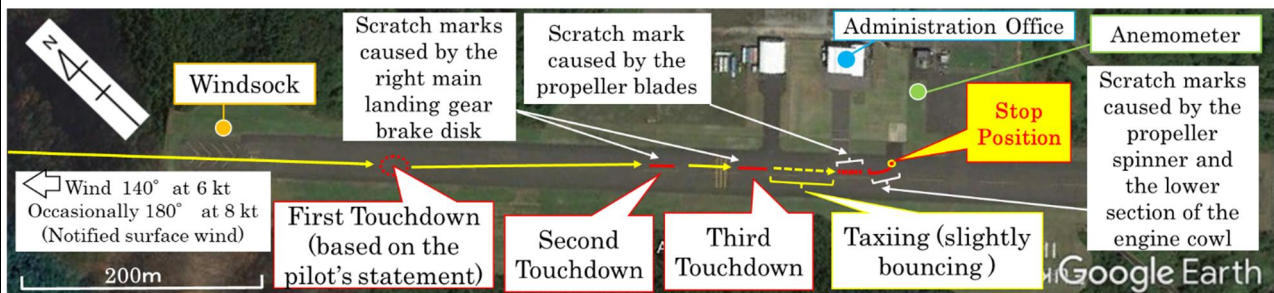
Figure 2: Estimated Flight Route and Runway Conditions

The captain turned off the ignition switch and the fuel shutoff valve. The location where the glider came to a stop was about 540 m southeast of the threshold of Runway 14 and about 5 m northeast of the runway centerline.

The following scratch marks were confirmed on the runway (Figure 2).

- Second touchdown: Scratch marks caused by the right main landing gear brake disk (about 435 cm long)
- Third touchdown: Scratch marks caused by the right main landing gear brake disk (about 520 cm long)
- After the small bounce: Seven scratch marks caused by the propeller blades (about 40 to 80 cm apart and about 300 cm long)
- Immediately before the stop: One scratch mark caused by the propeller blades, and scratch marks caused by the propeller spinner and the lower section of the engine cowl

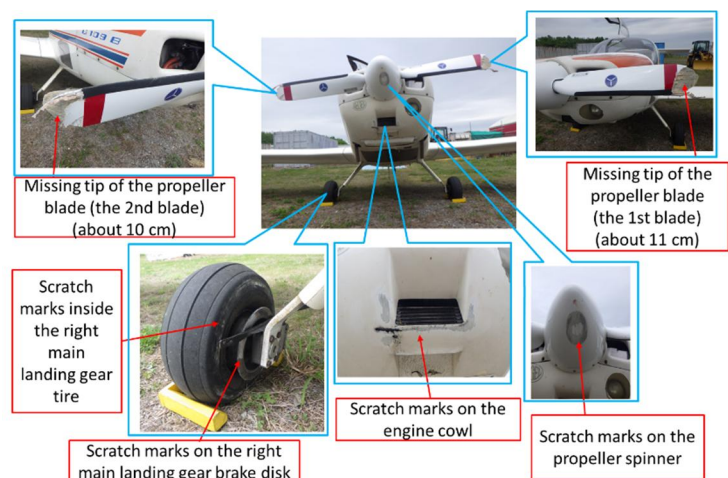
Figure 3: Damage to the Glider

Minor damage (Figure 3)

- Scratch marks on the right main landing gear brake disk
- Scratch marks inside the right main landing gear tire
- The tip of the propeller blade (the 1st blade) was missing (about 11 cm)
- The tip of the propeller blade (the 2nd blade) was missing (about 10 cm)
- Scratch marks on the propeller spinner
- Scratch marks on the engine cowl

It is most likely that as the glider's brakes were applied too hard at insufficiently reduced speed during the landing roll, locking the tires of the main landing gear and causing the aft fuselage to lift and the glider to tilt forward and nose over, then its propeller blades then touched the runway, followed by the propeller spinner and the lower section of the engine cowl.

The JTSCB concludes that the probable cause of this serious incident was that it is most likely that as the glider's brakes were applied too hard during the landing roll, locking the tires of the main landing gear and causing the aft fuselage to lift and the glider to tilt forward and nose over, then its propeller blades touched the runway, followed by the propeller spinner and the lower section of the engine cowl.

As shown in ANALYSIS, a tailwheel airplane should be brought to a full stop after the speed has been sufficiently reduced.

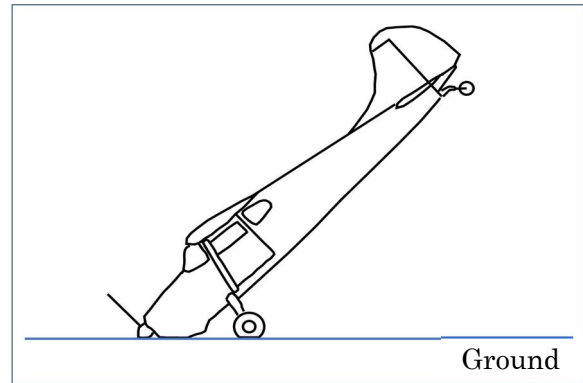
Figure 4: Nose Over

Differing from tricycle-gear airplane where the nose-wheels are located ahead of the main landing gear, tailwheel airplane where tailwheels are located behind the main landing gear tend to make a nose over, where the airplane's aft fuselage floats, the airplane tilts forward, and its nose touches the ground, when the brakes are applied hard at high speed, as shown in Figure 4.

A tailwheel airplane should be brought to a full stop after the speed has been sufficiently reduced.
