AIRCRAFT ACCIDENT INVESTIGATION REPORT

Company	Corporation
Type, Registration Mark	Alexander Schleicher ASK13 (Glider, Two-Seater), JA2469
Accident Class	Trainee pilot injury due to hard landing
Date and Time of the Occurrence	At About 11:31 Japan Standard Time (JST:UTC+9hours), July 14, 2024
Site of the Accident	On the Runway Strip at Kitami District Temporary Operation Site, Kitami City, Hokkaido Prefecture (43° 46' 48" N, 143° 43' 51" E)

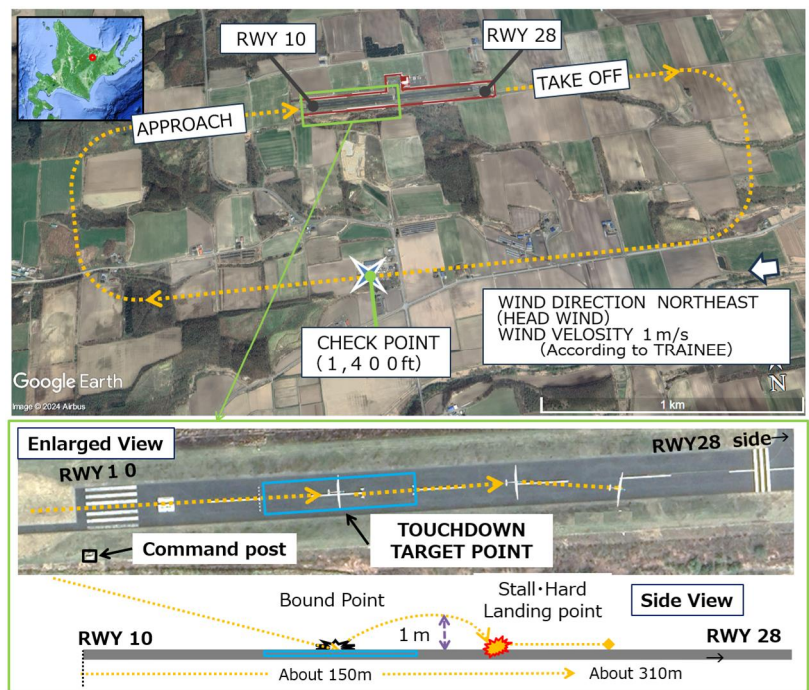
Figure1 Flight overview

At approximately 11:31, when the glider flew at an airspeed of approximately 100 km/h and touched down at the touchdown target point, which was located approximately 150 m from the threshold of Runway 10, it bounced, floated approximately 1 m, then made a hard landing, landing roll to a position approximately 310 m from the threshold of Runway 10, and came to a stop.

The JTSCB concludes that if the glider was bouncing and floating at the time of the touchdown, the recovery maneuver to regain its attitude should have been to close the dive brakes and hold the stick until the glider started to sink again, then flare it again as it descended, however, it is most likely that as the trainee pilot kept the nose of the glider up, the angle of attack gradually increased and the glider made a hard landing from a height of about 1 meter, injuring the trainee pilot.

The JTSB concludes that the probable cause of this accident was that when the glider bounced and floated at the time of the touchdown, the trainee pilot most likely kept the nose of the glider up without performing the recovery maneuver, causing the angle of attack to gradually increase and the glider to make a hard landing from a height of about 1 meter, resulting in the injury to the trainee pilot.

Flight instructors who certify solo flying skills must ensure that the skills and knowledge they have taught are steadily improved.
