AIRCRAFT ACCIDENT INVESTIGATION REPORT

CRASH

PZL-BIELSKO SZD-55-1(GLIDER, SINGLE SEATER), JA2502

AT ABOUT 13:19 JST, APRIL 9, 2023

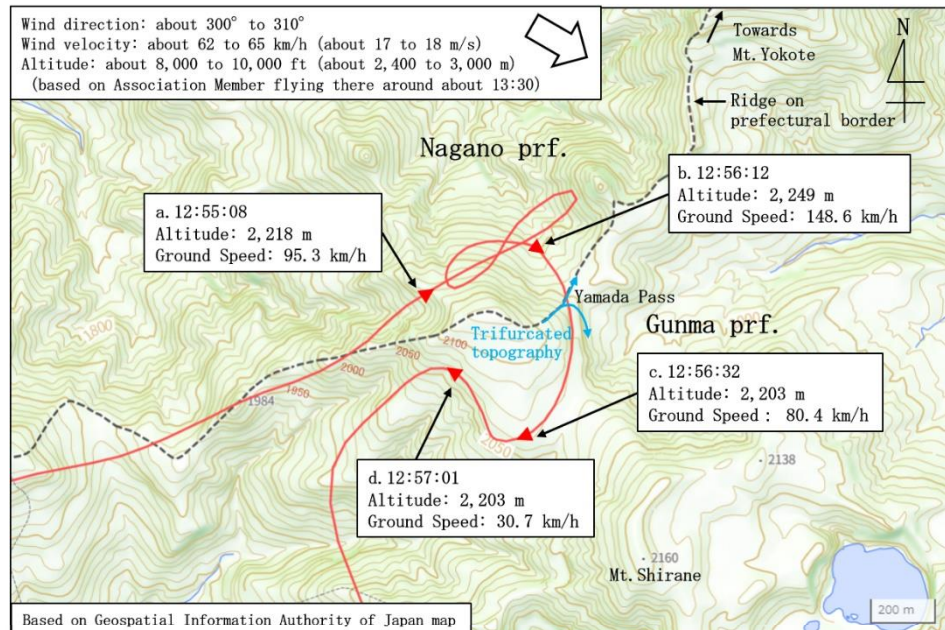
Figure 3: Estimated Flight Route at the Time of Crossing the Prefectural Boundary (based on the GPS records of the pilot's smartphone)

to the lee side of the ridge is possibly because the pilot misjudged the topography of the ridge. Factors contributing to the pilot's misjudgment of the topography of the ridge were possibly the trifurcated topography of the ridge, which made it difficult to identify the ridge at the prefectural boundary, and the pilot's insufficient experience of flying near Mt. Yokote and Yamada Pass (Figure 3 and 2.7 (7)).

The glider then made a right turn to return the windward side of the ridge and was flying with its nose to the north-west when the glider's IAS (estimated using the procedure in 2.7 (11)) was more likely to have dropped rapidly from about 108 km/h (c. in Figure 3) to about 84 km/h (d. in Figure 3). In addition, as the altitude AGL between the glider and the nearby ridge was probably about 100 to 250 m (d. in Figure 3), it is more likely that the pilot judged that the glider's airspeed and AGL were insufficient to cross the ridge, once gave up on returning to the windward side of the ridge and flew downwind with the nose to the lee side.

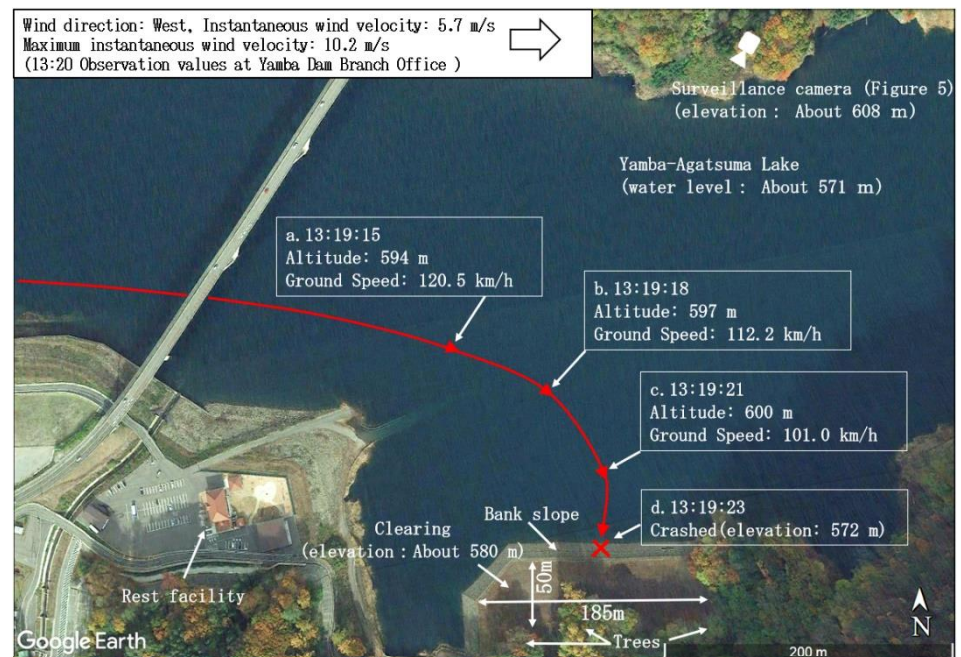
Figure 4: Estimated Flight Route near the Accident Site (based on the GPS records of the pilot's smartphone)

It is probable that eight seconds before the crash, the glider's IAS was about 97 km/h (estimated using the procedure in 2.7 (11)), and its AGL (the altitude above the water surface) was about 23 m (a. in Figure 4). The glider then probably climbed slightly while continuing a right turn (b. in Figure 4).

It is more likely that about two to three seconds before the crash, the glider's IAS was about 90 km/h (estimated using the procedure in 2.7 (11)), its AGL (the altitude above the water surface) was about 29 m, and the bank angle was increasing to the right from about 45° to almost 90° (c. in Figure 5). At the weight of the glider (307.8 kg) at the time of the accident, if the bank angle exceeded about 56°, the glider likely stalled (2.7 (9)) because the stall speed of the glider exceeds about 90 km/h IAS.

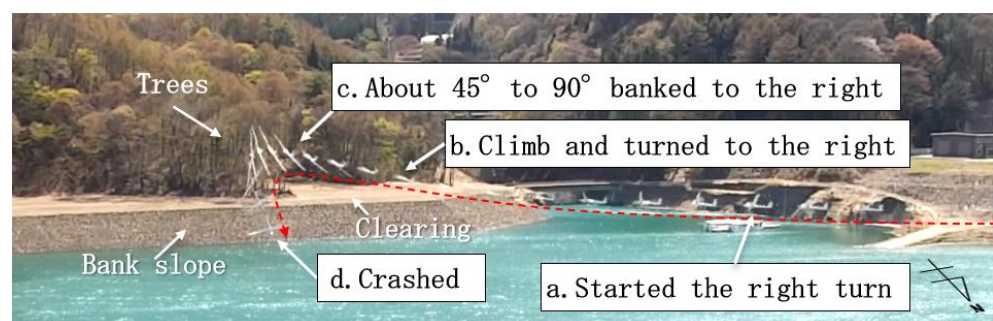
Figure 5: Continuous Synthesized Photo from Surveillance Camera Video Taken at the Time of the Crash (at 0.4 second intervals).
 (a. to d. in this Figure correspond to those in Figure 4)

The JTSCB concludes that as the glider had made a turn with its nose towards a clearing near the accident site while flying close to the accident site, it is likely that the glider found the clearing and attempted an off-field landing at the clearing (Figure 4). It is possible that while the glider was making a right turn at a low altitude and attempting to land at the clearing without securing the straight final approach path, the pilot spotted the trees which could be an obstacle immediately before the off-field landing and made excessive corrections to avoid the trees, causing the glider to stall, spin, and crash from the nose into the bank slope in an inverted position with no recovery due to the low altitude.

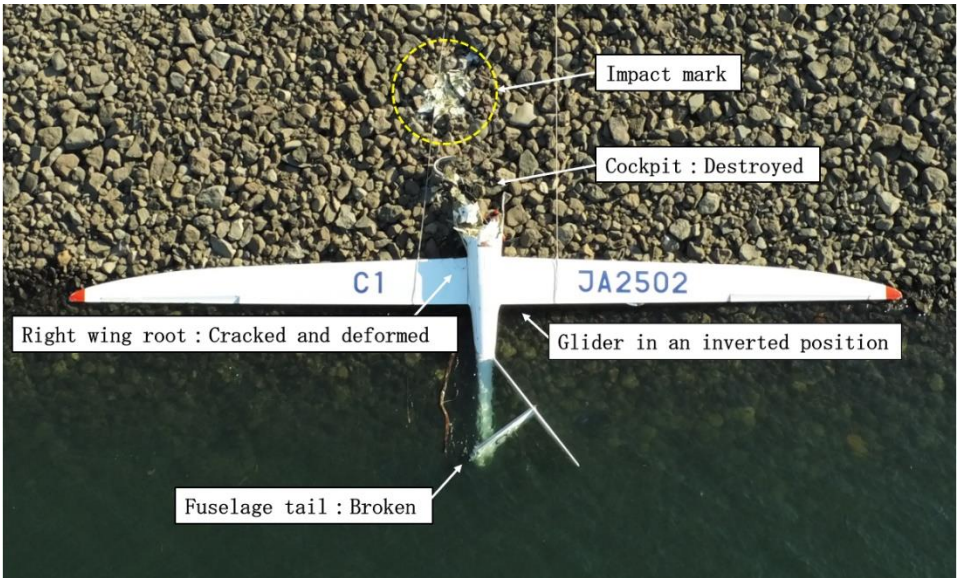
<p>Figure 6: Damage of the Glider</p>														
2.4 Personnel Information	<p>Pilot, Age 68</p>

2.2 Injuries to Persons	The pilot was fatally injured.														
2.3 Damage	<p>(1) Extent of Damage: Destroyed</p> <p>(2) Damage to the Glider Components (see Figure 6)</p> <ul style="list-style-type: none"> • Cockpit: Destroyed • Right wing root: Cracked and deformed • Fuselage tail: Broken

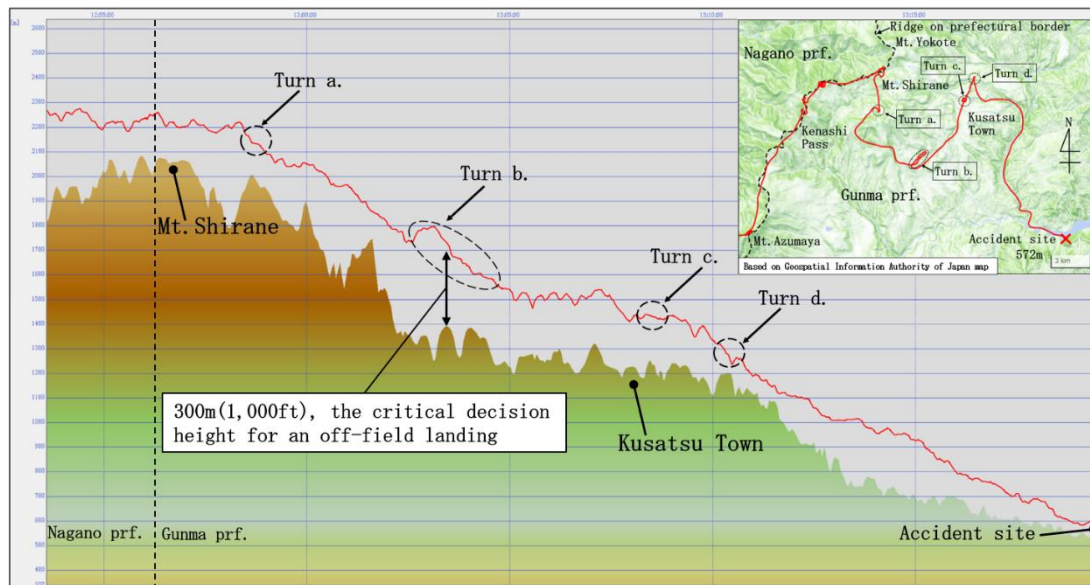
Figure 15: Flight before the Crash

The JTSCB concludes that the glider was probably trying to gain altitude from thermals or was looking for a suitable off-field landing site, as it made four turns after entering the Gunma side (Turns a. to d. in Figure15). However, it is probable that the glider was unable to gain altitude from thermals, gradually losing altitude, and even after descending below about 300 m (about 1,000 ft AGL), the critical decision height at which pilots should decide to perform an off-field landing, the glider did not approach for the off field landing, therefore, it is more likely that the glider was unable to identify a suitable off-field landing site and was flying close to the accident site.
