**AIRCRAFT SERIOUS INCIDENT  
INVESTIGATION REPORT**

**Nagano Gliding Association  
J A 2 5 2 4**

**January 25, 2024**

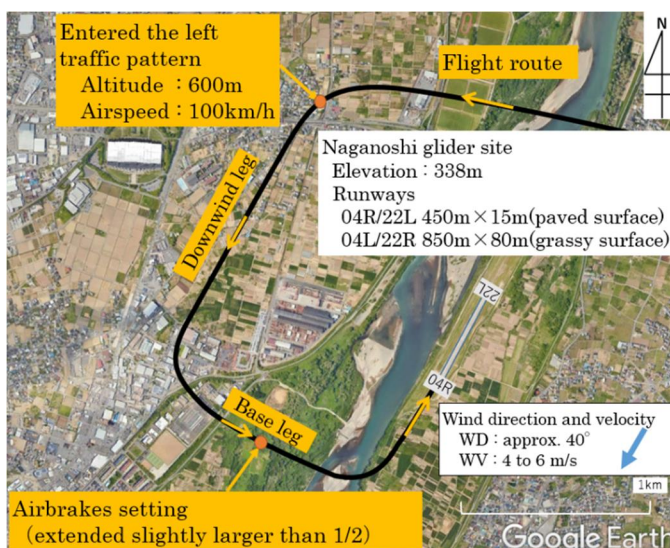
Figure 1: Flight Route  
(according to the statement)

At about 11:40, the glider launched with winch towing from Runway 04L at the glider site with only the captain on board for leisure flight. After flying for about two hours, at about 14:00, the glider entered the left traffic pattern to land on Runway 04R at the gliding field. The captain extended the airbrakes\*1 slightly larger than 1/2 after flying about halfway through the base leg.

When the glider was passing over the grassy area short of Runway 04R, the captain felt the approach altitude was lower than usual from the way how the designation marking looked, pulled the control stick back in order to approach the original aiming point, and closed the airbrakes to less than 1/2 to try to correct the path angle (Figure 2 ①). When the glider was passing over the designation marking that was the usual target for the captain to start flare maneuver\*2, the captain felt that the height from the runway surface was higher than usual, but flared the glider for the original aiming point while pulling the control stick back (Figure 2 ②). After that, as feeling the glider shaken, the captain thought about the possibility of stall, and quickly pushed forward the control stick (Figure 2 ③). Immediately after that, the main wheel and the lower surface of the fuselage forward section landed violently on the runway

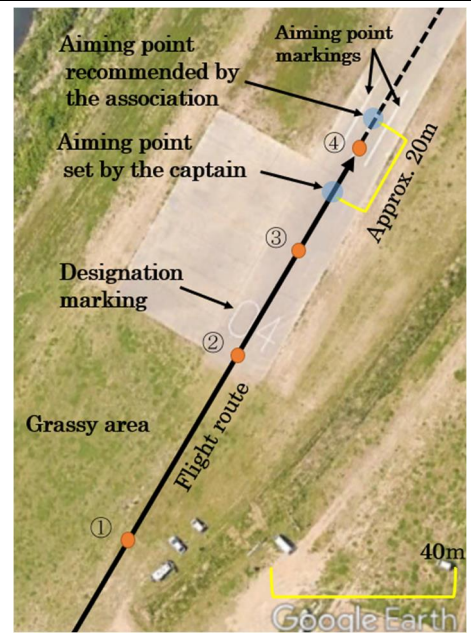
Figure 2: Situation of Touch Down (according to the statement)

almost at the same time (Figure 2 ④), the glider made a landing roll to around the middle of the runway without bouncing, and stopped.

The JTSB concludes that when the glider was passing over the grass area short of Runway 04R, the captain felt the approach altitude was lower than usual, pulled the control stick in order to approach the original aiming point, and closed the airbrakes to less than 1/2, which probably caused excessive nose-up and resulted in the glider floating.

After that, when the glider was passing over the designation marking, the captain felt that the height from the runway surface higher than usual, but started to flare the glider for the original aiming point before the glider started to sink again, which more likely caused the speed of the glider to slow down, resulting in the shaking of the glider. The captain, who felt the glider shaken, thought about the possibility of stall, and quickly pushed forward the control stick immediately before the touchdown in order to make nose down operations, but failed to recover the airspeed and the glider sank with the nose-down attitude, which more likely that the glider resulted in the lower surface of the fuselage forward section contacting with the runway surface.

The JTSCB concludes that the probable cause of this serious incident was that the lower surface of the fuselage forward section more likely contacted with the runway surface because the nose of the glider went down immediately before the touchdown and glider sank with the nose-down attitude.

It is probable that the nose of the glider went down because after the glider floated as its nose was excessively up during the approach, the flare maneuvers were initiated before the glider started sinking again, and the captain, who felt the glider shaken, thought about the possibility of stall, and quickly pushed forward the control stick in order to make nose down operations.

As indicated in ANALYSIS, it is desirable for glider pilots to image the countermeasures in advance in order to response to even the circumstances different from those originally envisaged, such as deviating from the planned route during the approach for landing, before making flight. In addition, even when the glider floats as its nose is excessively up before the touchdown, it is necessary to ensure thoroughly basic procedures such as making flare maneuvers and airbrakes control according to the sink without rapid nose-down control inputs to attempt to land.
