**AIRCRAFT ACCIDENT  
INVESTIGATION REPORT**

**J A 2 5 2 9**

## FUSELARGE DAMAGE CAUSED BY HARD LANDING PRIVATELY OWNED SCHEIBE SF25C (MOTOR GLIDER, TWO-SEATER), JA2529 AT SHIKABE AIRFIELD, SHIKABE, KAYABE-GUN, HOKKAIDO, JAPAN AROUND 12:04 JST, MAY 6, 2014

February 27, 2015

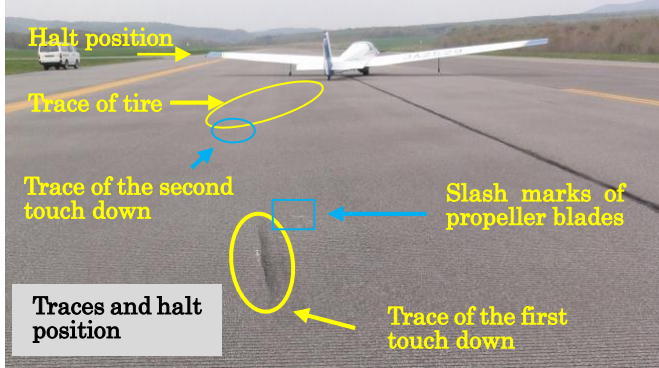
<p>The aircraft came to a halt around 93.5 meters from the touchdown zone marking of runway 25, with its nose direction to nearly 290 degrees. The first trace of touch down (tire mark, metal scratch mark, etc) and slash marks made by propeller blades were observed. In addition, several broken pieces of tire wheel were found near the first trace of touchdown.</p>

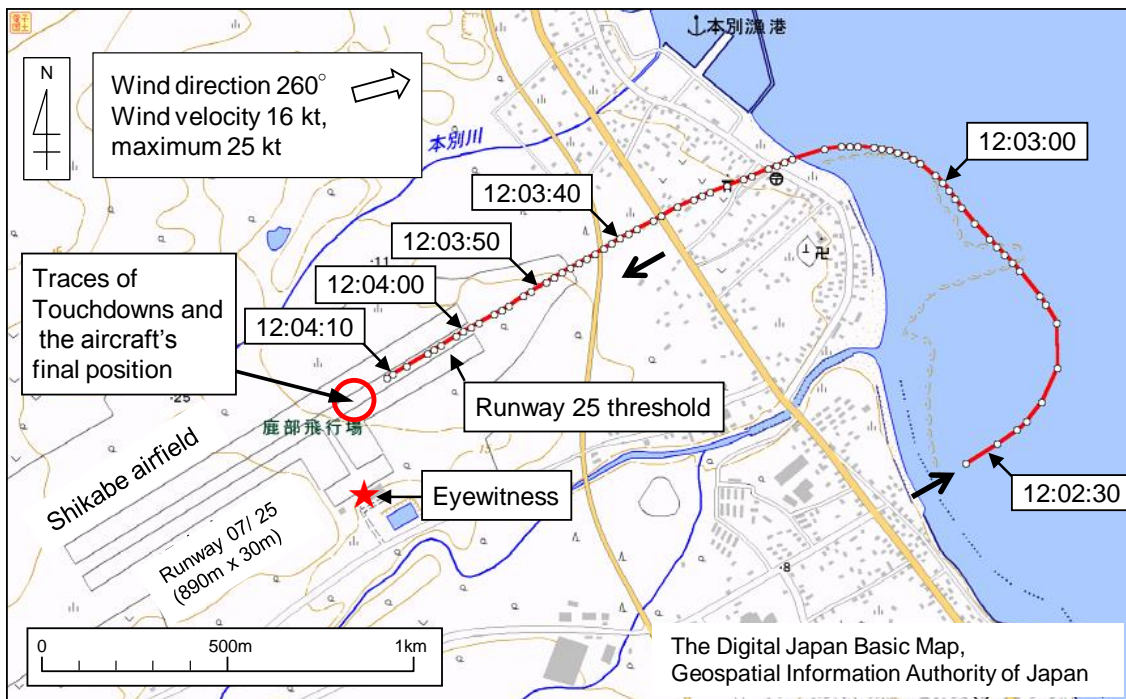
Figure 1 Estimated Flight Route

<b>2.8 Record of GPS Data</b>	<p>A handheld GPS device was brought into the aircraft, which retained the data of the flight until the accident. The estimated flight course of the aircraft and others are depicted in figure 1 and figure 2.</p> <p>Figure 1 and figure 2 indicated that altitude above ground level at the position 700 meters from the touchdown zone marking (as of 12:03:41) was determined about 105 meters, and the glide path between this point and touchdown zone marking was about 7:1 (approximately 8° ).</p>	
<b>2.9 Additional Information</b>	<p>(1) Landing maneuver of the same type of aircraft.</p> <p>According to a flight instructor of gliders who has experiences in the operation of the same type of aircraft, the outline of landing maneuver was as follows:</p> <p>The maneuver generally used in landing with the same type of aircraft is, after putting the engine to idle between the downwind leg and the base leg, basically the same as the landing of other gliders without engines.</p> <p>A straight path between about 700 meters and 800 meters long is generally used for final approach, and the final approach is initiated at roughly 100 meters (approximately 300 ft) AGL (Above Ground Level), with the airspeed at about 90 km/h, the spoilers extended halfway, aiming for the runway designation marking. The glide ratio is about 10:1 with</p>

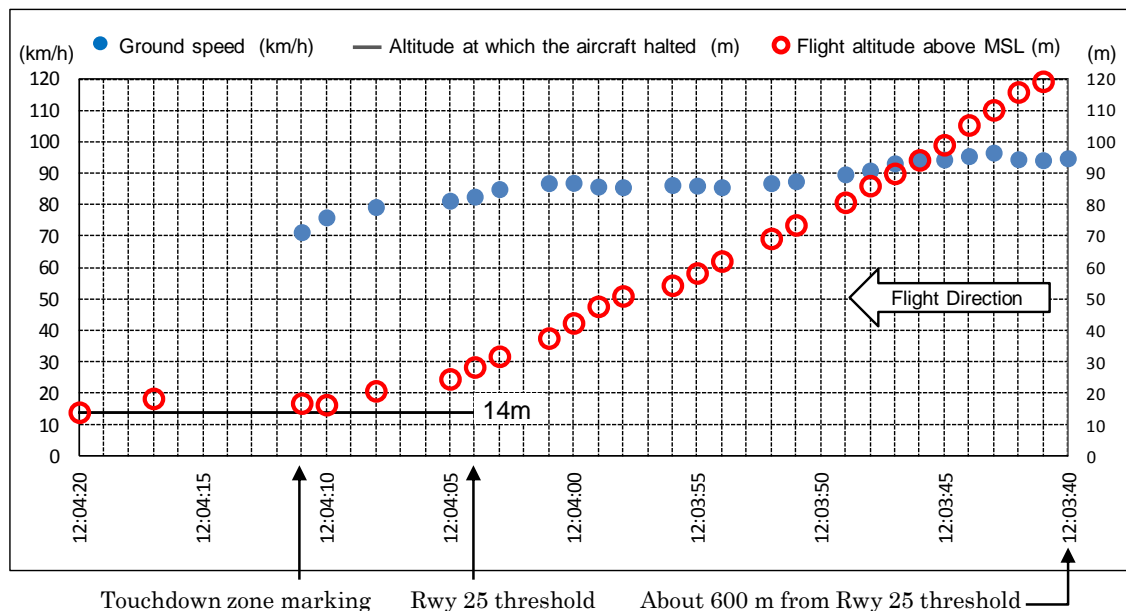
Figure 2 Flight altitude and Ground speed

- “Flight altitudes (m)” are the corrected values of GPS data referring to the ground level(14m) above MSL.
- “Ground speeds (km/h)” are the estimated values based on GPS records.
