AA2023-8

**AIRCRAFT ACCIDENT
INVESTIGATION REPORT**

**Japan Airlines Co., Ltd.
J A 3 0 7 J**

November 30, 2023

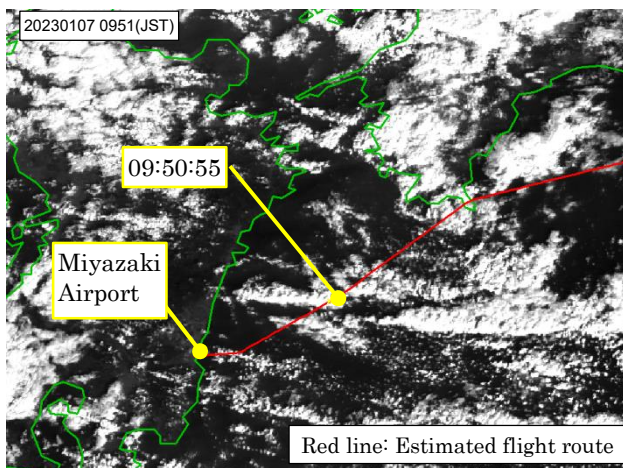
Figure 1: Meteorological Satellite Image (Visible)

According to the meteorological satellite image (Figure 1) and the radar composite chart (Figure 2) by Japan Meteorological Agency, on the flight route the aircraft descended to make an approach toward Miyazaki Airport, there were cumulus-like clouds spreading zonally and weak radar echoes*¹ were slightly scattered.

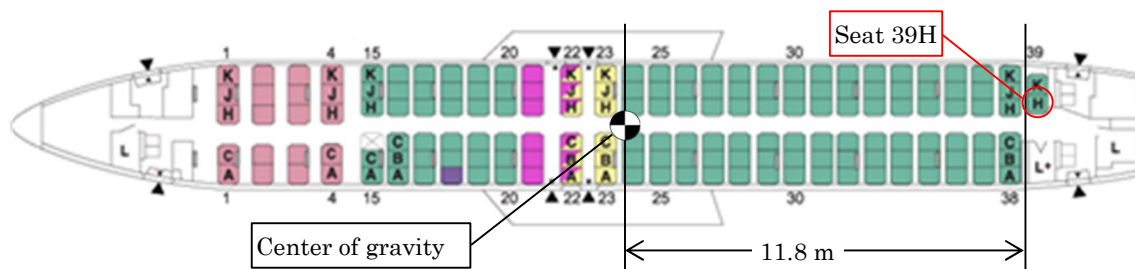
Figure 3: Seat Location of the Injured Passenger

Seat 39H was the rearmost seat in the cabin and located on the aisle side of a two-row seat. When the accident occurred, the aircraft's center of gravity was estimated to be 23.0%MAC*², and the distance from the center of gravity to the passenger was approximately 12 m.

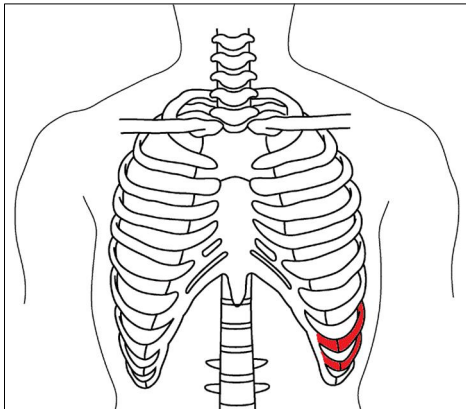
Figure 4: Injured Regions

The passenger's fractured regions were the eighth and ninth ribs from the top on the left side. The armrest of the seat is approximately 20 cm above the seat surface and is made of metallic components with a plastic cover installed.

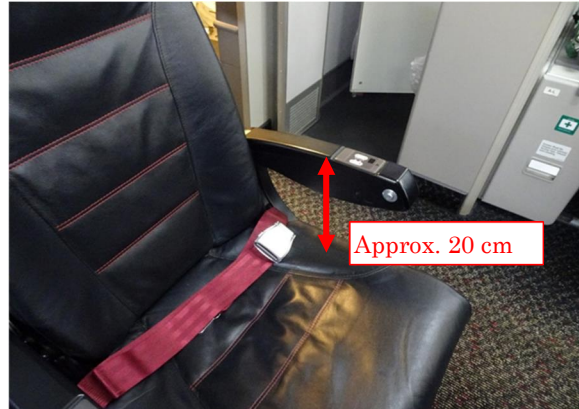
Figure 5: Seat Armrest

It is most likely that the upper body was swung to the left due to momentary change in lateral acceleration of the aircraft, the left side of the passenger hit hard against the armrest of the seat, resulting in injury.

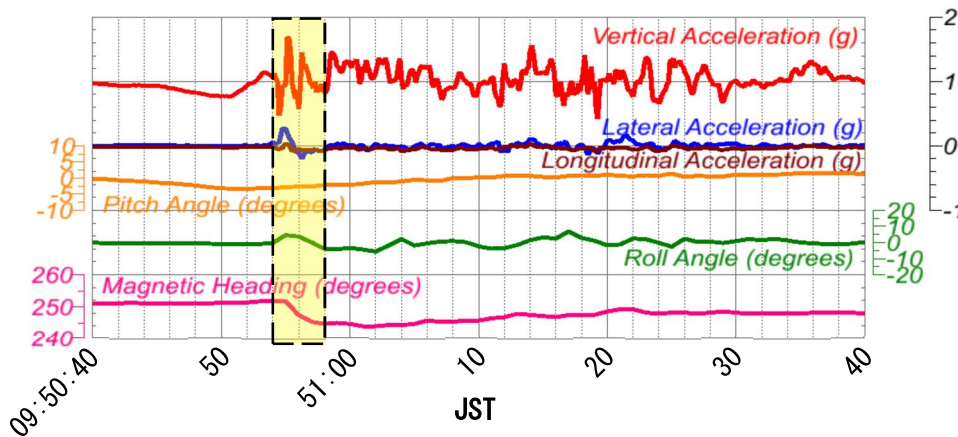
Figure 6: QAR Data

For one second from 09:50:55 to 09:50:56, the heading of the aircraft suddenly changed by 4° to the left, and for two seconds from 09:50:55 to 09:50:57, the lateral acceleration was also fluctuating between 0.27G to the right and 0.20 G to the left.

It is highly probable that when the aircraft was shaken, the heading also changed momentarily by 4° to the left, in addition to change in lateral acceleration due to translational movement oscillating from side to side, therefore, the tail side rotated by 4° to the right around the center of gravity, and change in lateral acceleration occurred near Seat 39H due to yawing. Therefore, it is most likely that the body of the passenger seated and wearing a seat belt was affected by the rightward lateral acceleration due to the translational movement and yawing of the aircraft, but the upper body was swung to the left due to the inertial law as an inertial force acted
