**AIRCRAFT ACCIDENT  
INVESTIGATION REPORT**

**Honda Airways Co. Ltd.**

**J A 3 1 T M (Rotorcraft)**

SAITAMA PREFECTURAL GOVERNMENT  
(OPERATED BY CONTRACTED HONDA AIRWAYS CO. LTD.)  
EUROCOPTER AS365N3, JA31TM (ROTORCRAFT)  
MOUNTAINOUS AREA IN OTAKI, CHICHIBU CITY  
SAITAMA PREFECTURE  
AROUND 11:03 JST, JULY 25, 2010

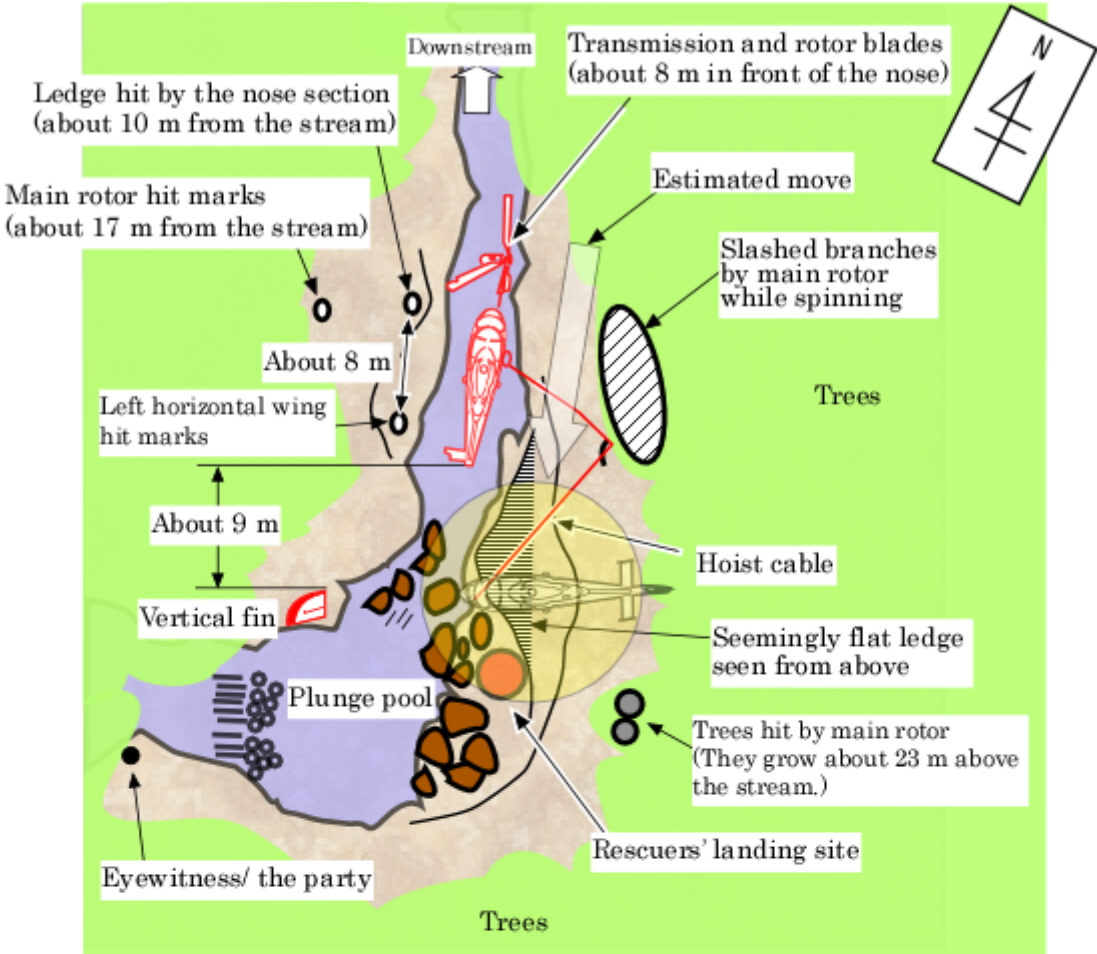
Figure 2 Detailed Accident Site

About 23 m above the rescuers' landing point (about 20 m upstream from the accident site) on the right bank cliff, there were chopped trees and about 10 m beneath them there were a tree whose branches were also chopped. Tree branches on the right bank cliff about 50 m above the aircraft were slashed as wide as about 7 m. Tree trunks and branches found in the plunge pool were damaged with scratch marks.

The full length of the aircraft's hoist cable was about 90 m and 52.8 m of it was drown out. It was not severed. The cable hanged on a right bank tree about 25 m above the stream with its hook near the landing point of the rescuers.

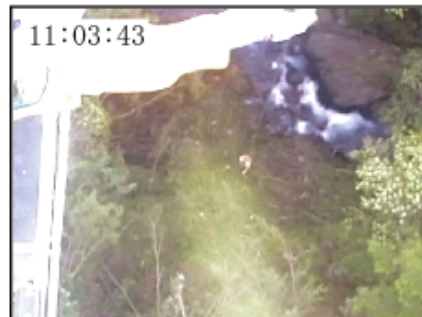
Small fragments flew in from the aft side of the aircraft (altitude about 51 m).

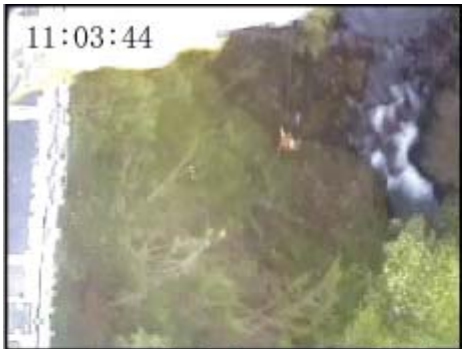
- (3) Hoist camera imagery showed small fragments followed by the emergence of block noises. This corresponds to the fact that the tree branches were sucked into the Fenestron and the aircraft lost yaw control due to the damaged tail rotor and the spinning to the left started.

Spinning to the left started. Block noises started to emerge.

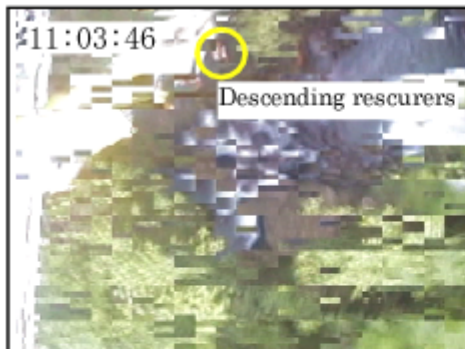
The aircraft span by 90° to the left.  
Narrower portion of the step was visible.

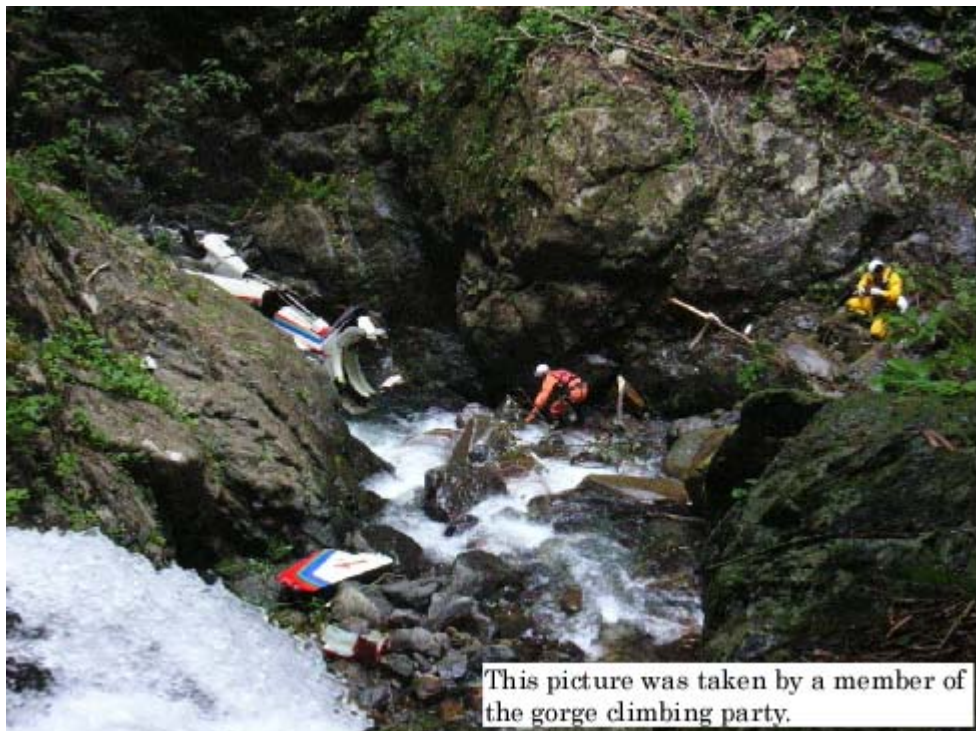
Photo 1 Just After the Occurrence of the Accident

The aircraft was lying in the stream half submerged up to its cabin floor, somewhat banking to the left and orienting downstream (north-north-west). Most of its debris scattered in the vicinity of the aircraft.

On the left bank cliff about 10 m above from the aircraft nose, a small ledge covered with red paint flakes was found. About 7 m upward from there hit marks were found. About 8 m upstream from the ledge, on the cliff about 5 m above the stream part of left horizontal wing stuck

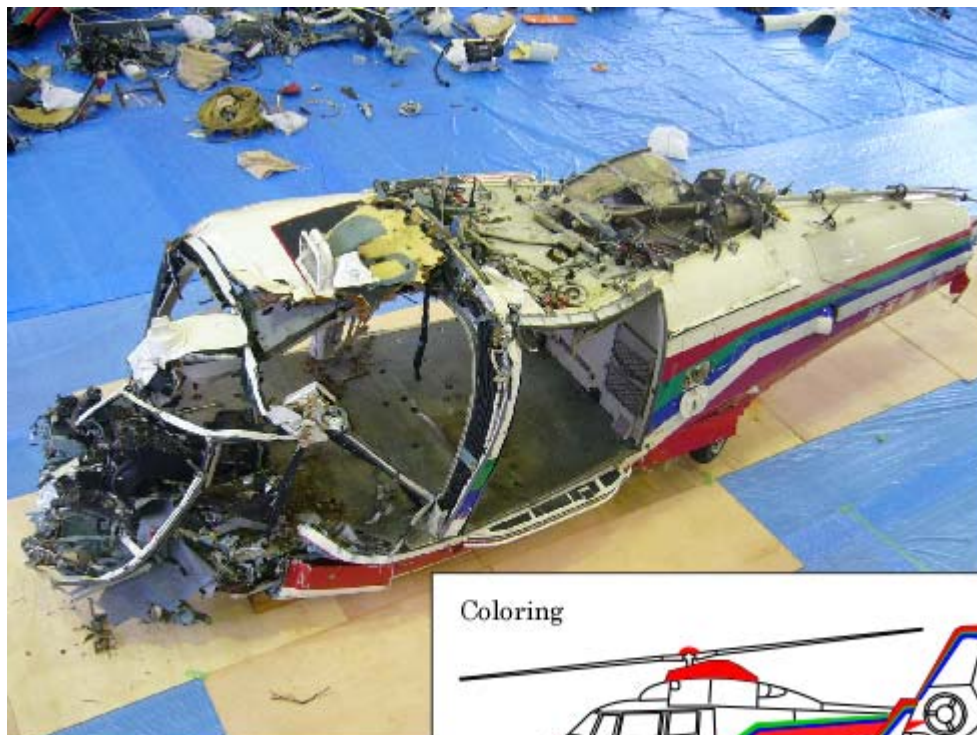
Photo 2 Damaged Fuselage

Nose section was crushed and left half of the front fuselage including left cockpit was severely damaged more than the right half. Frame aft of cockpit kept most of its integrities; however, the left cabin ceiling sagged. Outer skin of under fuselage and fuel tank cells were not damaged.

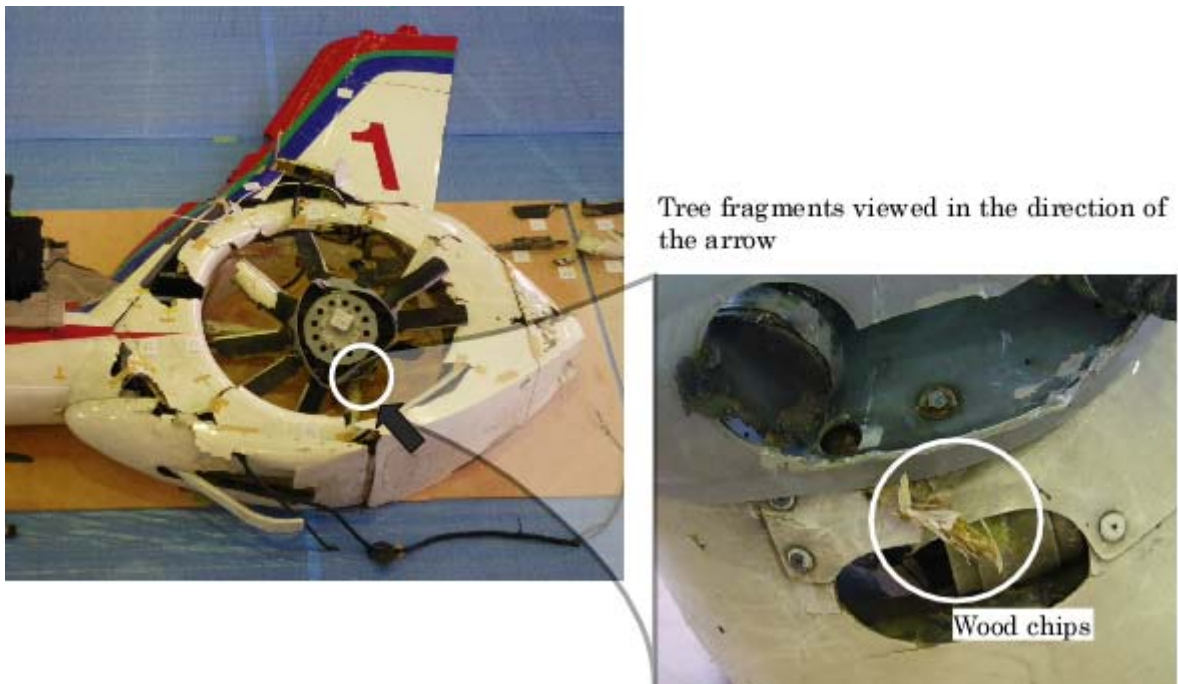
Photo 3 Damaged Fenestron

The tail rotor assy was found submerged right side of the fuselage. Out of the tail rotor assy's ten blades, two of them were fractured at root and another two were fractured at half span length. Remaining blades suffered many scratches. The tail rotor rotating axis was wedged with wood chips.

The Fenestron was shattered. Inside of the Fenestron duct had many scratch marks seemingly caused by trapped FODs and had cracks aligned with the direction of blade rotation.

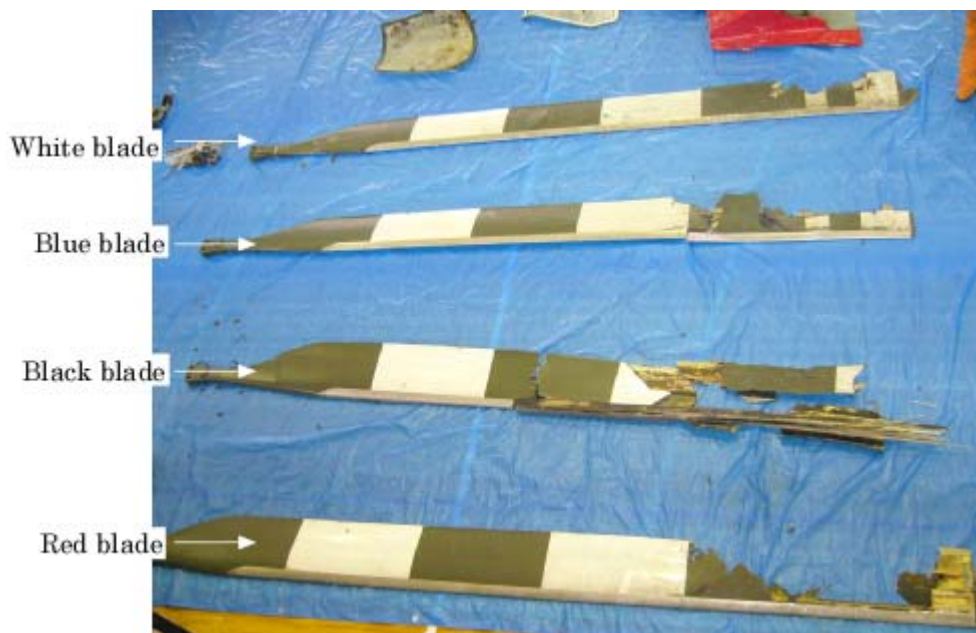
Photo 4 Damaged Main Rotor Blades

Main rotor system consists of four 530 cm long blades which are color-coded in black, red, blue and white. The rotor turns clockwise when viewed from above, and blades are sequenced as the color-coded order. Black blade had a large crack about 80 cm from its root and the section about 240 cm from its tip was almost destroyed. Outer sections about 370 cm from the roots of red and blue blades were smashed. White blade had minor damage: the section about 430 cm from its root on the trailing edge was the sole damaged area. The blade kept most of its integrity.

Leading edge of black blade was found near the root of the right bank tree about 23 m above the landing point of the rescuers.
