AIRCRAFT SERIOUS INCIDENT INVESTIGATION REPORT

LANDING ON A RUNWAY BEING USED BY OTHER AIRCRAFT

KUMAMOTO AIRPORT

AROUND 13:05 JST, AUGUST 26, 2021

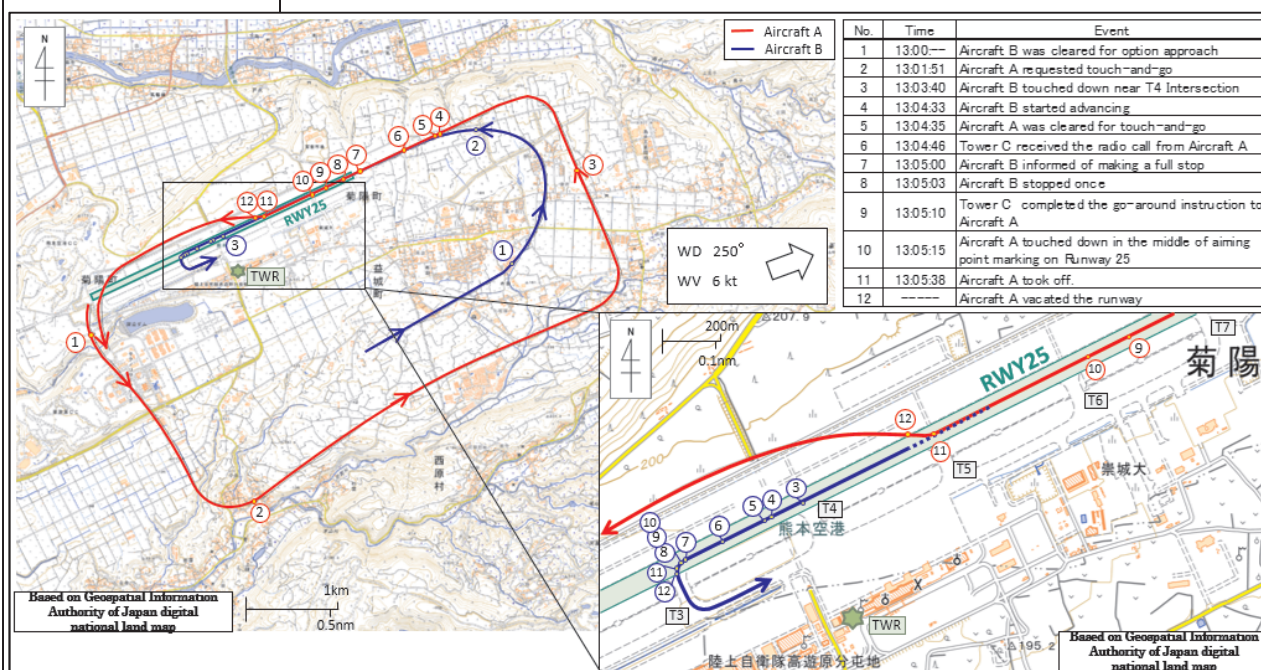
Figure 3: Situation at the time of the serious incident

in 2.7 (3)) by Tower D (at the position of ① in Figure 3). And when reading it back, Aircraft B informed Tower D that it would return to the south traffic pattern after the option approach. Captain A listened to the radio communication between Aircraft B and Tower D before and after the take-off, recognizing that Aircraft B would perform an optional approach that would occupy the runway for longer than usual and then return to the south traffic pattern.

Aircraft A entered the south traffic pattern of the Airport after taking off and requested a touch-and-go clearance to Tower D on the downwind leg at 13:01:51 (at the position of ② in Figure 3). In response to the request, Tower D instructed Aircraft A to continue the approach, and provided the traffic information*³ that Aircraft B was turning to the final approach (at the position of ② in Figure 3). Upon receiving this information, Captain A and Trainee A tried to visually recognize Aircraft B, but were unable to do so. Captain A thought that there would be sufficient distance between Aircraft B and Aircraft A even taking into consideration that Aircraft B would perform an option approach. In addition, Captain A thought that the visibility was not so good because they could not visually recognize Aircraft B, however, Captain A judged that it would not be a problem to continue the training for Trainee A. After being instructed by Tower D to continue the approach, Captain A concentrated on instructing Trainee A, was unable to visually recognize preceding Aircraft B, and new information about Aircraft B was not provided, as a result, Captain A became less and less aware of the presence of Aircraft B.

Aircraft B touched down in the vicinity of T4 Intersection on Runway 25 (the position of ③ in Figure 3) at 13:03:40, and soon stopped. After stopping for approximately 20 seconds, Aircraft B became airborne again, and at 13:04:33, started proceeding (at the position of ④ in Figure 3). Tower C, who had visually recognized that Aircraft B took off (airborne again and proceeding), confirmed that Aircraft A was on the final approach course about 0.5 nm (about 926 m) from the runway threshold on the Tower Display, and issued a touch-and-go clearance to Aircraft A by applying “Reduced Separation” (later described in 2.7 (5)) at 13:04:35 (at the position of ⑤ in Figure 3). Pilot B heard the radio communication, felt that the timing for the clearance was too early although he was not sure of the position of Aircraft A, and thought the distance between Aircraft A and Aircraft B would be

As being able to visually recognize Aircraft A before long, Tower C was going to confirm the condition of the runway again, but received the radio call from Aircraft A at 13:04:46, therefore turned to the final approach side (at the position of ⑥ in Figure 3).

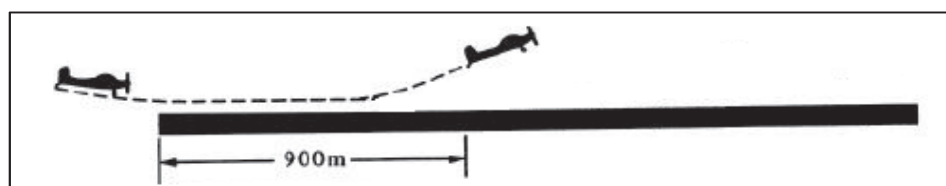
Figure 4: “Reduced Separation” (Between category I aircraft)

*Between category I aircraft*⁵ (omission): 900 meters (Figure 4).*

According to ① to ③ above, ② can be applied to the separation between the preceding aircraft to take off and the succeeding aircraft to execute a touch-and-go. As for the separation between the preceding aircraft to make a full stop (including the case of the preceding aircraft

It is highly probable Tower C judged that the necessary separation could be established between Aircraft A and Aircraft B by applying the “Reduced Separation” when visually recognizing the take-off (airborne again and proceeding) of Aircraft B, and thus gave the touch-and-go clearance to Aircraft A. At the time of this serious incident, Aircraft B intentionally aborted its take-off in order to conduct the Exam, however, Tower C, which applied the “Reduced Separation”, should have grasped the movements of both aircraft definitely and continuously. In the case where the preceding aircraft is a departure, whether to apply the “Reduced Separation” or not shall be judged carefully in consideration of operation methods of the relevant aircraft and the weather conditions, because the said departing aircraft may abort its take-off even after its take-off. It is desirable for the Civil Aviation Bureau to use this serious incident as an example and share the special characteristics of helicopters, which generically can abort take-off with a shorter runway length than fixed-wing aircraft can, among all concerned.
