AIRCRAFT ACCIDENT INVESTIGATION REPORT

Adopted by the Japan Transport Safety Board

Company	Tohoku Air Service, Inc.
Type, Registration Mark	Eurocopter AS332L1 (Rotorcraft), JA332T
Accident Class	Serious injury to a ground operator during cargo sling work
Date and Time of the Occurrence	At about 10:50 Japan Standard Time (JST: UTC+9 hours), March 15, 2025
Site of the Accident	Kawasaki Town, Shibata County, Miyagi Prefecture (38° 14' 16" N, 140° 35' 05" E)

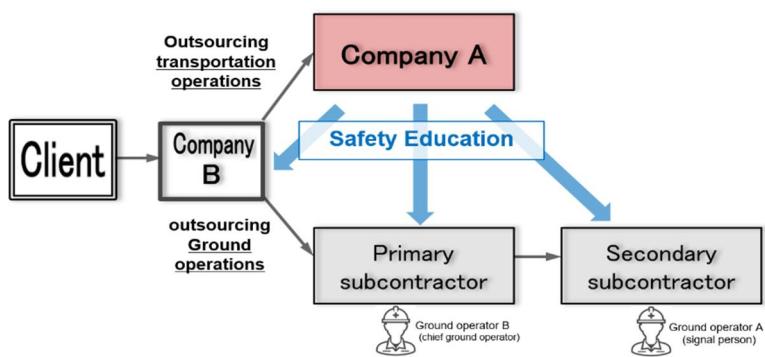
Figure 3: Roll Divisions in the Construction

The ground operators were subcontracting company employees, whereas Company B employees were not included. The signal person and the ground operator B (hereinafter referred to as "the chief ground operator") were employed by a different subcontracting company (see Figure 3).

Company B was contracted to perform ground operations for the construction project and was in charge of the site representative at the work site where several companies worked together. Therefore, risk management at the work site was probably not conducted appropriately.

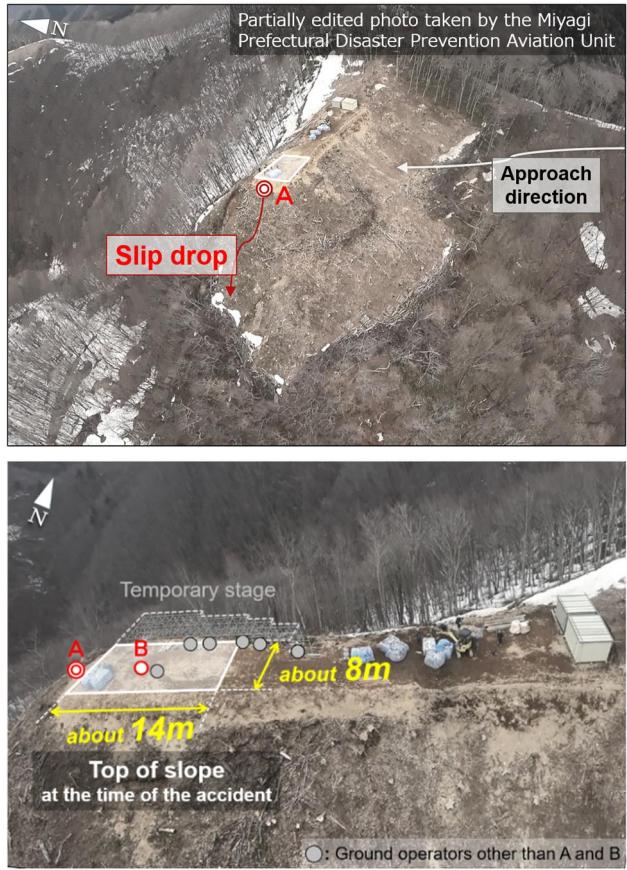
Figure 2: The Accident Site and the Slope

The work site was located in a cleared area on the ridge, and measured about 14 m wide from east to west and about 8 m wide from north to south. The surrounding terrain was steeply sloped, resembling a cliff, except on the east side (see Figure 2).

On the ground, the ground operator A in charge of guiding the helicopter (hereinafter referred to as "the signal person") visually confirmed the helicopter and then moved from the west side of the top of slope^{*2} to uneven ground about 2 m wide, located about 2 m down the slope, in order to move to a position where the onboard mechanic on the helicopter could be seen.

To reduce the influence of the wind pressure and dust caused by the downwash, the signal person adopted a low posture, and put on the helmet's face guard while facing away from the aircraft. However, when looking back, the signal person lost the balance and fell about 17 m off the cliff.

The accident site located on the west side of the top of slope was a cliff, which made it a place where there was a risk of falling off. And it was an uneven ground that would make it easier to lose one's footing than at the top of slope.

As a site representative at the work site, Company B should ensure the safety of ground operators by understanding the contents of the meeting and installing a fall prevention fence, if necessary.

- d. It was decided that a fall prevention fence should be installed at the top of slopes with an inclination angle exceeding 40°. (On April 4, 2025)

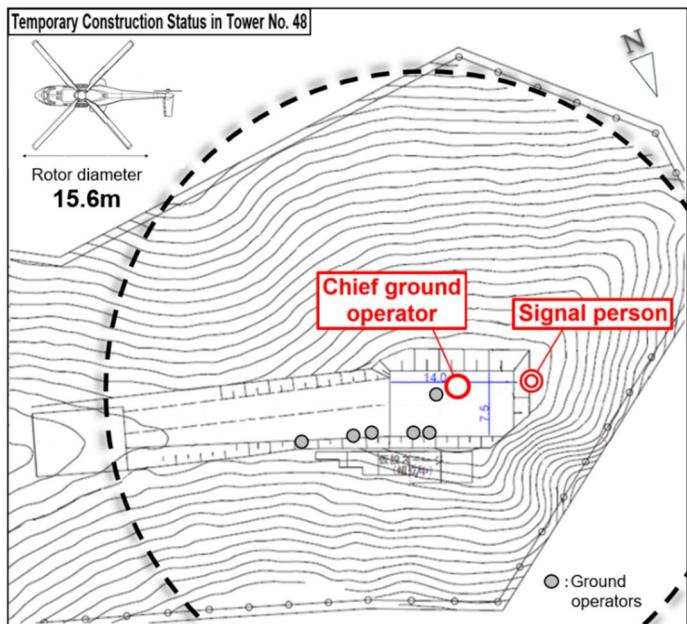
Figure 4: Range Requiring Caution for Downwash
(Black broken line area: Partially added to the construction drawing)

In this accident, the AGL altitude from the work site of the helicopter was about 19 m. The work site measured about 14 m from east to west and 8 m from north to south. Therefore, the entire work site was within the range requiring caution against downwash (see Figure 4).

The JTSB concludes that, according to the statements of several ground operators who were interviewed, that the work site was most likely narrower than a normal work site. In addition, based on the reference in 2.(7), the work site as a whole was located within a range strongly affected by downwash, in which it was most likely difficult for ground operators to avoid the effects of the downwash.
