**AIRCRAFT ACCIDENT
INVESTIGATION REPORT**

**PRIVATELY OWNED
JA 3357**

AIRCRAFT DAMAGE AT LANDING A PRIVATELY OWNED BEEHCRAFT 35-C33A JA3357 AT OSHIMA AIRPORT AT ABOUT 11:00 JST, FEBRUARY 11, 2017

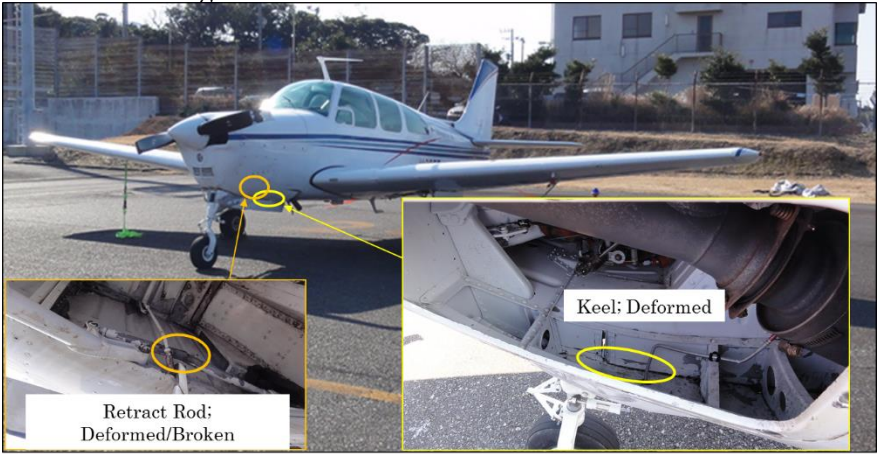
2.2 Injuries to persons	None
2.3 Damage to Aircraft	<p>Extent of damages to the Aircraft; Substantial damages</p> <p>(1) Nose Section</p> <p>Propeller; bowed, Downside Surface of the Nose; Scratched,</p>

<p>Keel; Deformed</p> <p>(2) Nose Landing Gear</p> <p>Tires on Nose Landing Gear; Damaged, Retract Rod; Deformed/Broken Landing Gear Door; Deformed</p> <p>(3) Left Main Landing Gear</p> <p>Landing Gear Door; Deformed Tires on Left Main Landing Gear; Scratch Mark on the Outside Edge of the Tires</p>

<p>Photo 1 Accident Aircraft (after moving to an apron and extending the landing gear)</p>
<p>2.4 Personnel information</p>	<p>The Pilot Male, Age 48</p> <p>Private pilot certificate (airplane) March 19, 2000</p> <p>Type rating for Single engine (land)</p> <p>Specific pilot competency assessment</p> <p>Expiration date of piloting capable period; November 28, 2017</p> <p>Class 2 aviation medical certificate Validity; October 31, 2018</p> <p>Total Flight Time 413 hours 36 minutes</p> <p>Total flight time on the type of the Aircraft 160 hours 23 minutes</p> <p>Flight time in the last 30 days 4 hours 18 minutes</p>

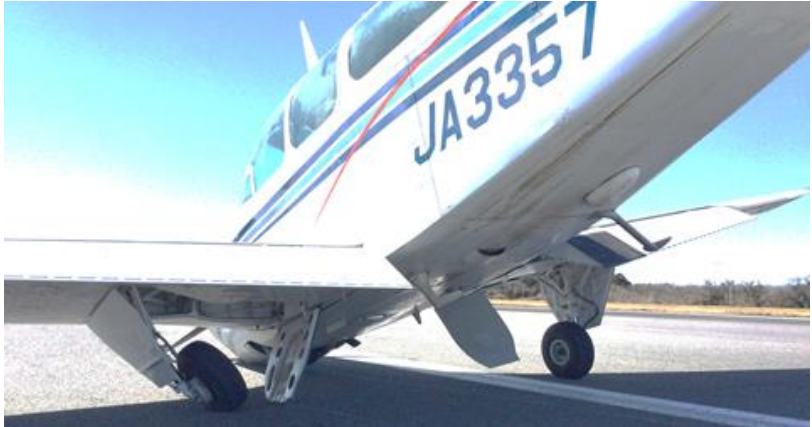
<p style="text-align: center;">Photo 2 Landing gear at Accident Site</p>

Moreover, it is probable that based on the situation of the landing gear after the accident (the nose landing gear was retracted and the left and the right of the main landing gears was stopped in a way to be retracted) and the position (down position) of the landing gear position switch after the accident, the landing gear position switch, which was moved once to the up position, was returned back to the down position before the landing gear was fully retracted, therefore, the landing gear

<p>motor reversed the rotation to the direction of extending the landing gear and this force bended retract rod of the nose landing gear in a process to push up the nose which was downed once. So, the nose landing gear was pushed into the nose wheel well by a dead weight of the Aircraft. Furthermore, it is probable that the circuit breaker was tripped and the activated motion was stopped, because the landing gear motor was overloaded because the main landing gear returned to the down direction against the dead weight.</p> <p>(5) Judgments and Action taken by the Pilot</p> <p>The Pilot, as considering the succeeding aircraft, continued the landing roll by increasing the engine rpm more than normal to avoid a rapid deceleration in the varying gust, and as thinking to raise the flaps to stabilize the Aircraft, it is somewhat likely that he moved the landing gear position switch instead of the flap position switch by a mistake, which located at the center lower position in the instrument panel and had a similar handling manner.</p> <p>(6) Prevention of occurrences of the similar accidents</p> <p>It is necessary to vacate a runway after performing full deceleration till an aircraft is stabilized without handling any switches, levers or others which are not required.</p> <p>When the switch, levers or others near the landing gear position switch will be handled, it is necessary to handle them for sure by visual confirmation.</p>

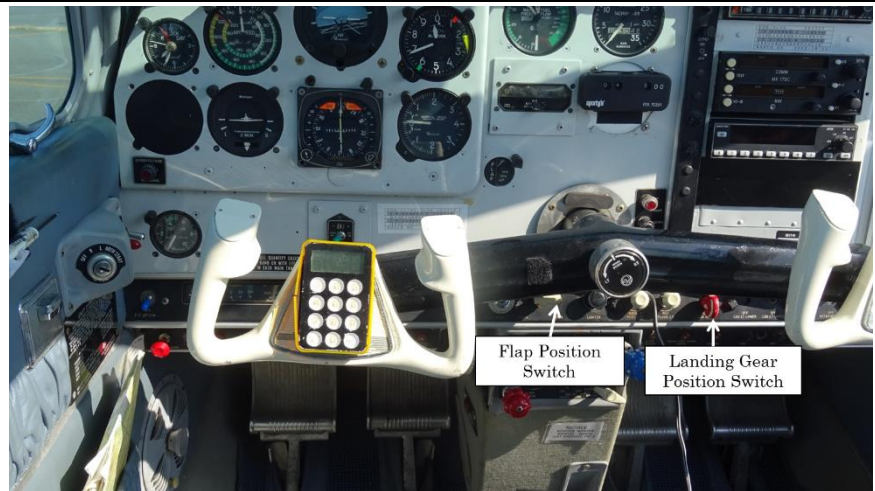
The landing gear position switch has two positions to retract and extend with dent (detent) in order to prevent switch to move opposite direction (return). When the landing gear position switch is operated, it has a mechanism to pull out the switch from the detent against the force of spring first, then move up or down.

At the time of investigation, it was confirmed that the detention mechanism worked normally.

Photo 3 Location of Flap position switch and Landing gear position switch

The Pilot stated that he did not have the memory of moving the landing gear position switch up by a mistake when he thought to raise the flaps. However, the detent of the landing gear position switch, the landing gear warning horn and the mechanism to extend or retract the landing gear were operated with no problem, and it is probable that an intermittent sound like warning horn that the Pilot heard was the warning horn activated because the landing gear position switch was moved to the up position while the safety switch was detecting the situation of being on the ground, therefore, it is somewhat likely that the Pilot moved the landing gear position switch to the up position.
