**AIRCRAFT SERIOUS INCIDENT  
INVESTIGATION REPORT**

**J A 3 6 8 9**

## RUNNING OFF THE SIDE OF A RUNWAY DURING LANDING PRIVATELY OWNED FUJI HEAVY INDUSTRIES FA-200-180, JA3689 AT SATSUMA-IOJIMA AIRFIELD, MISHIMA-MURA, KAGOSHIMA PREFECTURE, JAPAN AT AROUND 11:40 LOCAL TIME, NOVEMBER 25, 2012

December 6, 2013

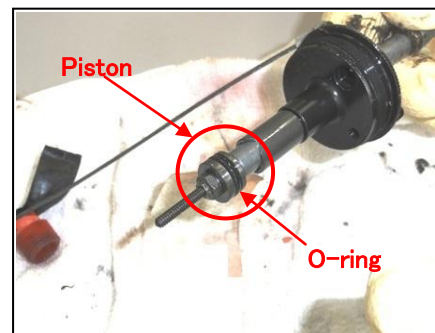
The left and right master cylinders in the brake system were removed from the aircraft and examined for hydraulic fluid leaks. In the left master cylinder, fluid leaks were confirmed. Then the left master cylinder was disassembled and it was found that a rubber-made O-ring mounted on the piston to prevent fluid leaks was worn out.

Worn O-ring

It is highly probable that the left brake system became ineffective because the O-ring of the left master cylinder in the brake system was worn out, and the master cylinder could not maintain sealing capability and could not sufficiently transmit the brake fluid pressure to the brake linings.

It is possible that the wear of the O-ring was caused from aging deterioration.

In the Fuji Heavy Industries FA-200 series aircraft, the O-ring of the master cylinder in the brake system is to be replaced if found defective when the master cylinder is disassembled and visually inspected at the 1,000hrs check. However, an O-ring tends to expand when soaked in hydraulic fluid, and in addition, the O-ring becomes hardened when pressured and may have wear or damage which is hard to recognize visually. Therefore, it is recommended to consider that the O-ring should be replaced when the master cylinder is disassembled and usable duration of the O-ring should be established.
