AIRCRAFT ACCIDENT INVESTIGATION REPORT

September 25, 2025

Adopted by the Japan Transport Safety Board

Company	NPO Hanyu Soaring Club
Type, Registration Mark	Diamond Aircraft HK36R Super Dimona (Motor Glider, Two-Seater)、JA36HK
Accident Class	Aircraft damage caused by forced landing
Date and Time of the Occurrence	At about 11:28 Japan Standard Time (JST: UTC+9 hours), November 19, 2023
Site of the Accident	Hanyu Glider Port, Hanyu City, Saitama Prefecture (36° 12' 15" N, 139° 35' 44" E)

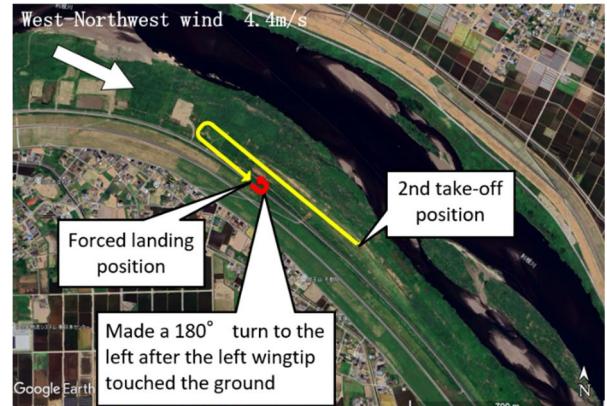
Figure 1: Estimated Flight Route

When the glider reached the above ground level (AGL) altitude of about 10 m, the sound of the engine changed suddenly, and the engine RPM dropped. The pilot made a left turn to return to the runway, however, as AGL altitude was reduced during the approach, the pilot decided to

make a forced landing. Just before the forced landing, the left wingtip touched the ground beside the runway, and the glider made a forced landing, (see Figure 1) while making a 180° turn to the left. According to the pilot, the glider's propellers were still rotating, and the engine had not stopped just before the forced landing.

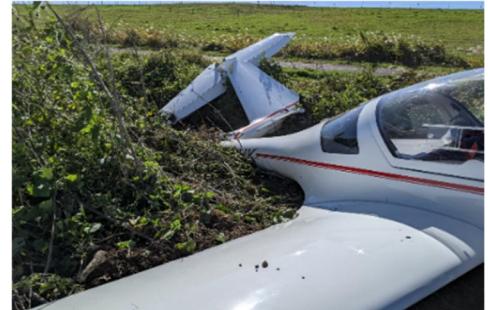
Figure 2: The Glider after the Accident

Substantial damage

- The fuselage tail and horizontal stabilizer attachment were broken (see Figure 2).
- Scratch marks were found on both wing tips and the right side of the horizontal stabilizer.
- The right main wheel was detached.
- One of the two propeller blades was damaged.

The JTSB concludes that among the damage to the glider, the broken fuselage tail, which would require major repairs, was more likely caused because the glider attempted to make a forced landing on the area beside the runway due to the reduced engine power during take-off, then its left wing tip touched the ground, and its fuselage tail came into hard contact with the ground while it was making a 180° turn to the left.

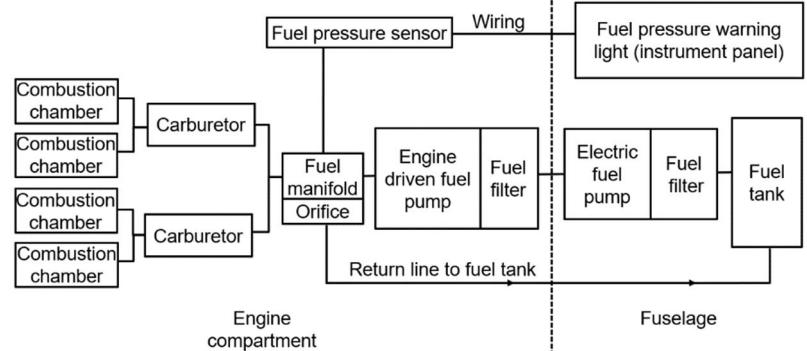
Figure 3: Fuel System

Besides, the orifice that adjusts the pressure of the fuel supplied from the fuel manifold by restricting the fuel flow returning from the fuel manifold to the fuel tank had been removed, instead, the fuel manifold and the return line were connected with a fitting that was not a genuine part of the glider. According to the statements of the pilot and Mechanic A, they did not remember the work involving the removal of the orifice.

The JTSB concluded that it is probable that the fuel pressure of the glider was constantly low due to the return line orifice having been removed. This investigation did not establish when the orifice had been removed. In addition, as this orifice was not subject to regularly inspection, it was highly probable that neither the pilot nor Mechanic A would have noticed that the orifice had

(2) Aircraft users must perform appropriate daily inspections and regular maintenance in accordance with the aircraft and engine maintenance manuals. When conducting maintenance or modifications that differ from the manufacturers' approved procedures, aircraft users should fully confirm that there will be no problems including by seeking confirmation from the manufacturers.

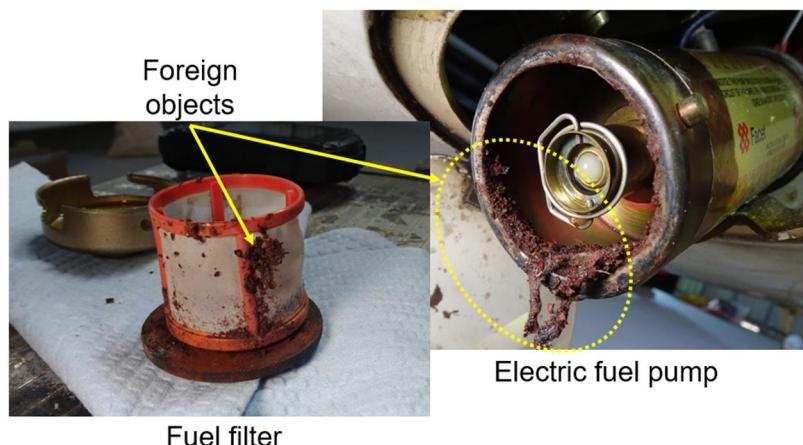
Figure 4: Foreign Objects in the Electric Fuel Pump and the Filter

Figure 3 shows its fuel system. The filter in the electric fuel pump (hereinafter referred to as "the filter") was examined during the investigation and it was found that foreign objects had adhered to the filter and inside of the electric fuel pump, blocking the fuel supply (see Figure 4). A detailed examination of the foreign objects collected from the filter using an optical microscope revealed the presence of metal powder, fibers, and others.

During the take-off roll and the take-off, the engine power of the glider had been probably reduced because foreign objects had clogged the glider's fuel filter, resulting in impeding fuel flow, reducing the amount of fuel supplied to the engine, and preventing the required amount for take-off from being provided. The pilot would have most likely failed to notice the fall in fuel pressure because the glider's fuel pressure sensor had been removed and the fuel pressure warning light would not illuminate. The case in which the fuel pressure sensor was removed, and the fuel pressure warning light did not illuminate does not comply with the airworthiness standards set out in Article 10, paragraph (4) of the Civil Aeronautics Act.

The JTSB concludes that the fabric collected from the filter was most likely part of the unwoven fabric that the pilot had used by wrapping around the nozzle tip during refueling, which had then entered the fuel tank. Regarding the metal powder, it is possible that the metal powder produced by corrosion of the fuel carrying can might have flown into the fuel tank with the fuel through the frayed texture of the unwoven fabric.

The JTSB concludes that the filter was most likely clogged because the inspection and cleaning of the filter were not conducted as specified in the aircraft maintenance manual during the regular maintenance work. However, the most recent work record had a check mark indicating that the inspection and cleaning of the filter had been done.

When refueling using a fuel carrying can, aircraft users should regularly check the fuel carrying can for corrosion. In addition, wrapping commercially available unwoven fabric around the nozzle tip during refueling could result in the frayed unwoven fabric entering the fuel tank to be foreign objects, which should be avoided.

(3) Adequate management is required when refueling and storing fuel to prevent contamination by foreign objects, which includes confirming that there is no corrosion in the fuel carrying can and that there are no foreign objects adhering to the tip of the refueling nozzle.

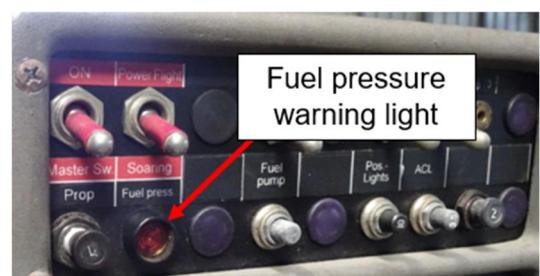
Figure 5: Fuel Pressure Warning Light

The glider's fuel pressure sensor is built into the fuel manifold. As shown in Figure 5, a fuel pressure warning light is mounted in the center of the instrument panel. The red fuel pressure warning light is designed to illuminate as soon as the fuel pressure falls below the specified value. However, according to the pilot's statement, during the engine replacement work on the glider on December 5, 2015, the shape of the wiring connection terminal on the glider side of the fuel pressure warning light did not match the shape of the fuel pressure sensor on the engine side, making it impossible to connect the two. As a result, the fuel pressure sensor was removed and the warning light did

not illuminate.

(3) The pilot would have most likely failed to notice the fall in fuel pressure because the glider's fuel pressure sensor had been removed and the warning light would not illuminate.
