AIRCRAFT ACCIDENT INVESTIGATION REPORT

Company	Privately owned
Type, Registration Mark	Piper PA-28-151, JA3712
Accident Class	Damage to the aircraft during landing
Date and Time of the Occurrence	At about 10:58 Japan Standard Time (JST: UTC+9 hours), June 5, 2024
Site of the Accident	Yoron Airport, Kagoshima prefecture (27°02'38"N, 128°24'09"E)

Summary of the Accident	On Wednesday, June 5, 2024, while the aircraft was landing at Yoron Airport, it deviated from the runway and collided with the airport's perimeter fence, resulting in damage the leading edges of both wings, and so on.
Outline of the Accident Investigation	An investigator-in-charge and two investigators were designated on June 5, 2024. Comments on the draft Final Report were invited from the parties relevant to the cause of the serious incident and Relevant State.

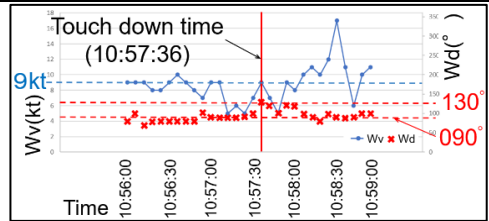
Instantaneous wind direction (Wd)/ velocity (Wv) at the time the aircraft touched down (10:57:36) : 130° / 9 kt

Figure 1: Instantaneous wind direction / wind velocity

The JTSA concludes that why the aircraft touched down to the left of the runway centerline marking was probable that the wind direction, which the student had recognized as 090° (080° true bearing), had changed to 130° true bearing at the time of the aircraft's touch down, and the crosswind component had decreased, but the student was unable to respond to this.

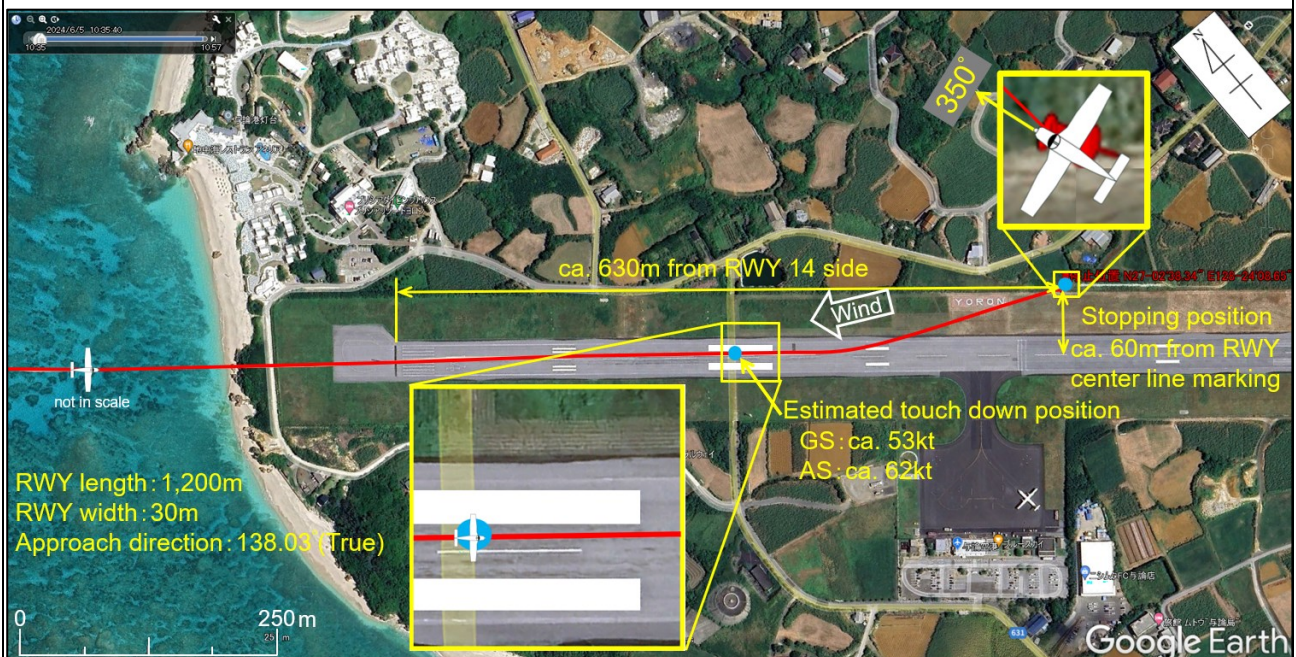
Figure 3: Estimated touch down position and stopping position

being careful not to drift to the right. Although the aircraft touched down near the aiming point marking, it did not drift to the right as much as the student had expected and touched down to the left of the runway centerline marking.

Therefore, the student applied the right rudder to bring the aircraft closer to the center of the runway, but as this resulted in a sudden right turn correction, he immediately applied the left rudder, which then resulted in a sudden left turn. The student applied both brakes strongly to try to stop the aircraft, but was unable to stop it on the runway and it veered off the runway and slid across the grass. The aircraft struck the leading edge of the left wing on a post in the airport's perimeter fence, turned left, and stopped when the propeller got entangled in the barbed wire of the fence, and the engine stopped at the same time. The student was not injured, and he reported the accident to his flight instructor by cell phone, reported the accident to Yoron Radio, turned off all power, and exited the aircraft on his own.

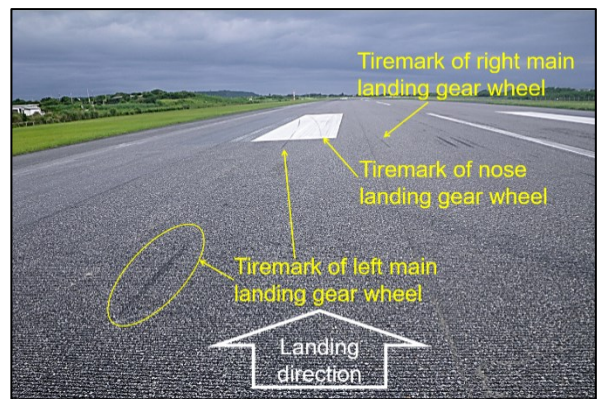
The Aircraft's three wheel tracks remained in the grass, followed by tiremarks on the runway. The tiremarks began with dark tiremarks that looked like the left main landing gear wheels had been braked, then stopped at one point, and tiremarks from both main landing gears and the nose landing gear curved left of the landing direction and continued across the grass.

Figure 4: Tiremarks on the runway

The JTSA concludes that the aircraft most likely touched down to the left of the runway centerline marking when it landed at Yoron Airport during a solo open air flight training by a student. During the ground run, the student used the right rudder to bring the aircraft closer to the center of the runway, but the correction was more abrupt than expected, so it is most likely that the student immediately used the left rudder. Immediately after that, the aircraft certainly turned left, entered the grass field, and collided with the perimeter fence, damaging the aircraft. It is most likely that the nose turned left during the ground run because the left brake was applied before the speed had sufficiently decreased, based on the uneven wear of the left main landing gear wheel tire and the tire marks on the runway.

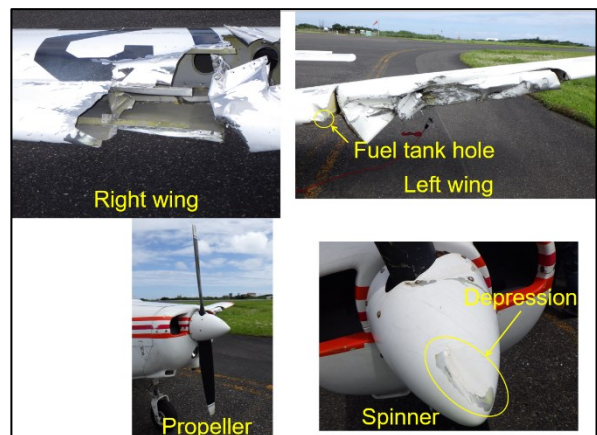
Substantially damaged

Damage with spars broken and abrasions to both wings

A breach in the left fuel tank

Depression and abrasions to spinner

Abrasions to the propeller and engine cowling

Figure 5: Main damage area

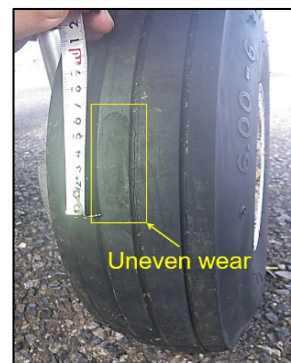
Uneven wear on part of the left main landing gear wheel tire

Figure 6: Left main landing gear wheel

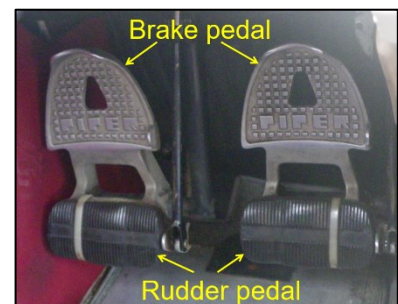
The JTSA concludes that when the student used the left rudder to correct the direction of travel to the left, the foot of the student also touched the left brake pedal, and it is most likely that the student applied the left brake at the same time as the student pressed the left rudder pedal. In initial training, it is desirable to instruct student pilots the proper foot position when using the rudder so that instruct student pilots does not accidentally press the brake pedal when the student intended to use the rudder.

Figure 7: Brake pedal and rudder pedal

As shown in the analysis, in the initial training, it is desirable to instruct student pilots to correct heading during the ground run after landing by using the appropriate amount of rudder depending on the speed and to master the appropriate foot position when using the rudder.
