**AIRCRAFT ACCIDENT  
INVESTIGATION REPORT**

**PRIVATELY OWNED  
J A 3 7 6 2**

## DAMAGE CAUSED BY BELLY LANDING A PRIVATELY OWNED BEEHCRAFT A36 JA3762 SENDAI AIRPORT AT AROUND 12:25 JST, NOVEMBER 16, 2015

September 8, 2017

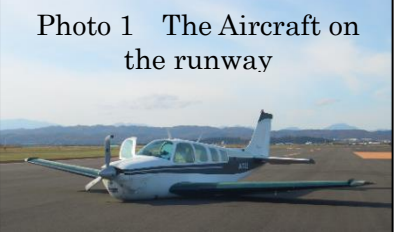
2.2 Injuries to the Persons	None
2.3 Damage to the Aircraft	<p>Extent of Damage: Substantial Damage</p> <ul style="list-style-type: none"> <li>• Fuselage: Damage on the bottom surface of fuselage (including major structural members)</li> <li>• Wing: Damage of the trailing edge of flap</li> </ul> <p>Deformation of the pitot tube</p>

<ul style="list-style-type: none"> <li>• Landing gear: Damage of the nose gear doors</li> <li>• Engine: Damage of the right and left exhaust pipes</li> <li>• Propeller: Bended of the every blade tip</li> </ul>	<p>Photo 1 The Aircraft on the runway</p>

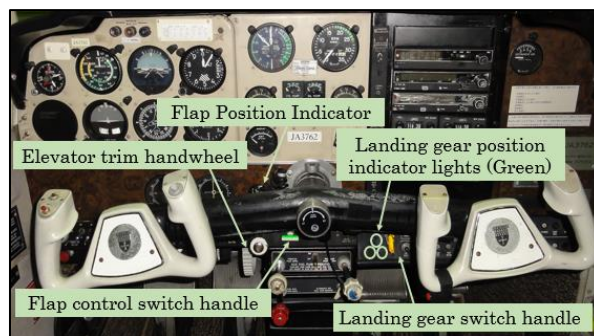
Photo 2 Instrument panel of the aircraft

Furthermore, the landing gear switch handle was at the “Up” position at the time of the aircraft investigation after the accident.

It is probable that because the passenger was operating to correct the flap position as turning his eyes to the flap position indicator located at the lower part of the instrument panel, he did not see the outside of the aircraft, temporarily.

As for the prevention of the forgetfulness of the landing gear extension, the before landing checks and others, it is probable that it is effective to use a checklist, and if an approach has no time to spare, it is probable that the captain should execute go-around in order to have the time to do the check.

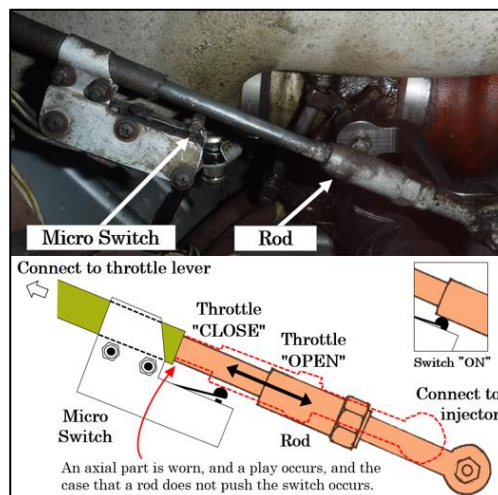
Fig.3 Micro switch

<p>the rod linked with a throttle lever had uneven wear, it was confirmed that there would be a case for the rod not to activate the micro-switch.</p> <p>It was confirmed that the system operated properly at 100 hours inspection implemented at April 2015.</p>
--	---

It was confirmed that because the system has a case that the rod could not activate the microswitch according to the operation check after the accident, and the captain and the passenger stated that both of them did not hear the warning sound, it is somewhat likely that the system was not activated when the throttle was closed and this fact contributed both of the captain and the passenger not to notice their forgetting the down operation of the landing gear till the end.

It is probable that the cases that the rod did not activate the microswitch could be occurred because the rod was worn due to a long time use.
