AIRCRAFT ACCIDENT INVESTIGATION REPORT

HELICOPTER DAMAGE

ALL NIPPON HELICOPTER CO., LTD.

EUROCOPTER EC 135 T2 (HELICOPTER), JA37NH

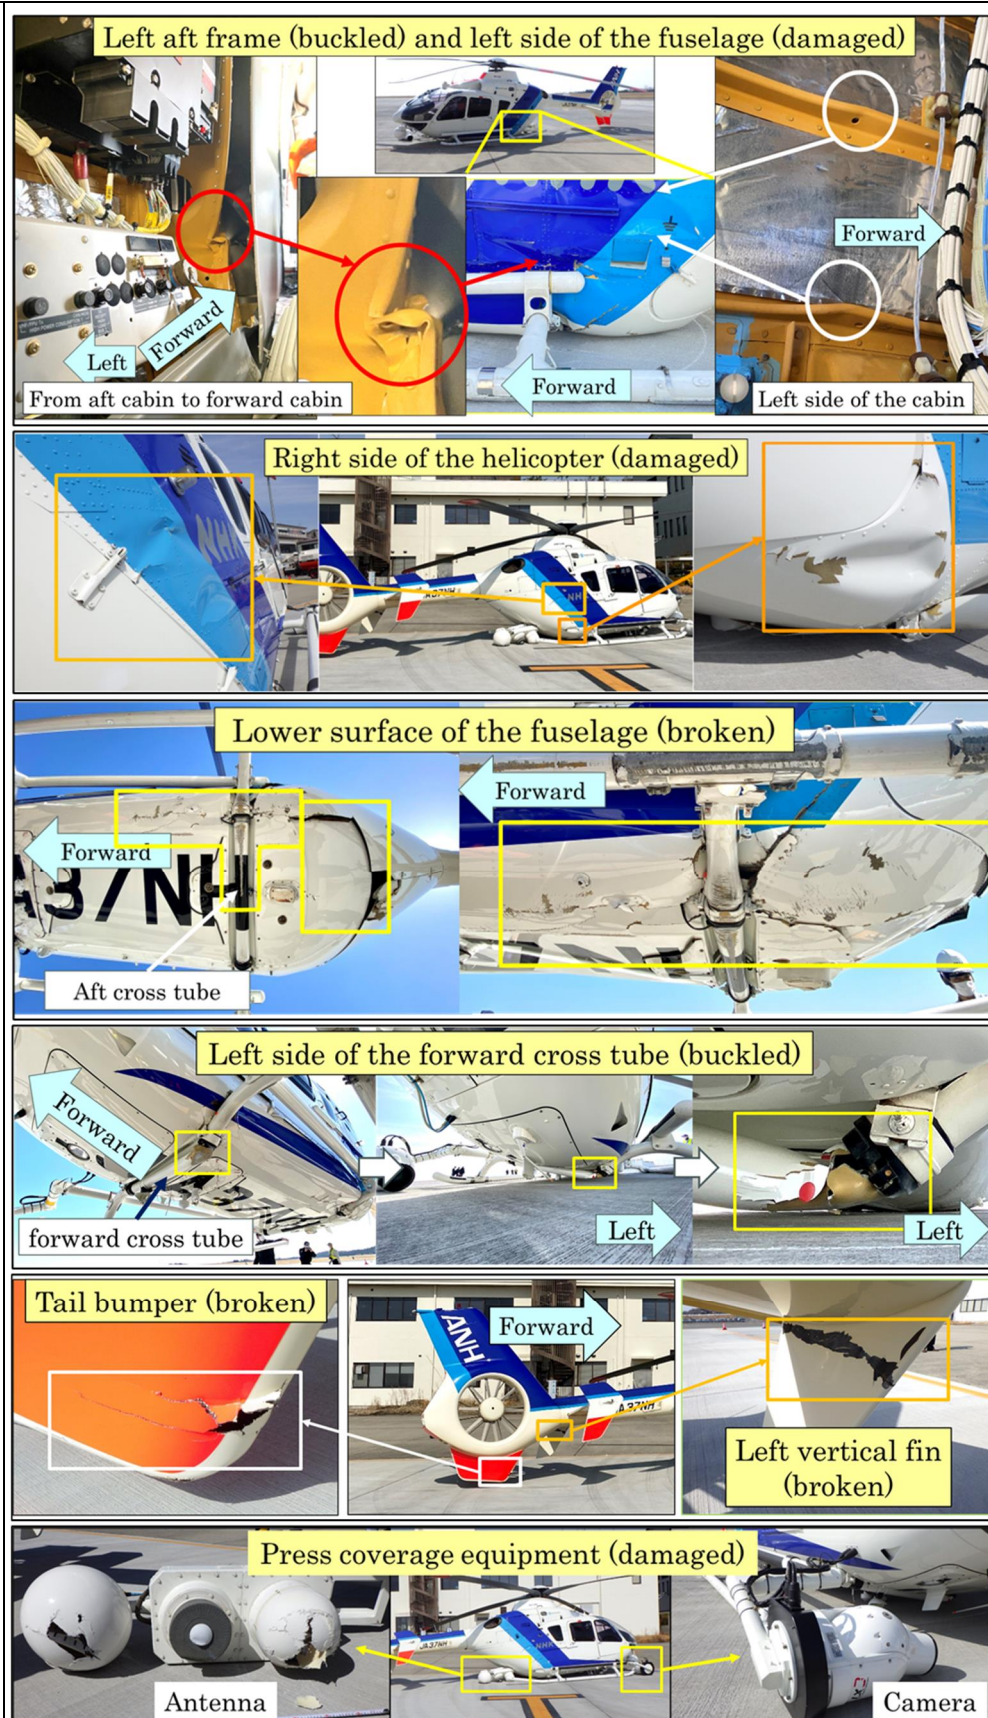
Figure 2: Damage to the Helicopter

2.2 Injuries to Persons	One passenger: minor injury
2.3 Damage to the Aircraft	<p>(1) Extent of damage: Substantially damaged</p> <p>(2) Main damage to the helicopter (see Figure 2)</p> <p>Left aft frame as a primary structure member: buckled</p> <p>Right and left sides and lower surface of the fuselage: broken</p> <p>Left side of the forward cross tube: buckled</p> <p>Tail bumper and left vertical stabilizer: broken</p> <p>Press coverage equipment (camera and antenna): damaged</p> <p>No abnormalities were observed in the engine, main rotor (hereinafter referred to as “MR”), fenestron^{*2}, rotor drive system and control system.</p>

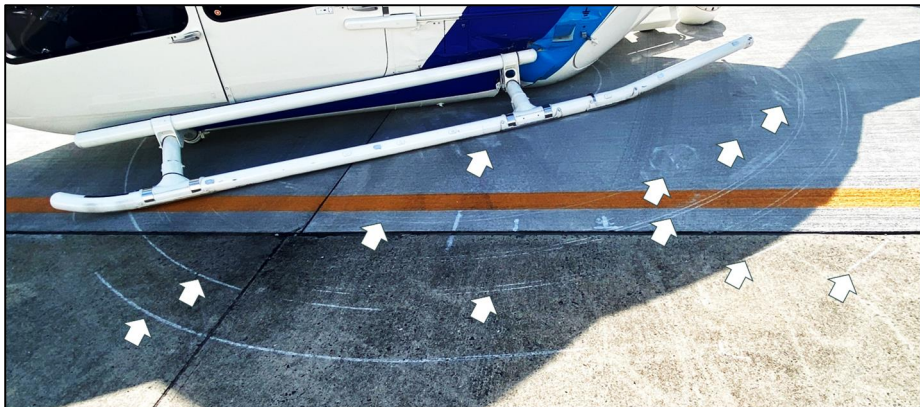
<p style="text-align: center;">Figure 3: Scratch Marks on Apron Surface</p>

<p>(3) On the surface of the apron where the helicopter had stopped, many scratch marks, including those from the skids, were confirmed (see Figure 3).</p>

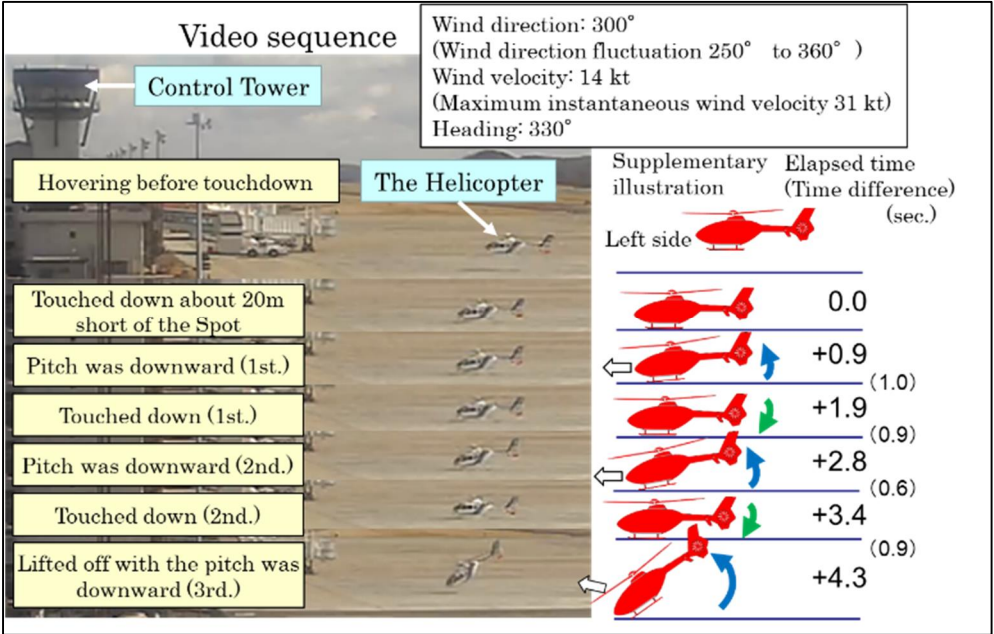
Figure 4: Situation from the Helicopter's Touchdown about 20 m Short of the Spot until the Lifting Off

Figure 4 shows the situation from the time the helicopter touched down about 20 m short of the Spot until it lifted off, with the sequence of images of the same angle of view cut from the Video on the left, and the helicopter movement corresponding to each image illustrated and indicated on the right as a supplement. In addition, the rightmost column shows the elapsed time and the time difference between each image when the time of the helicopter's touchdown about 20m short of the Spot is set to 0 second.

According to the Video, the change to downward pitching attitude was observed three times after the helicopter's skids had touched down: the first time, about 0.9 seconds after initial touchdown, about 20 m short of the Spot, the helicopter's pitch attitude was downward, as if it were pivoting around the front of the skids, and it touched down again about one second after it had advanced slightly: the second time, about 0.9 seconds after the first touchdown, the helicopter's pitch attitude was pitch more downward than the first time, as if it was pivoting around the front of the skids, and it touched down again about 0.6 seconds after having advanced slightly: the third time, about 0.9 seconds after the second touchdown, the helicopter's pitch attitude was significantly downward (about 30°), and then it lifted off while moving forward.

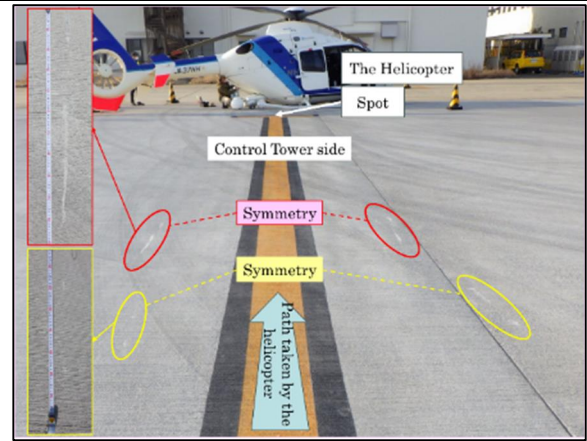
Figure 5: Contact Marks on the Apron Surface where the Helicopter Touched Down about 20 m Short of the Spot

On the surface of the apron, where the helicopter touched down about 20 m short of the Spot, there were contact marks confirmed in two places each to the right and left (four in all), symmetrically along the path taken by the helicopter, with those on the control tower side

being clearer and deeper than the others (see Figure 5).

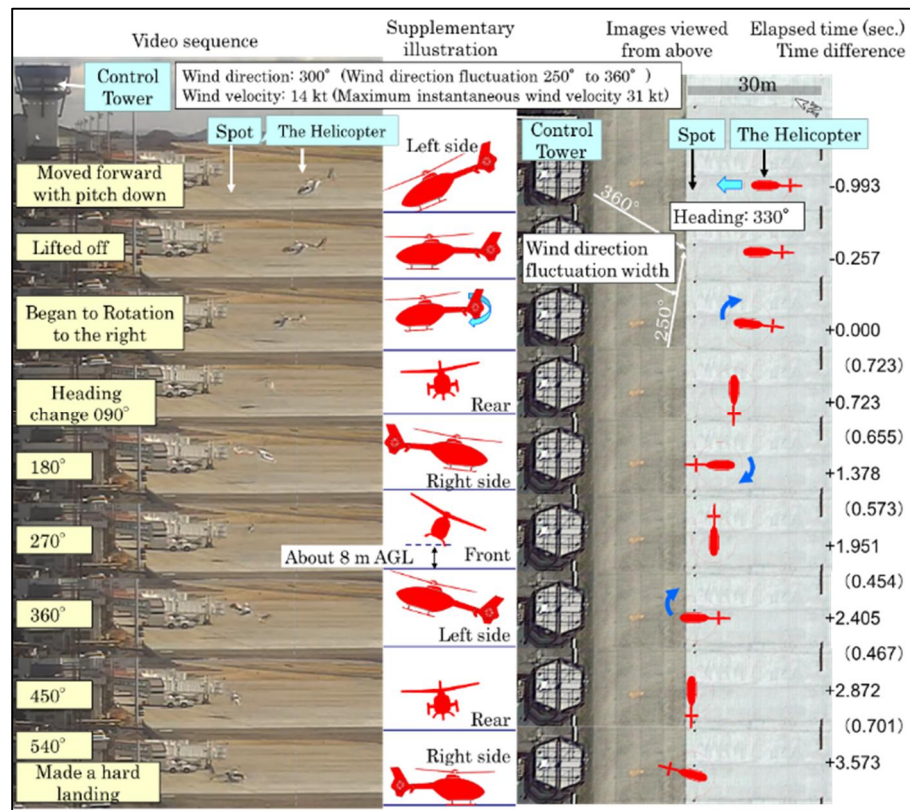
Figure 6: Situations when the Helicopter Started the Right Turn until It Made a Hard Landing

Figure 6 shows the situations when the helicopter's pitch attitude became was significantly nose down, lifted off while moving forward, then rotated to the right and landed harder.

It was confirmed that after the helicopter's pitch attitude was significantly downward and lifted off while moving forward, its attitude became level and immediately thereafter it began to rotate to the right. The right rotation of the helicopter in the air was one and a half turns (about 540°). It took 3.6 seconds from the start of the right rotation to the hard landing. The AGL during the right rotation was almost constant, and as a result of a comparison with the three angle views of the surrounding buildings, the maximum AGL was about 8 m (about 26 ft), and this was when the helicopter rotated about 270°.

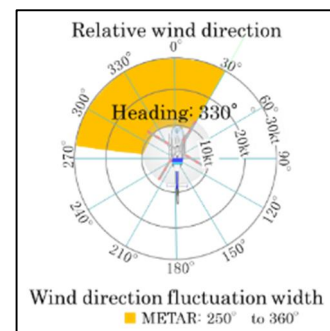
Figure 10: Relative Wind Conditions at the time of the Accident

Figure 10 shows the relative wind conditions at the time of the

accident. According to the pilot's statement, the pilot felt a strong crosswind from the left when the approaching the apron.

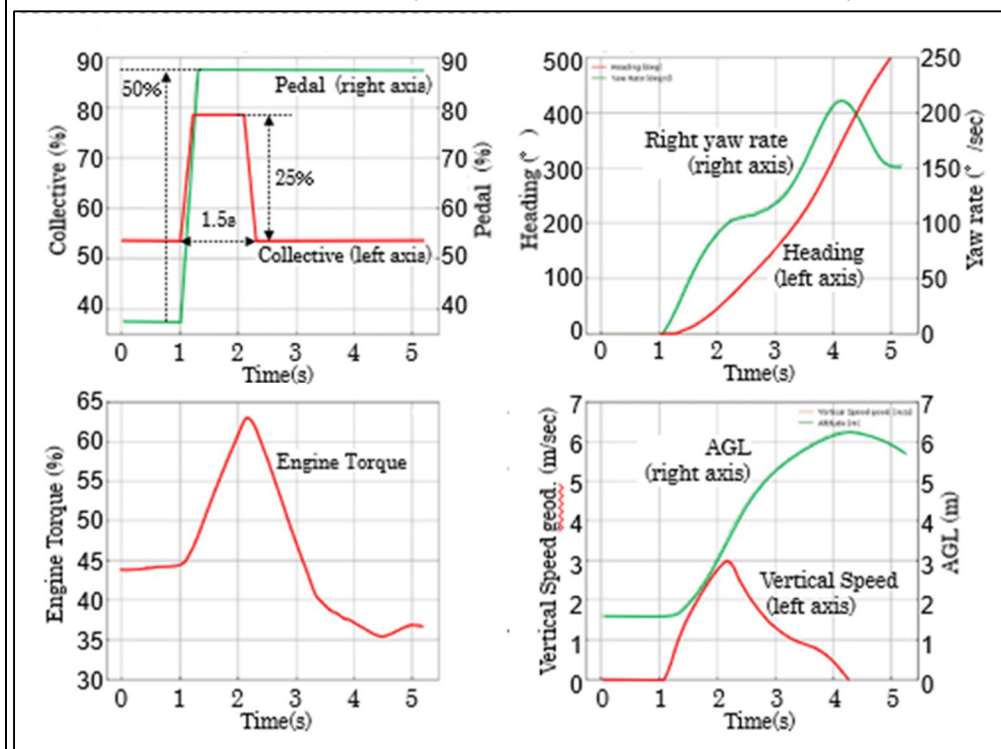
Figure 12: Results of the Simulations at AHD (Excerpt)

Figure 12 shows the simulation results that were most consistent with the Video analysis.

As can be seen from the top left graph in Figure 12, the simulation scenario that most closely matched the AHD's video analysis was an

operation that increased the right pedal by 50% and raised the CP by 25% from the hover state and returned only the CP to its original position after about 1.5 seconds.

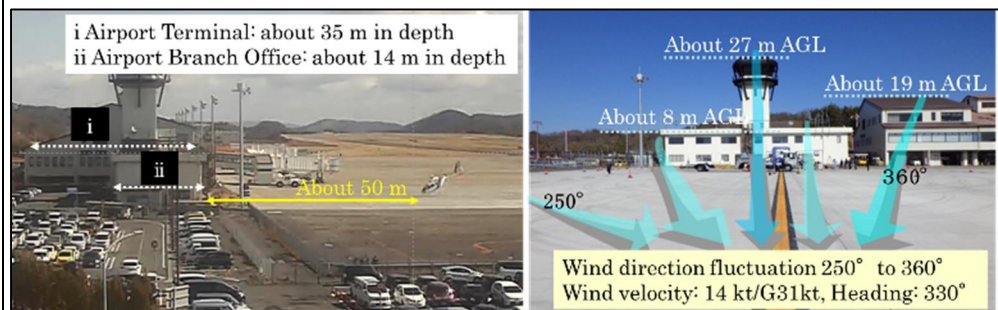
Figure 13: Geographical Situation and Wind Direction in the Area where the Helicopter Touched Down about 20 m short of the Spot

The location where the helicopter touched down about 20 m short of the Spot was on the apron about 50 m from the building with the Okayama Airport Branch Office, on the windward of which were buildings of varying depth and height and a wide-open car park (see Figure 13).
