# AIRCRAFT ACCIDENT INVESTIGATION REPORT

## DEATH OF PERSONS CAUSED BY DITCHING

FUJI FA-200-160, JA3803

ARIAKE SEA, ABOUT 10 KM WEST OF MIIKE PORT,

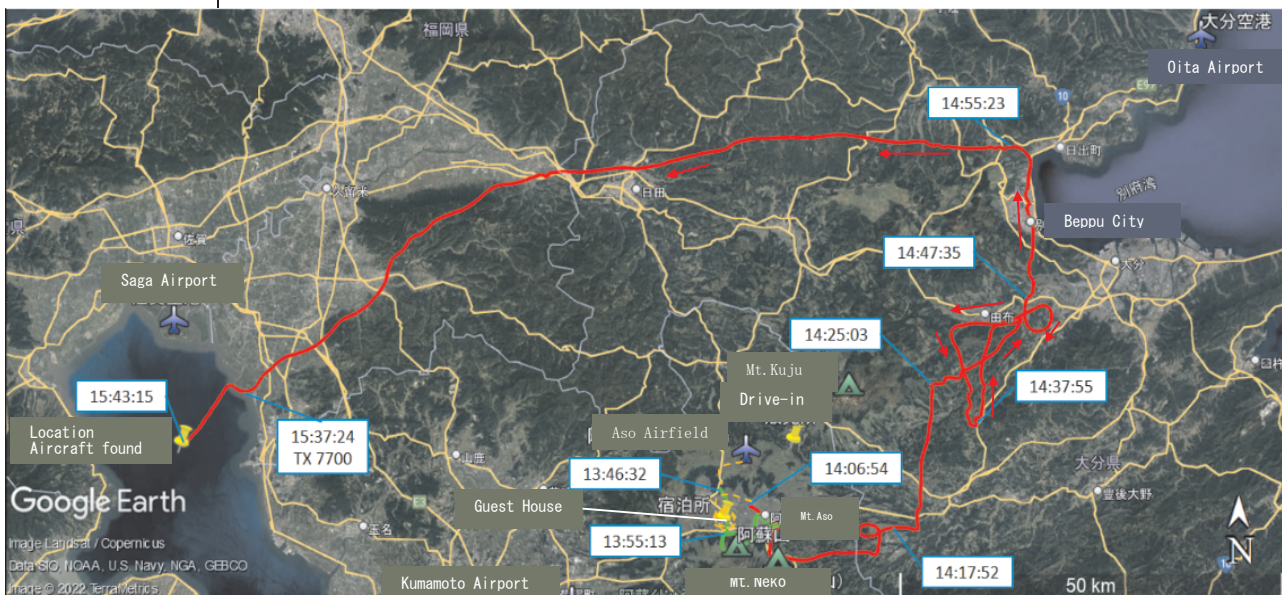
Figure 2: Flight route of the aircraft

It was 13:46:32 when the air traffic control radar first captured the image of the Aircraft which was flying south after taking off from Runway 26 of the Airfield. After that, the radar lost the image of the Aircraft at 13:55:13, but recaptured at 14:06:54, and had been capturing the Aircraft until it was lost at 15:43:15 over Ariake Sea. Details are as following.

The Aircraft then flew northeast, went north along the coastline of Beppu Bay, (see Figure 2) then flew toward west at 14:55. As the captain saw sea in the east, he may assumed that the Airfield might in the west. At this point, the Aircraft altitude was about 4,000 ft, and it was about 50 km away from Mt. Nekodake which he used as a ground reference and he tweeted “Where is the jagged mountain?” and also tried to communicate with somewhere by radio, the captain had most likely lost the position of his aircraft completely in around Beppu Bay.

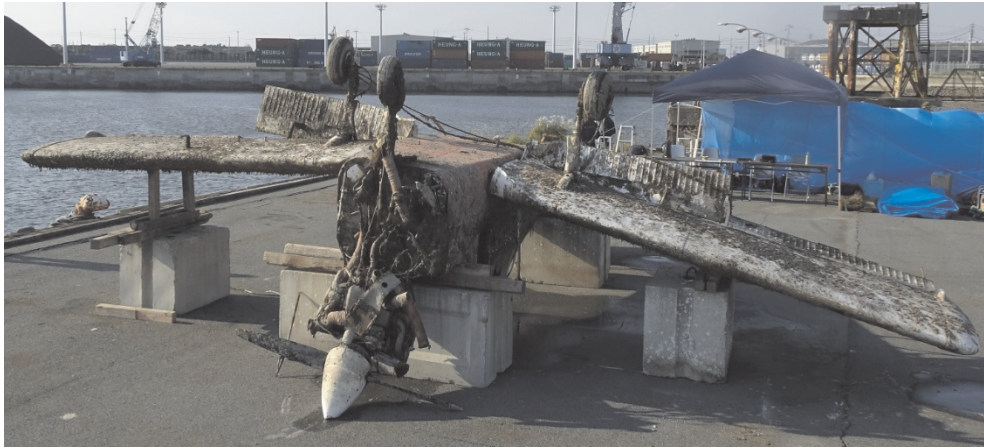
<p><b>2.2 Injuries to Persons</b></p>	<p>Captain: Fatal injury  Passenger: Fatal injury</p>
<p><b>2.3 Damage to the Aircraft</b></p>	<p>The Aircraft was found at the bottom of the Ariake Sea about 10 km west of Miike Port (latitude 33° 00' 56" north, and longitude 130° 18' 33" east) on April 20, 2022, and raised out of sea on October 23, 2022.</p> <p>Extent of damage of the Aircraft: Substantially damaged</p> <p>① Nose section</p> <p>Engine cover: Detached  Engines: Detached from the engine mount  Engine detail: No failure leading to the engine stop were confirmed.</p> <p>② Fuselage section</p> <p>Vertical tail: Upper part broken (May be damaged at the bottom or upon raising)</p>

<p>Rudder: Upper part broken (May be damaged at the bottom or upon raising)</p>

<p>Figure 3: The Aircraft (upside-down position as it was in the sea)</p>																												
<p><b>2.4 Personnel Information</b></p>

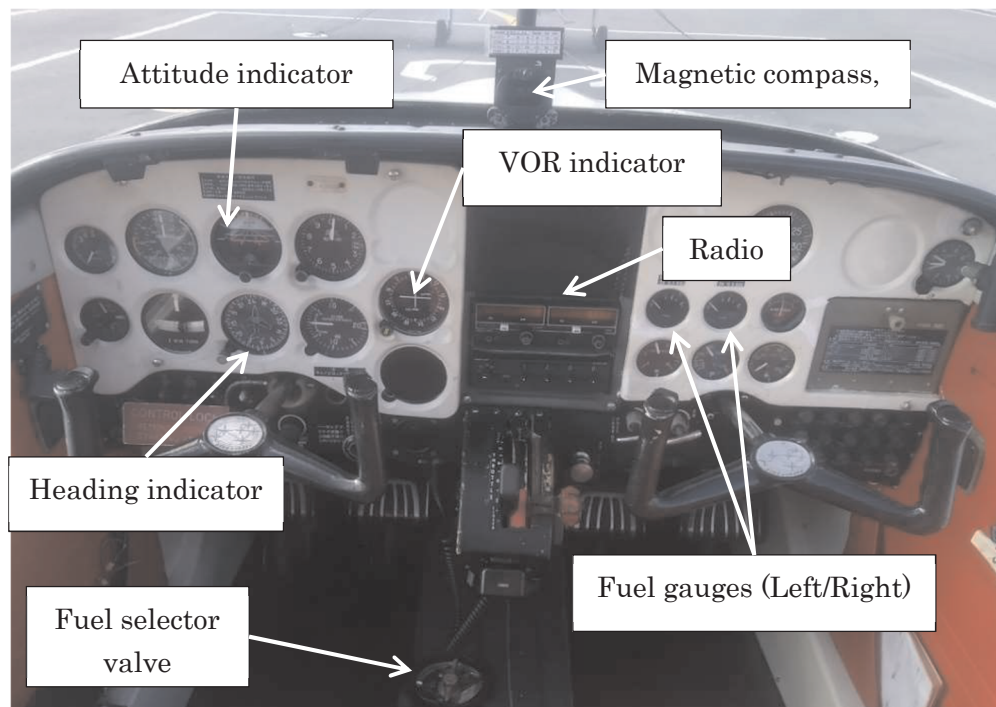
Figure 4: Instrument panel of the accident aircraft

The Aircraft was equipped with navigation instruments such as the attitude indicator, heading indicator, magnetic compass, and VOR\*<sup>2</sup> indicator. During flight when the accident occurred, there were nearby three airports such as Kumamoto Airport, Oita Airport, and Saga Airport which had the VOR station, respectively.

Aircraft radio, which was raised out of sea was investigated, and it was found that the frequencies last set were as following.

Radio	126.2 MHz: Common backup frequency used in control towers at airports in Japan.
Radio STBY* <sup>3</sup>	130.75 MHz: Frequency for Aso flight service
Navigation	112.8 MHz: Frequency for Kumamoto VOR

frequency which was set on the radio, the information of Kumamoto VOR was possibly displayed on the indicator. However, as Kumamoto VOR is announced unusable from magnetic bearing 030° to 180° below 8,000 ft, at the location around Mt.Kuju where the captain lost its position, Kumamoto VOR was not usable. As the captain and the Trainee did not carry any flight chart, they were unable to check other VOR frequencies, so more likely the situation unable to find their position continued.

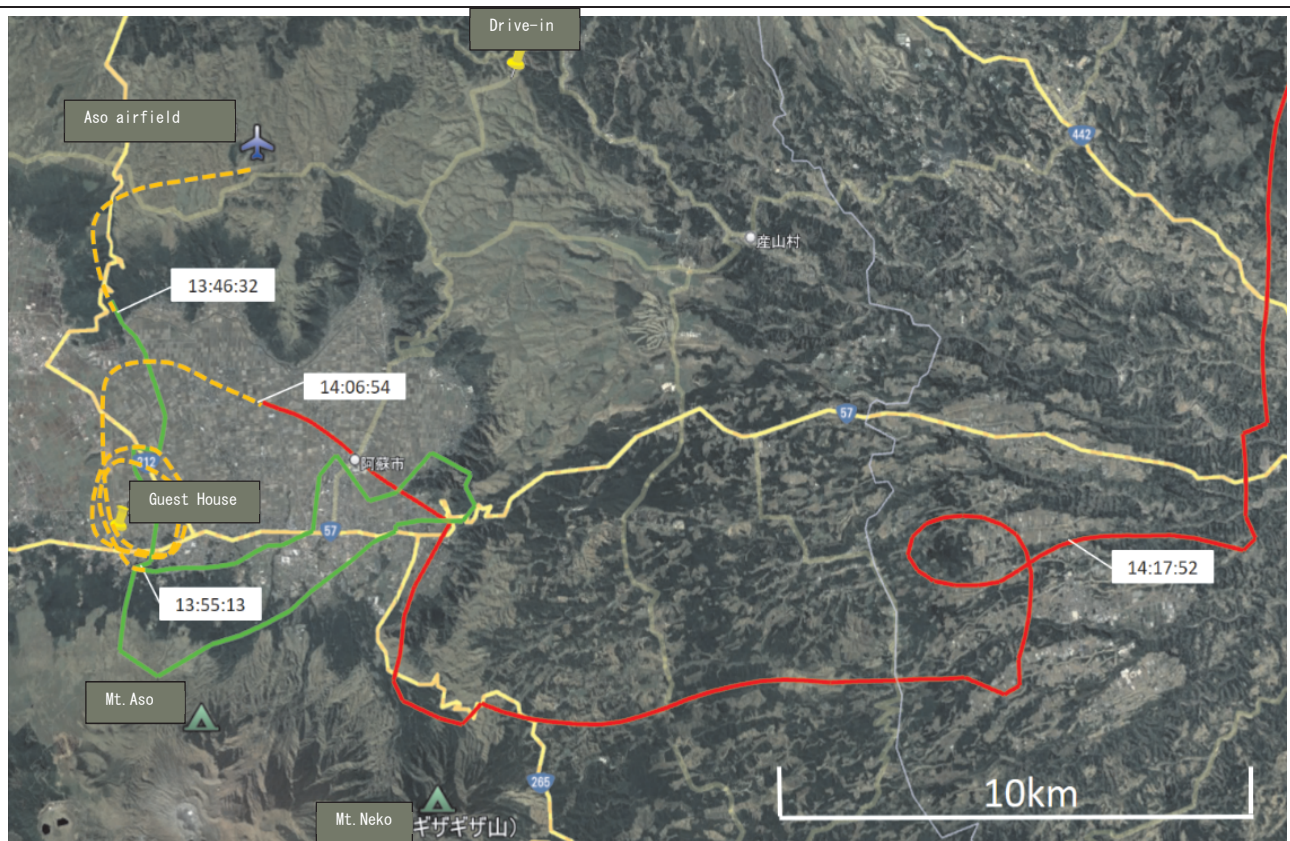
Figure 5: Flight route of the Aircraft

According to the statements of the Trainee and the Persons involved, and radar track records, the Aircraft took off and flew over the Guest House run by the passenger, flew in the vicinity of Aso City, then circled again at a lower altitude over the Guest House, and then, flew nearby Mt. Nekodake, therefore, at this time, the captain more likely had visual contact with Mt. Nekodake and was aware of the position of the Aircraft.

And then, the Aircraft flew 20 km east, and continued flying 20 km north (for about 10 minutes), and at around 14:25, after flying 10 km east from the east side of Mt. Kuju, it flew 10 km back and forth in a north-south direction. At this time, the captain may lost sight of Mt. Nekodake, which was used as a reference for the position of his aircraft, and may lost the position.

After that, the Aircraft flew west about 120 km (for about 50 minutes), went out to the Ariake Sea, as the Trainee urged to fly near the land and made a right turn along the coast. The Saga Airport was straight ahead, but the captain possibly misidentified the location of the Airport although the Aircraft was about to head to Saga Airport since when the Aircraft turned left toward the center of the Ariake Sea, and the captain explained to the Trainee “Saga Airport is straight ahead”.
