**AIRCRAFT SERIOUS INCIDENT  
INVESTIGATION REPORT**

**KAWASAKI AIR Co., Ltd.**

**J A 3 8 1 8**

KAWASAKI AIR CO., LTD  
CESSNA TU206G, JA3818  
2,000 FT OVER THE BUILT-UP AREA  
2 KM SOUTHEAST OF YOKOTA AIRFIELD  
AT 14:12 LOCAL TIME, OCTOBER 23, 2010

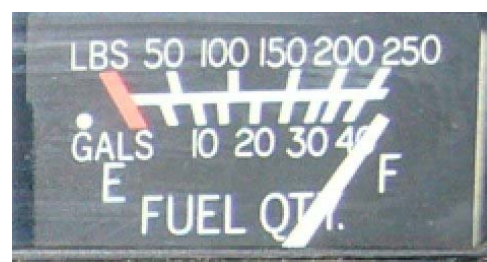
Fuel quantity is measured by two float-type fuel quantity transmitters. The picture here shows the fuel quantity indication of a filled-up fuel tank.

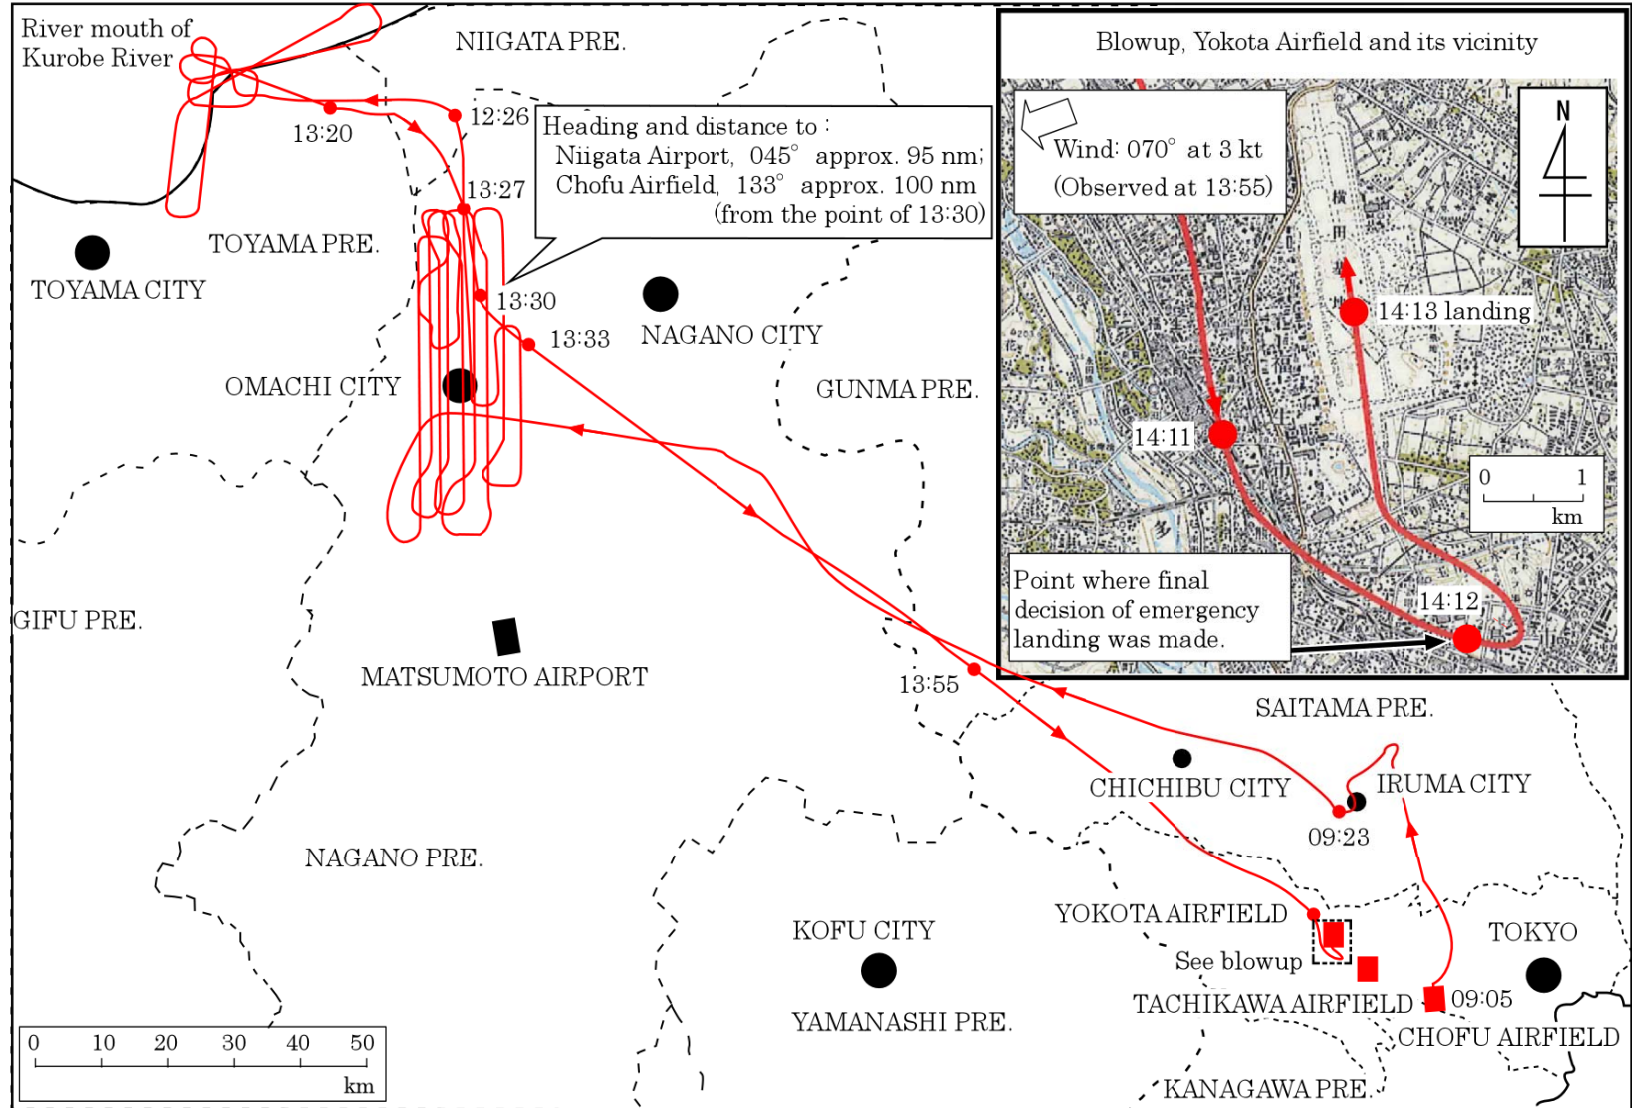
Figure 1: Estimated Flight Route

- Airfield and requested a landing there.
- 14:11 The PIC changed his mind to land at Tachikawa Airfield and withdrawn his emergency declaration.
- 14:12 The PIC changed his mind again and declared a state of emergency again.
- 14:13 The airplane landed at Yokota Airfield.
- (See Figure 1: Estimated Flight Route, Attachment: Radio Communication Records)

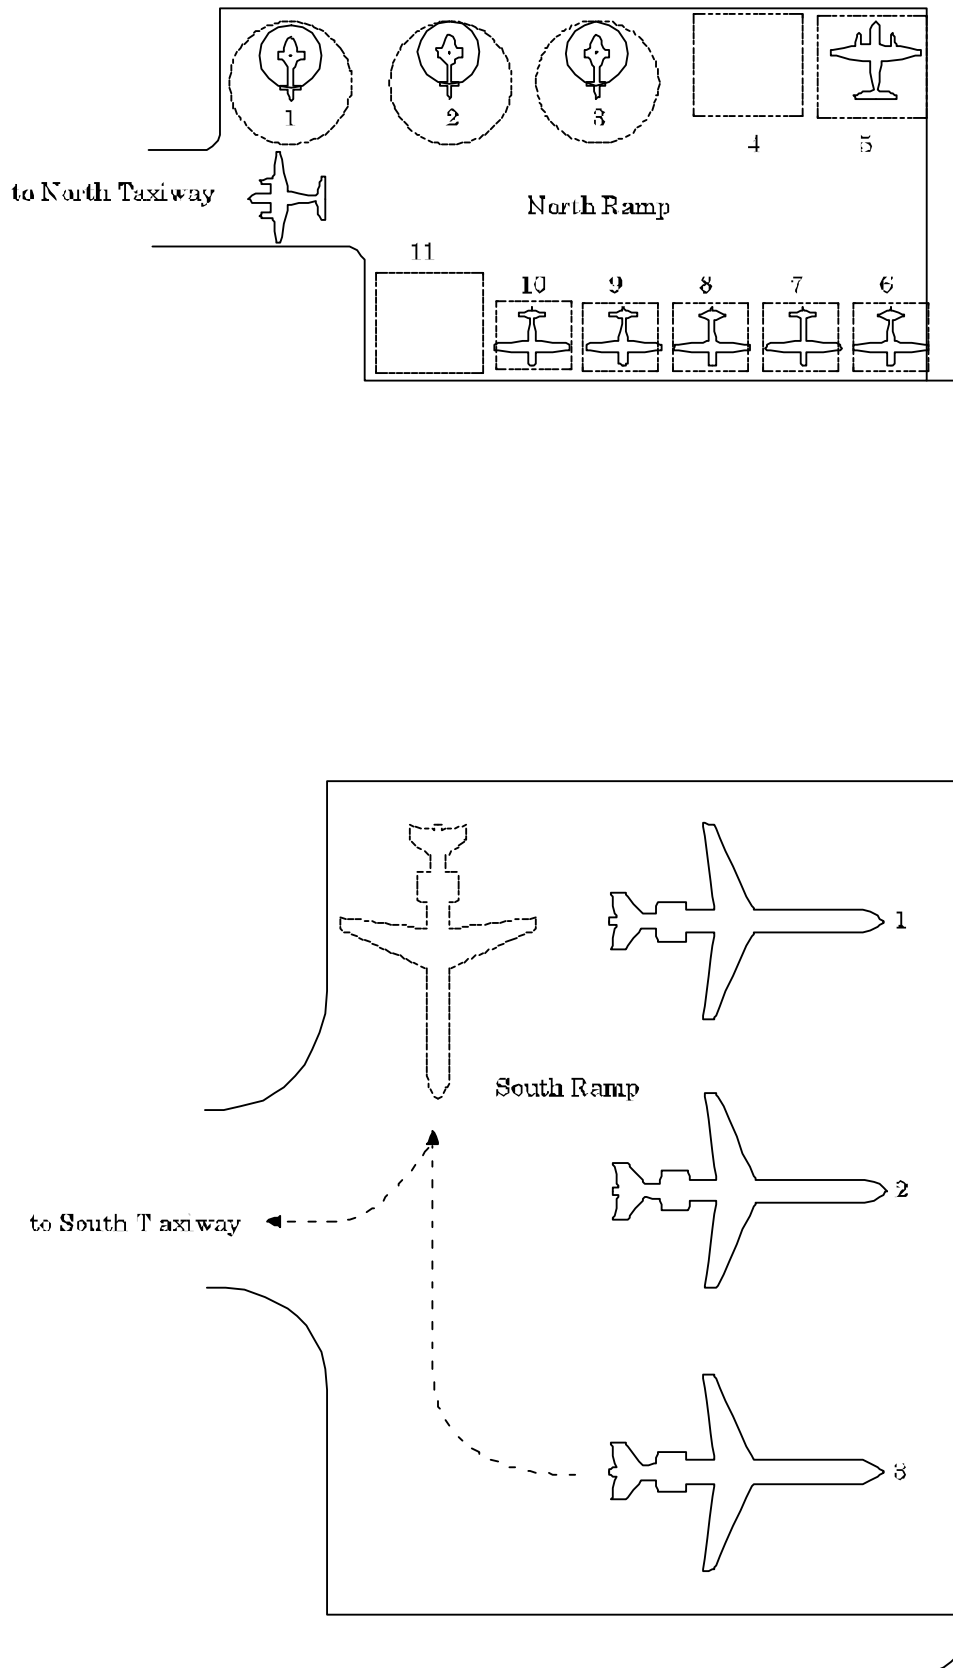
Figure 3: Ramp Diagram at Matsumoto Airport

However, slots No.4 and No.11 are usually not in use: No. 4 due to downwash generated by helicopter parked at No.3 slot; No.11 due to a blast generated by an airplane which taxis out after being pushed back from No.3.

- b. During one hour and half timeframe on and after 13:30, slot No.4 which was kept open was available and one of slots for scheduled airlines was available.

The person who was in charge of ramp slot management probably did not feel the urgency for the airplane's refueling while all ramp slots but No.4 were booked, so that he replied to the FSC saying that all the slots are booked. It is probable that the PIC's intention of refueling was not strong enough.

On the other hand, booked slots do not mean they are parked with aircraft all the time, some booked ones may be unoccupied depending on timeframe.

It is desirable that each airport office's flexible acceptance of refueling request when they receive a refueling destination change even aircraft does not declare a state of emergency.

*Considering the fact that some airports lack some types of fuel service, when an airport office receives a request of refueling landing, even if an aircraft does not declare a state of emergency, try to secure a temporary refueling slot. In case of no available slot, try to create a temporary one with the suggestion of CAB personnel.*

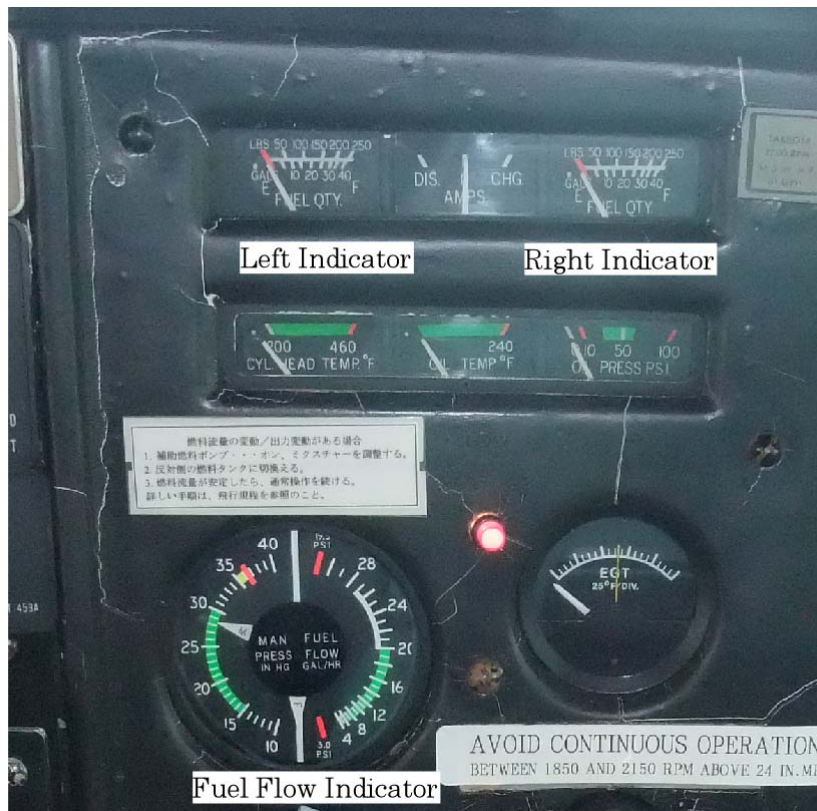
Photo 2: Fuel Quantity Indicator

When both drain bolts are unscrewed and tanks were emptied, the left tank indicator showed 5 GALs and the right tank indicator touched the red line.

Next, after filling 3 gallons of fuel, each amount of fuel shown here was added and each indication was recorded. The discrepancy between the usable fuel quantity and indication for usable fuel was largest for the left tank at 1 gallon and 12.5 gallons, as shown here.

When above mentioned values are compared to CES-1210G, allowable error is zero at empty, ±1.2 gallons at points less than indication 11.5 gallons, ±2 gallons at other points, meaning that the indications of both fuel indicators were out of standard at empty and 11.5 gallons.

However, as described in 2.6.2 the fuel indication study showed that the discrepancy between the usable fuel quantity and indication was 4 gallons and 4.5 gallons for left tank at 1 gallon and 12.5 gallons usable fuel; right indicator was

The airplane's flight with erroneous fuel indication resulted in "shortage of fuel requiring urgent measures."

The indication error very likely obscured the PIC's recognition of erroneous fuel indication although the actual FCR was bigger than the calculation value.

In this serious incident the airplane went into a fuel starvation because the PIC did not know the actual FCR was bigger than his value of calculation and he did not notice that the fuel indicators read larger amount than the real one. In order to prevent a fuel starvation from happening, it is important for airplane operators to maintain accuracy of fuel gage reading and share latest FCR information among the concerned.
